## The Day After Heritage Protection Initiative

### Site Monitors Project

#### Damage Report Khan Asa'ad Pasha Regime Airstrike

July 2015

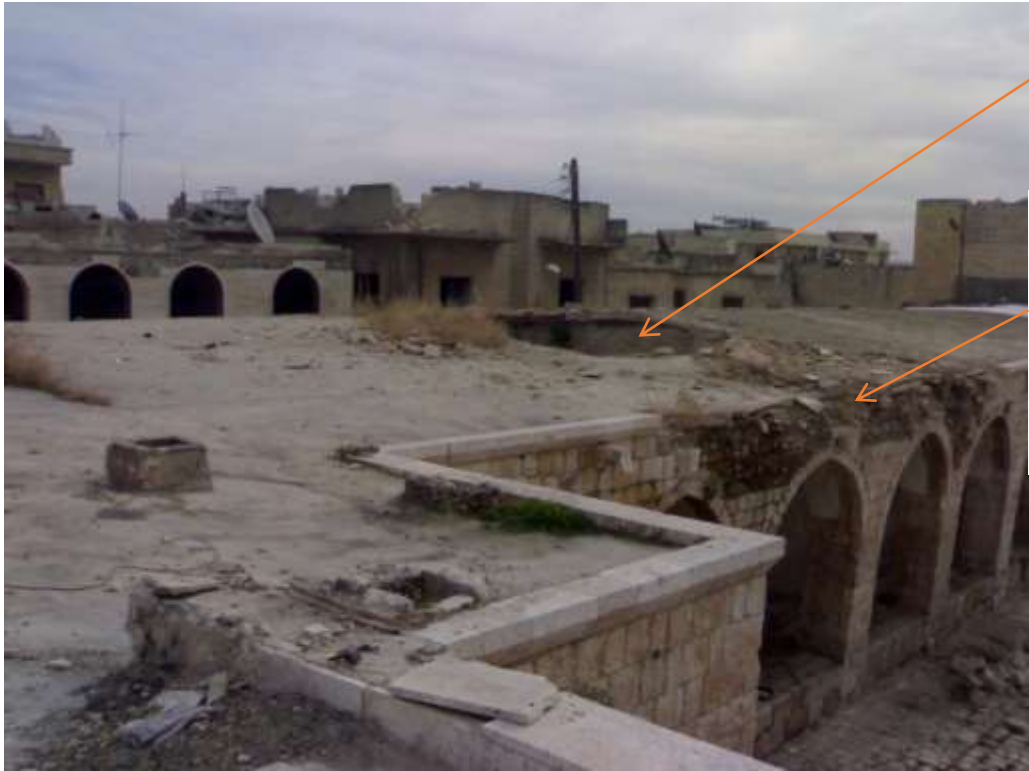
Location of the missile

Partial collapse of the corridor in the eastern side

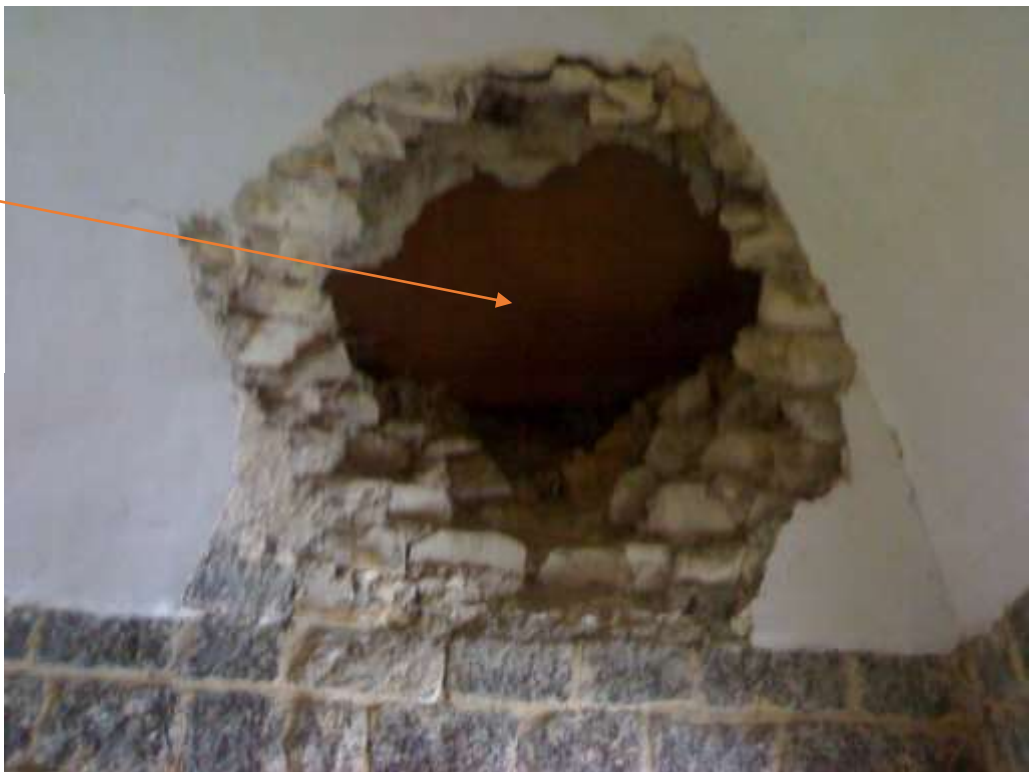
Area affected by mortar fire on the dome of the second floor

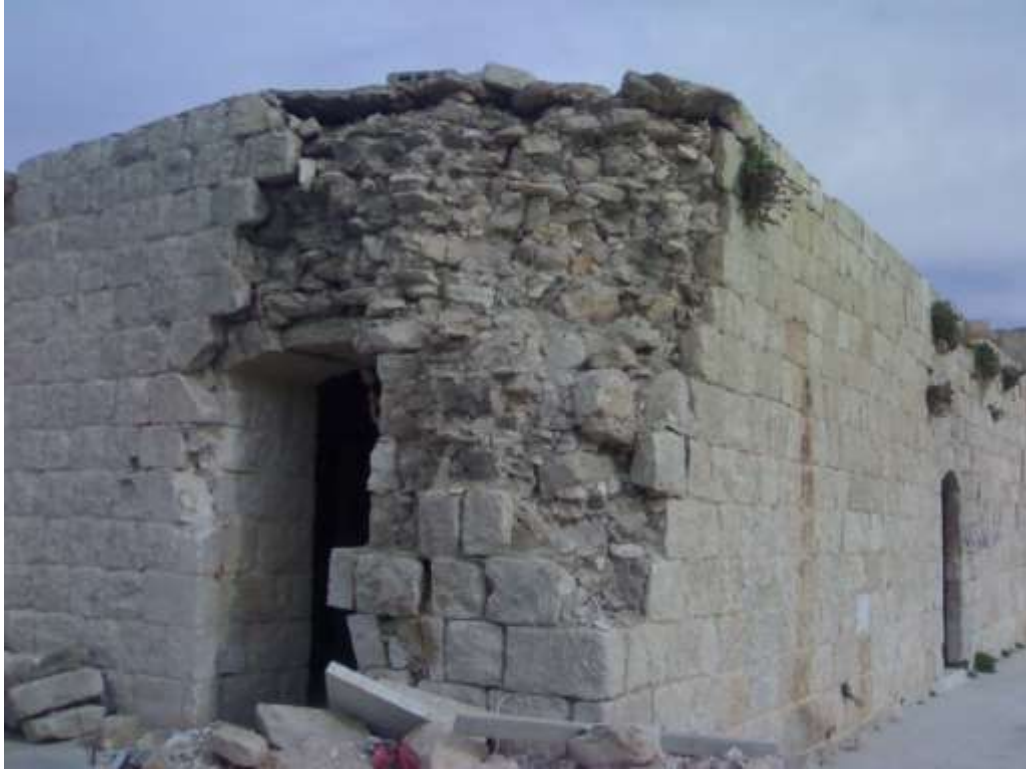
Partial collapse in the southeastern side of the second floor as a result of a missile.

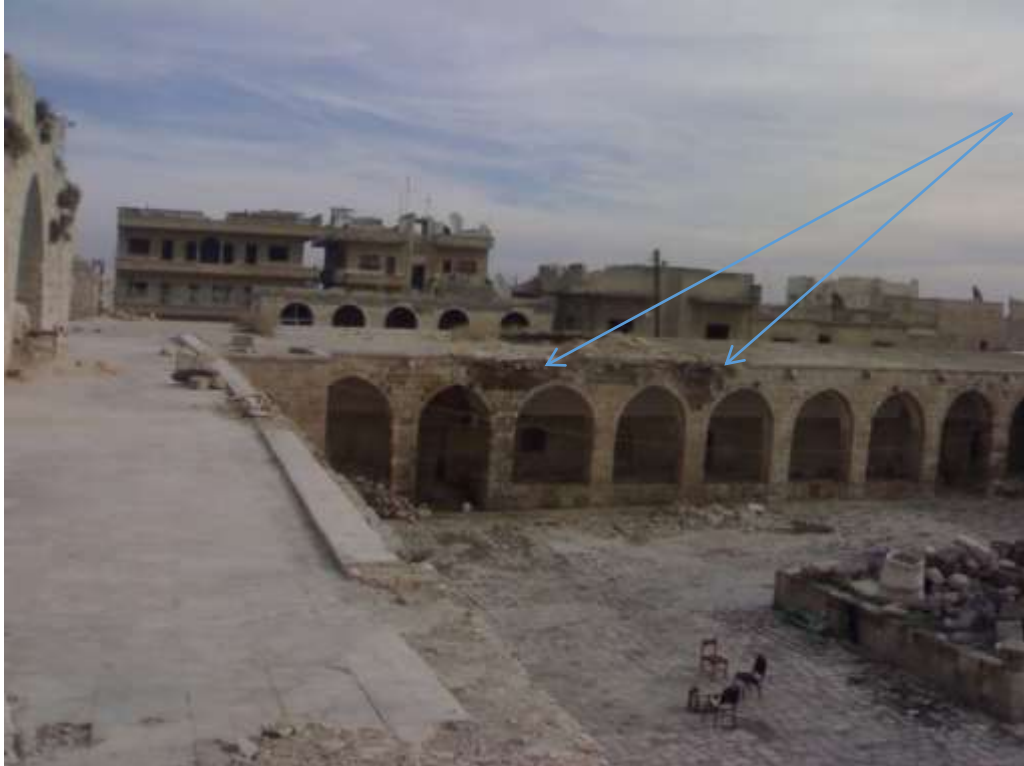
Partial collapse of the corridor on the east side

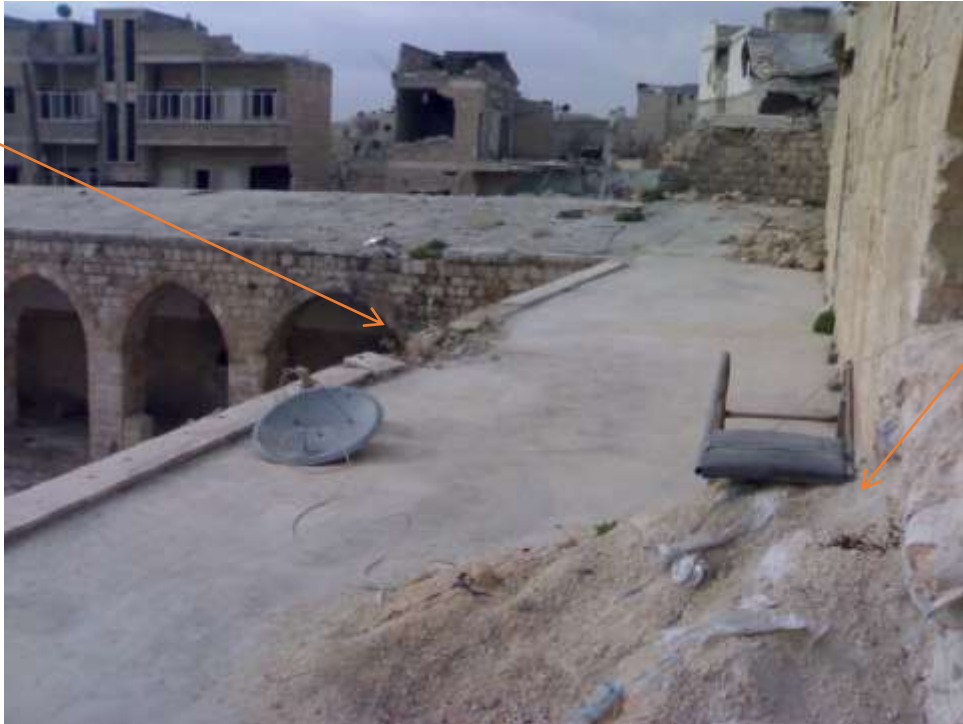
Rubble resulting from the collapse of the corridor

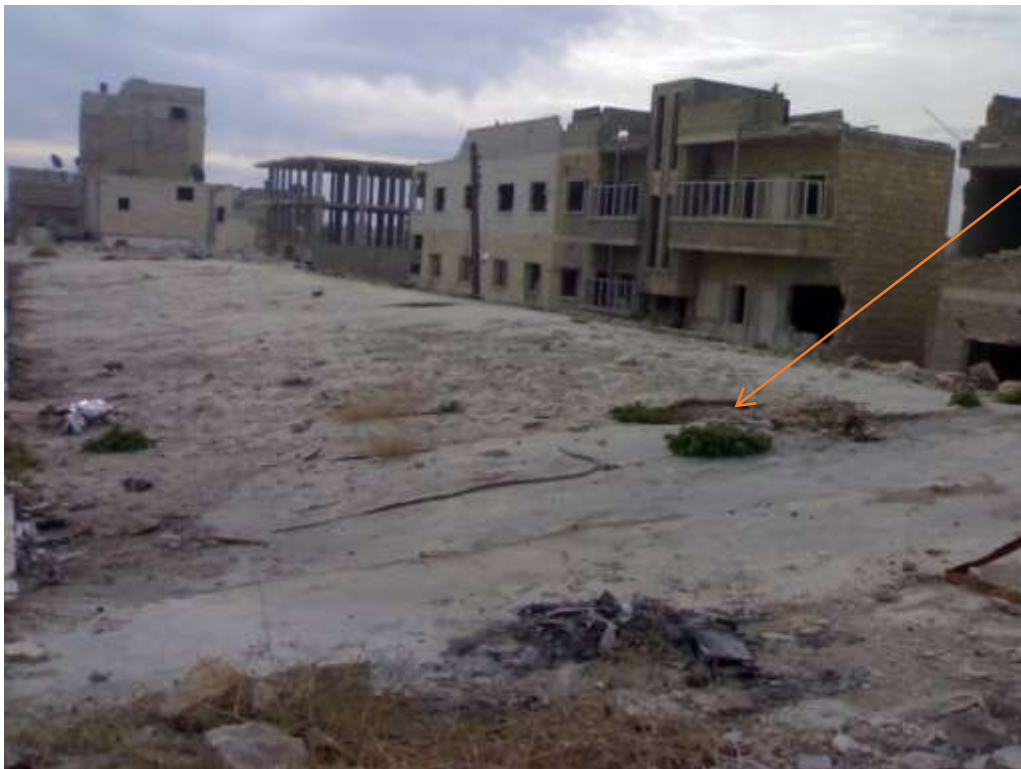
Area affected by mortar fire in the western side of the west wing

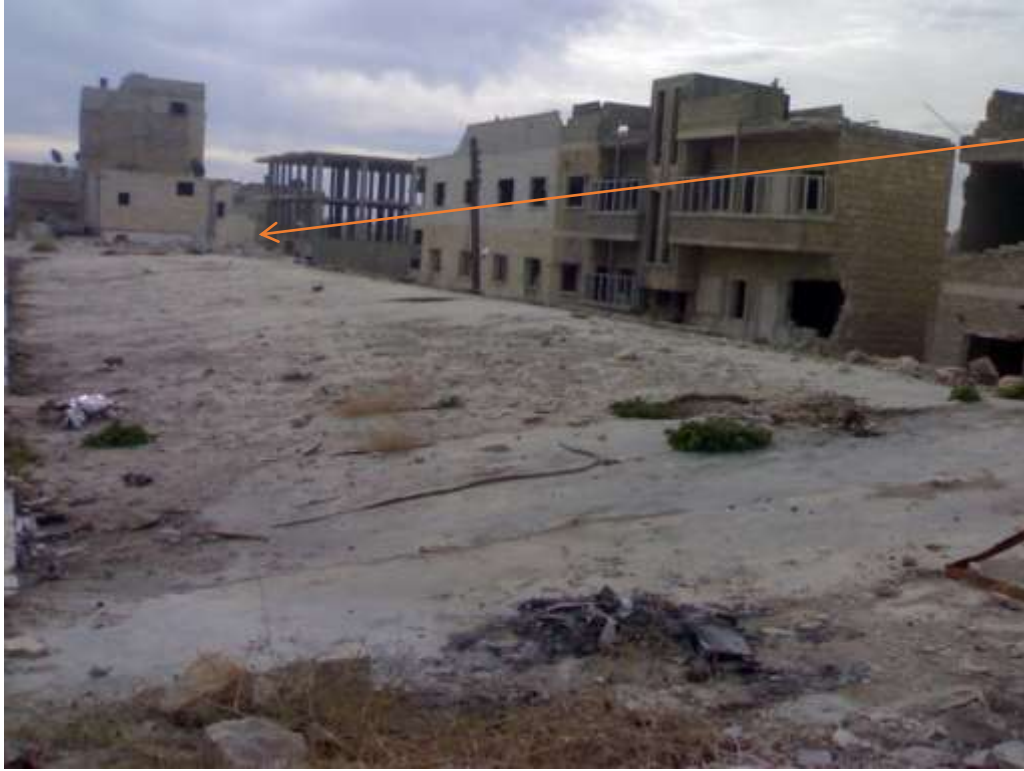
Damage in the south western area near the minaret of the Al Masri mosque

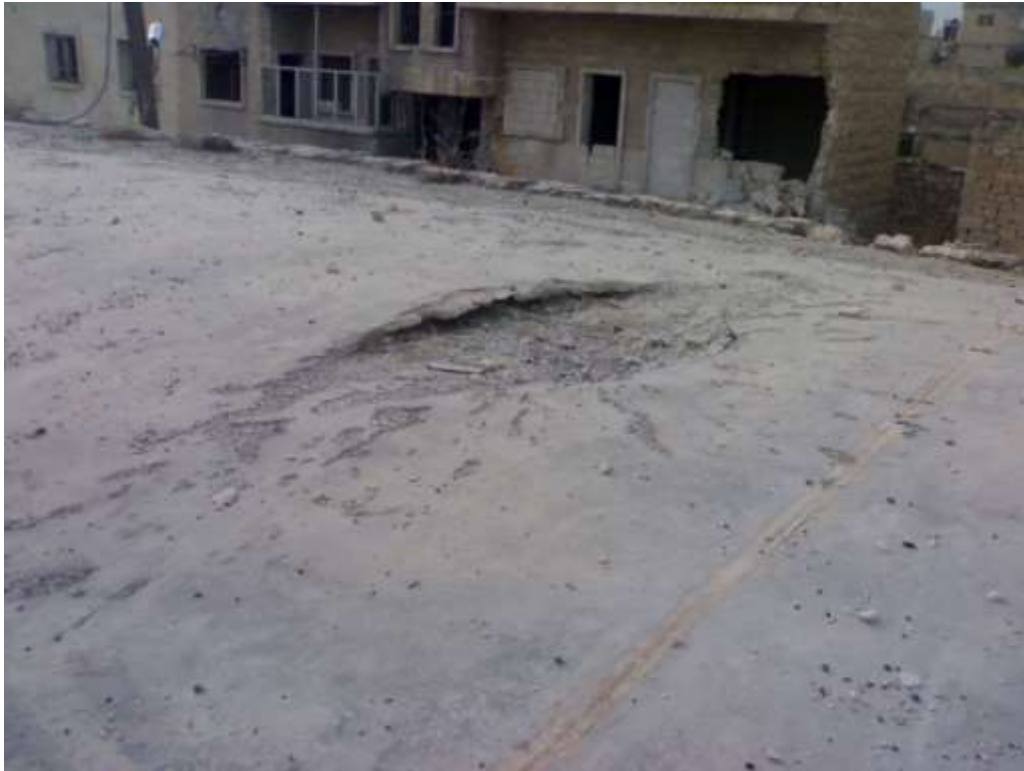
Damage caused by mortar fire

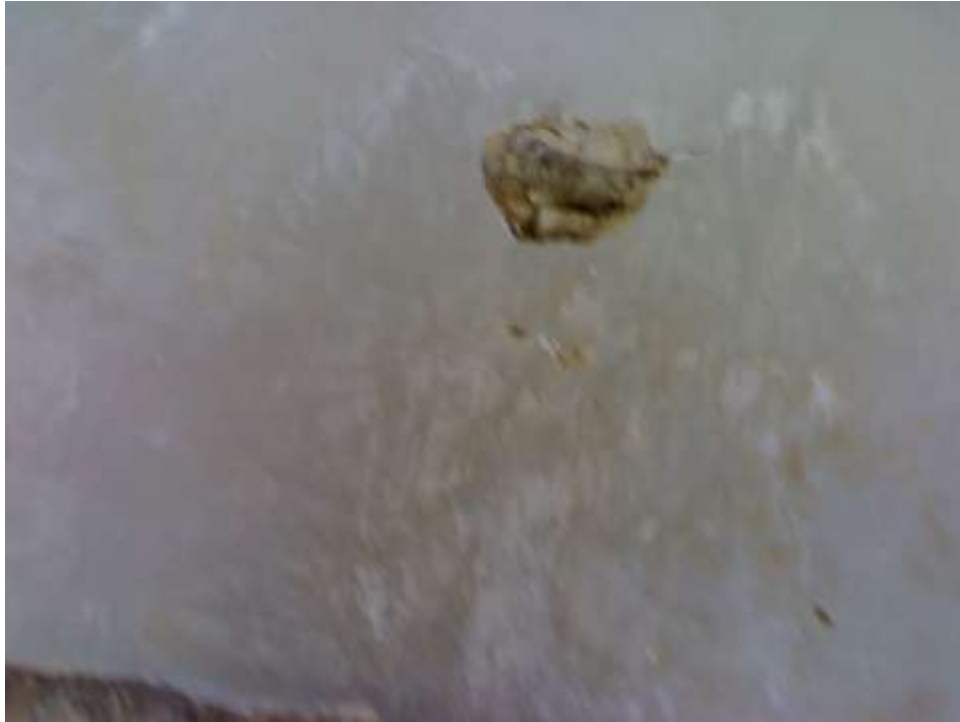
A partial opening in the roof

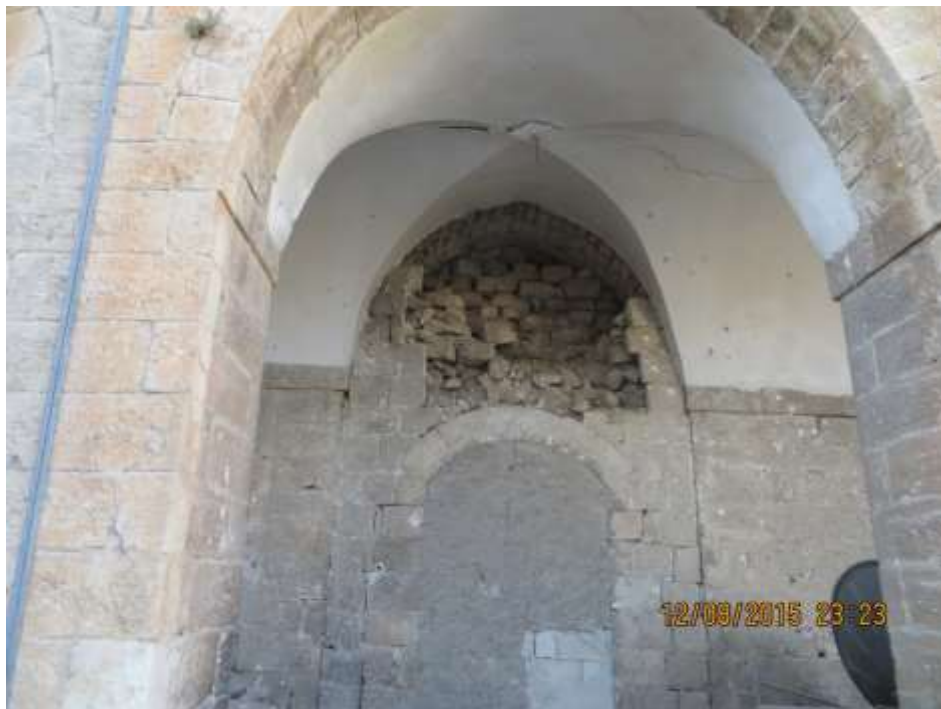
Partial collapse of the first wing as a result of an exploding barrel bomb landing near the Khan

Complete opening in the second floor, which was originally used as a guest house.

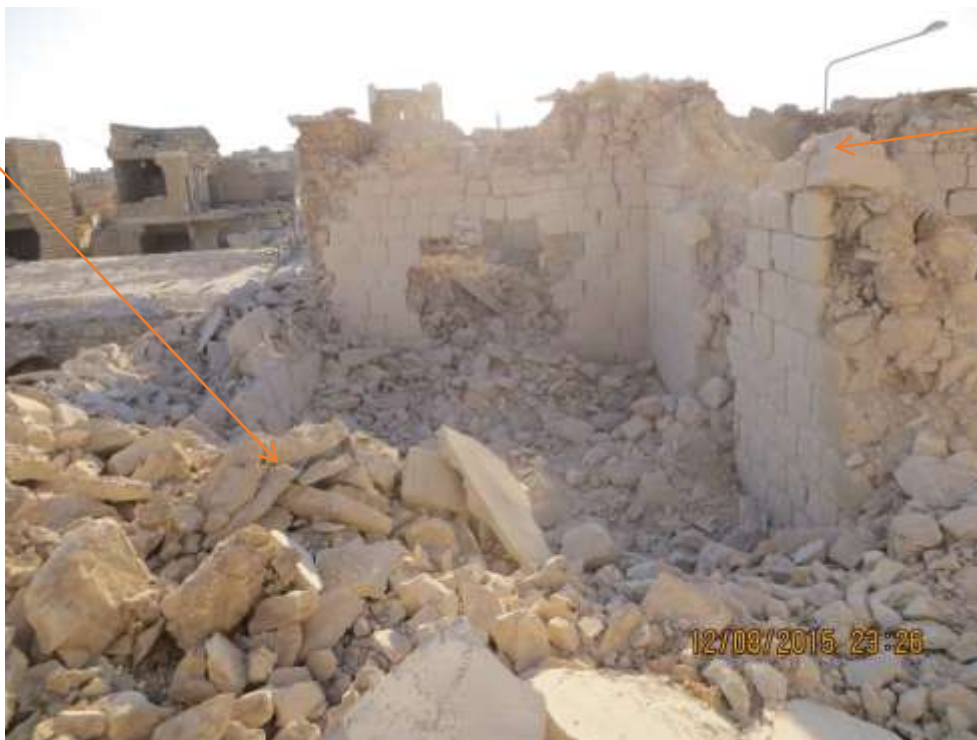
The second floor lobby

The heaviest and most destructive damage to Khan Asa'ad Pasha was caused by the latest airstrike on 8/7/2015. A large section of the second floor (the lobby) and a portion of the rooms in the western side of the building mostly collapsed as a result of this attack. The lobby on the second floor has two restored mosaics mounted on *Aerolam* boards that are now partially buried in the rubble. Both are in need of emergency extraction from the rubble and stabilization/repair (see images below).

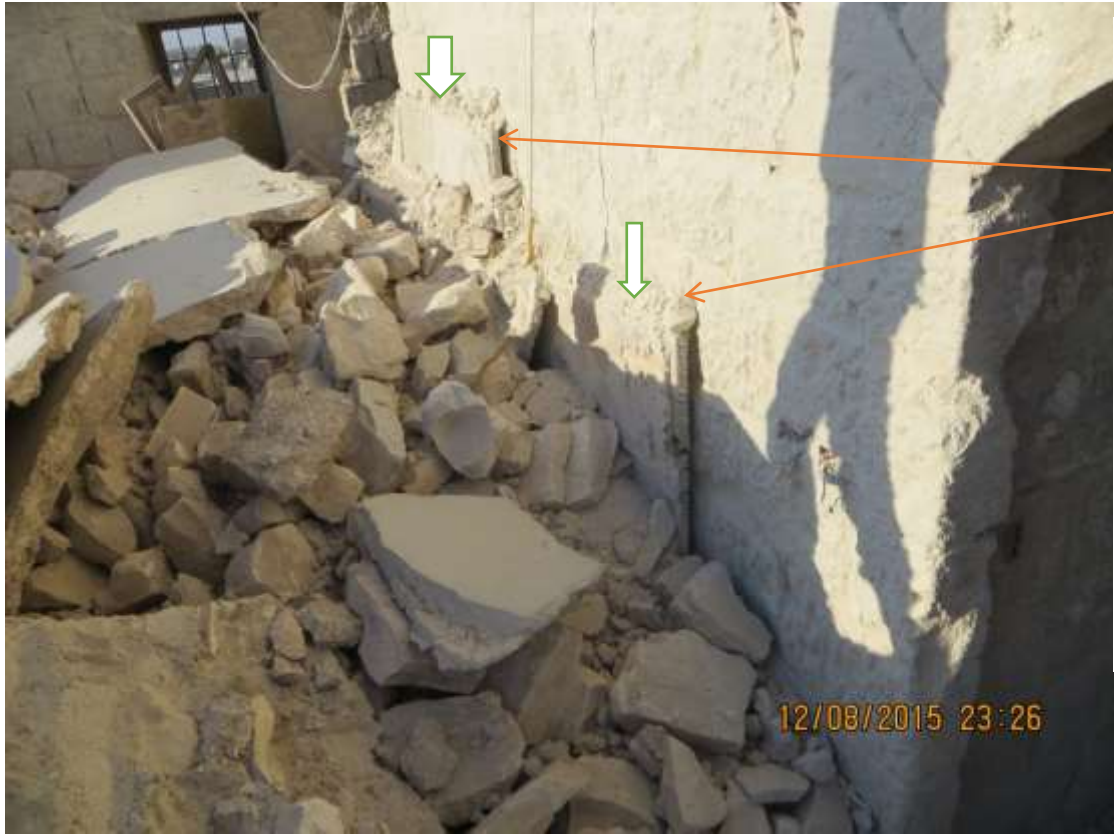
The western side, which was used as a guesthouse.

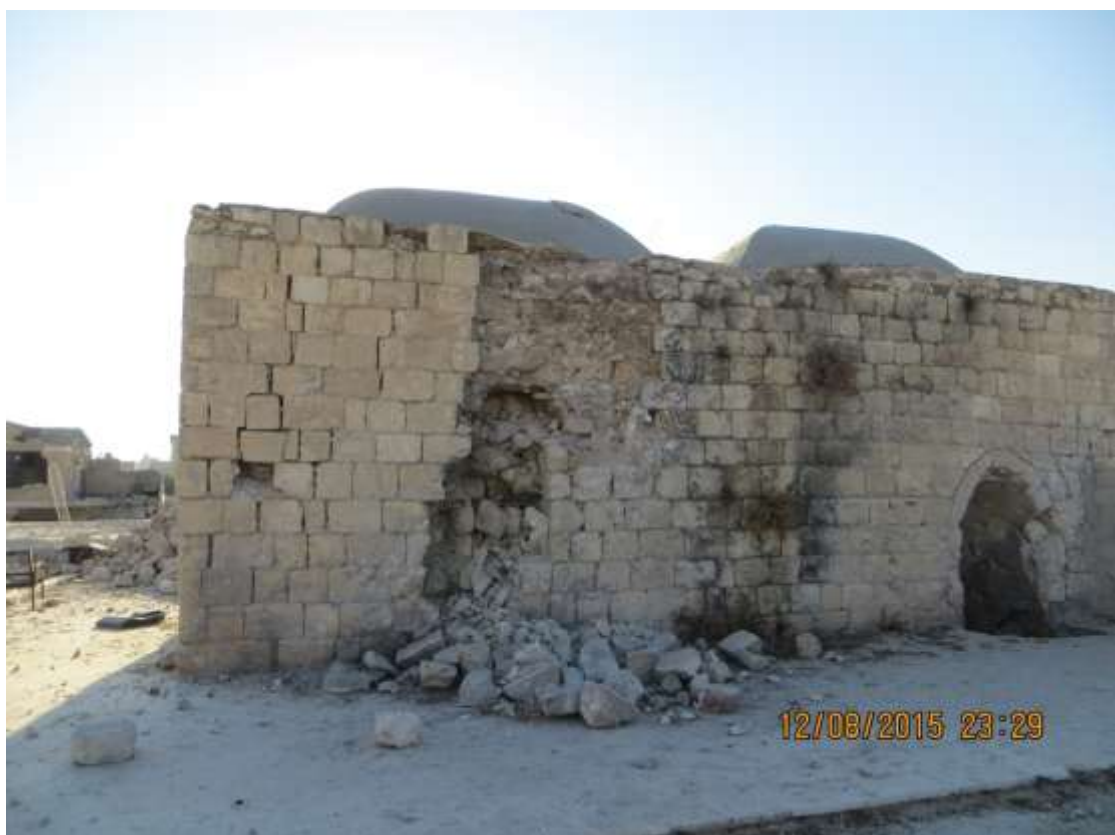
The north side of the second floor showing damage following the latest airstrike

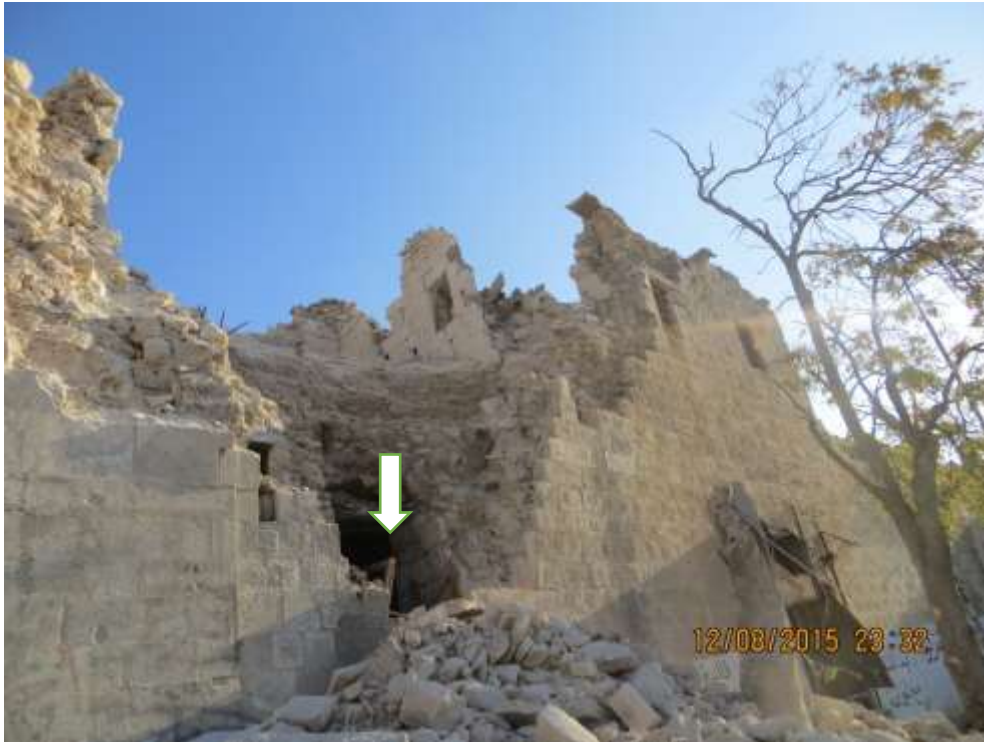
The eastern façade of the second floor showing partial collapse.

A partial collapse in the northern side of the first floor created a large opening in the wall, as shown in the image below.

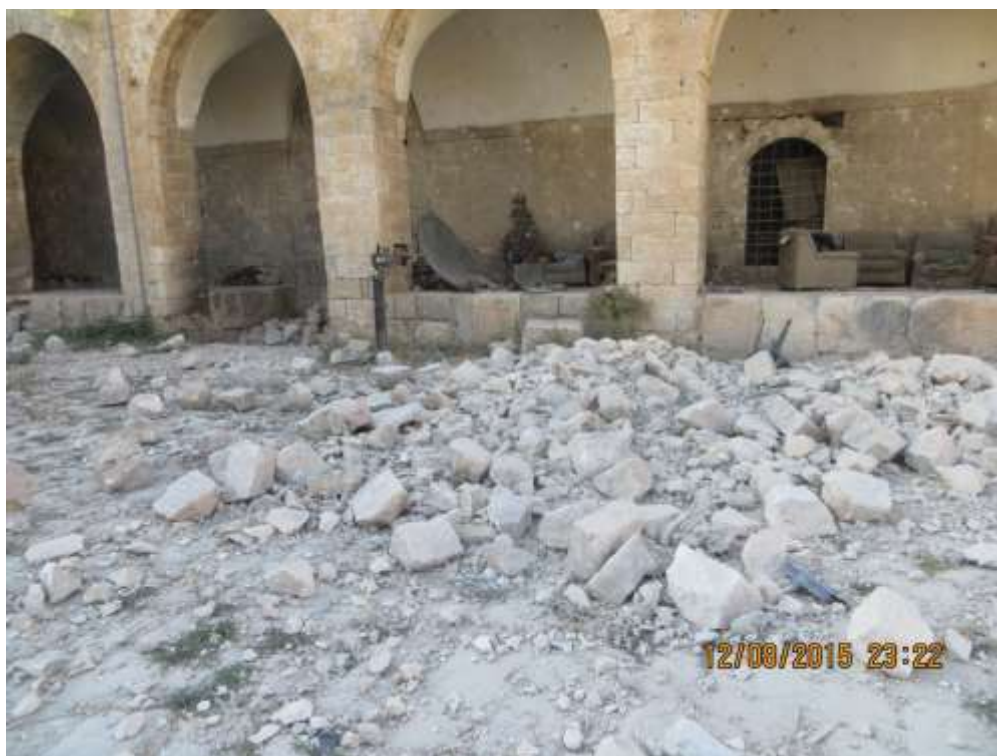
The northern façade of the Khan, after being hit with Airstrikes

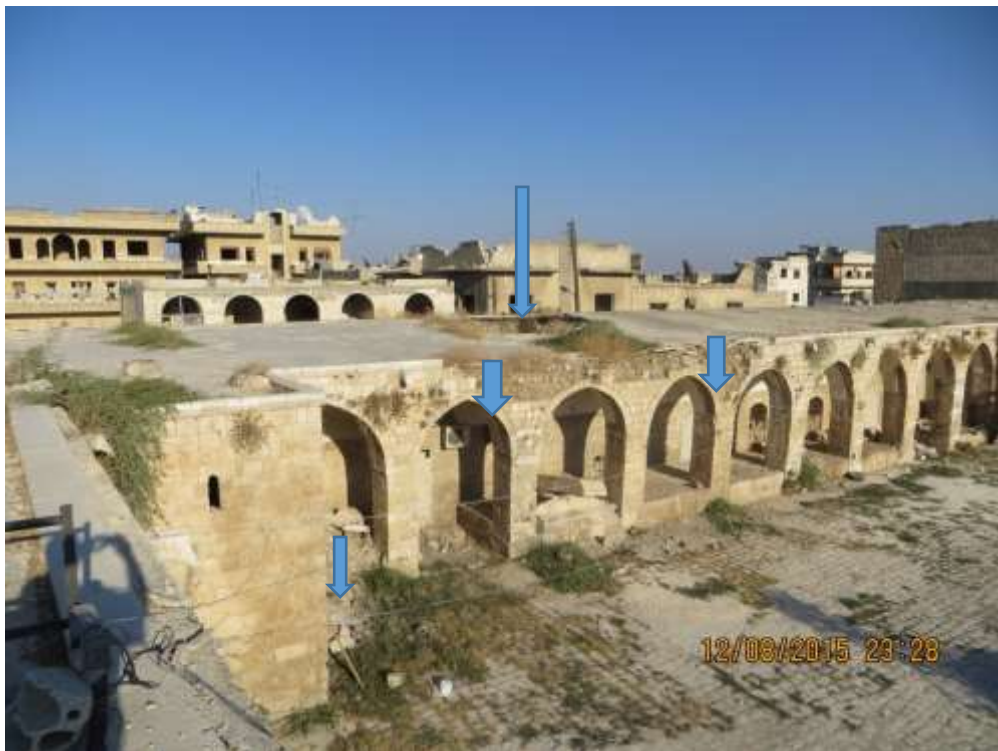
Cracks in the surviving section of the second floor that are a result of the explosion caused by the airstrike.

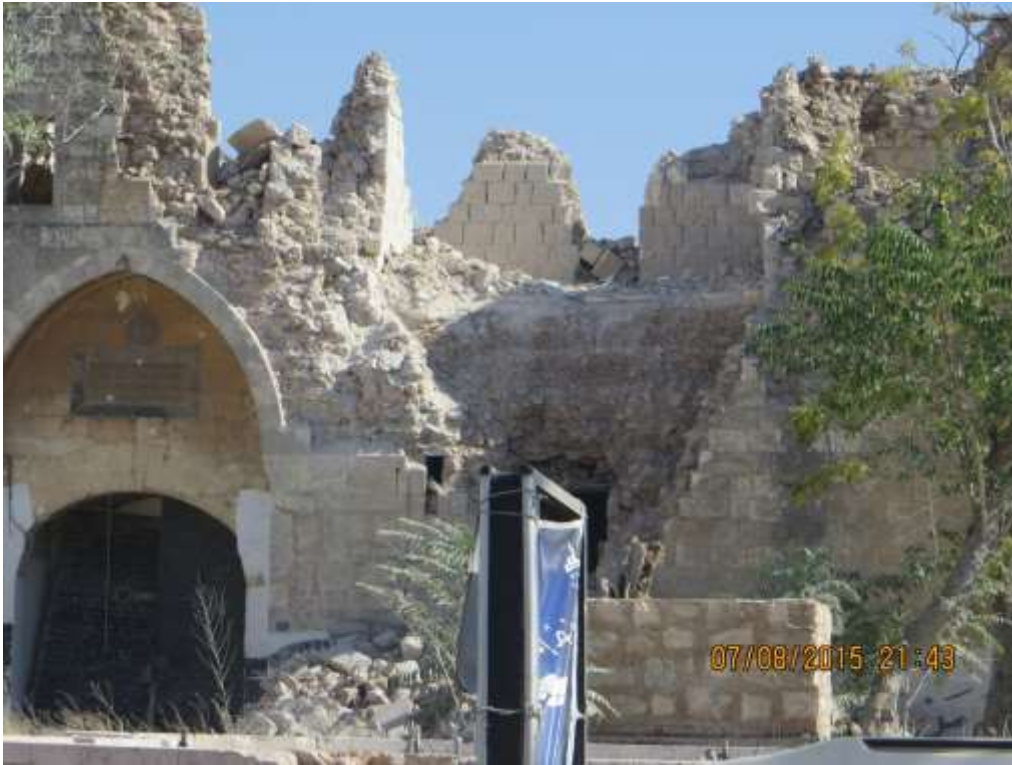
Furthermore, the airstrike caused the large gate at the main entrance to the Khan to come off its hinges and become inoperable. It is currently in need of emergency restoration work in order to return it to use (see images below).

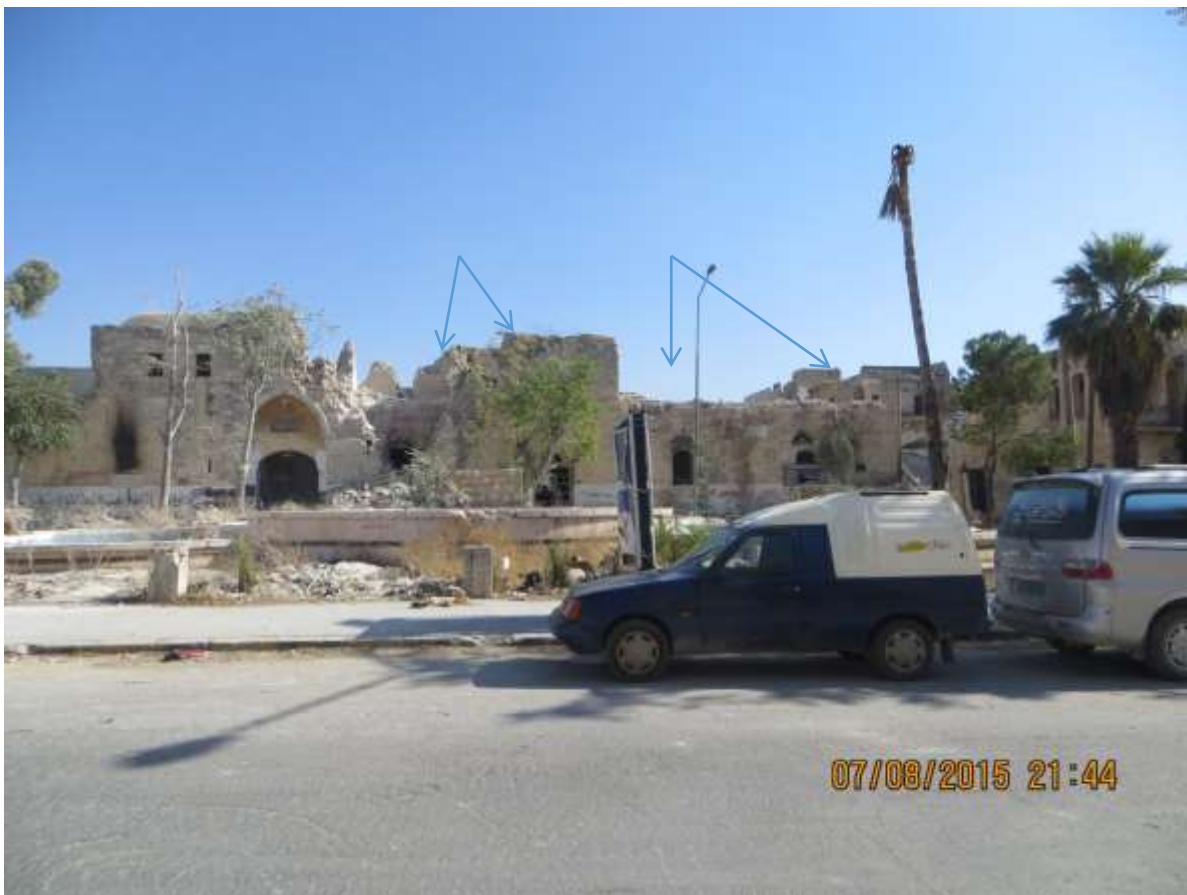
The main entrance from the northern side and the northern façade of the building, which was directly hit with a missile

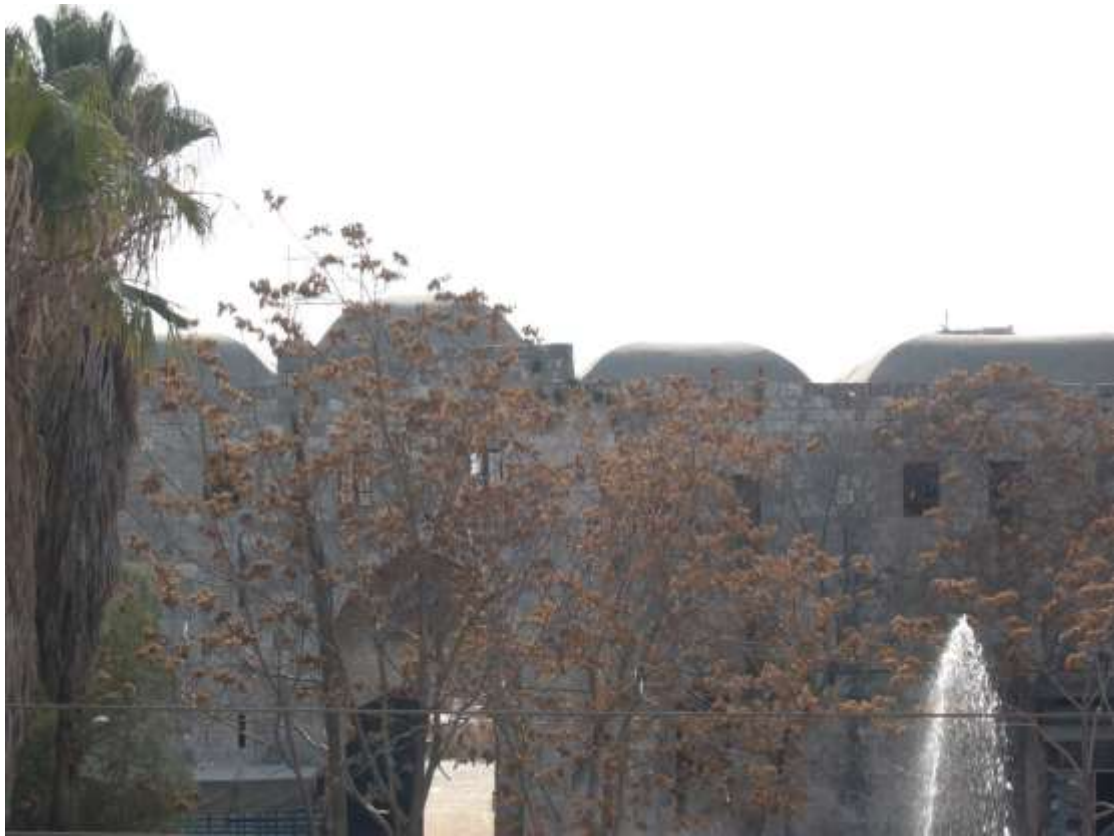
The north side of Khan Asa'ad Pasha after the latest regime airstrike
