## The Day After Heritage Protection Initiative

### Final Report: Stabilization and Reinforcement of the North West Corner (entrance to the third wing) with a Timber Frame

### Ma'arrat Al-Numan Museum (Khan Asa'ad Pasha)

2 August 2018

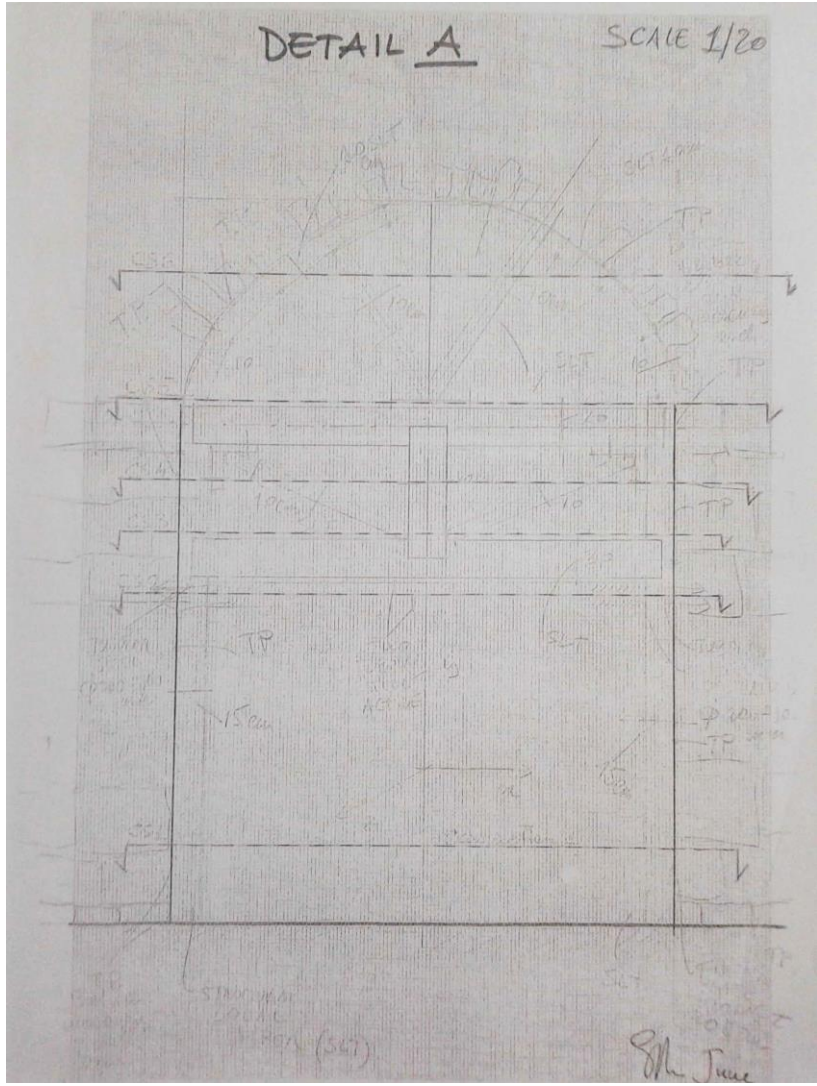
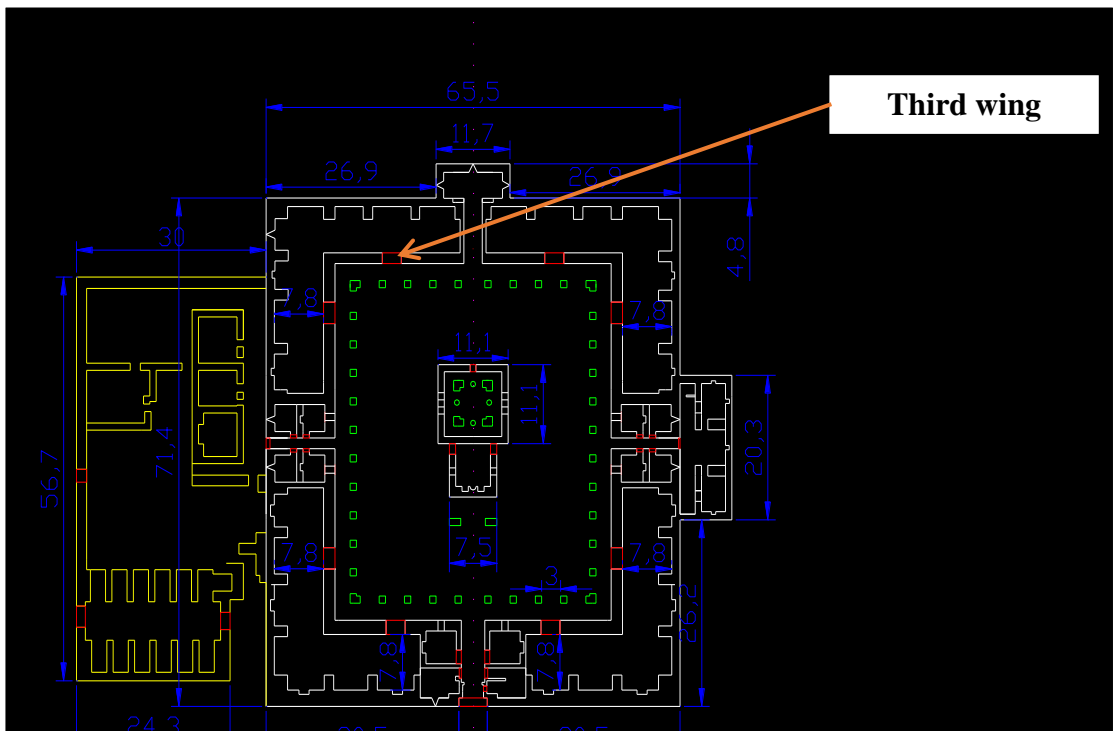
- Emergency intervention began by documenting damaged areas, creating topographic maps, and drafting a intervention plan with the support of the UNESCO expert.
- Reinforcing the walls following the same method used in the miniature model where 20x20cm knot-free first grade timber (pine) was used to create 10x20cm and 15x20cm support columns as outlined below and according to the previously completed miniature model.

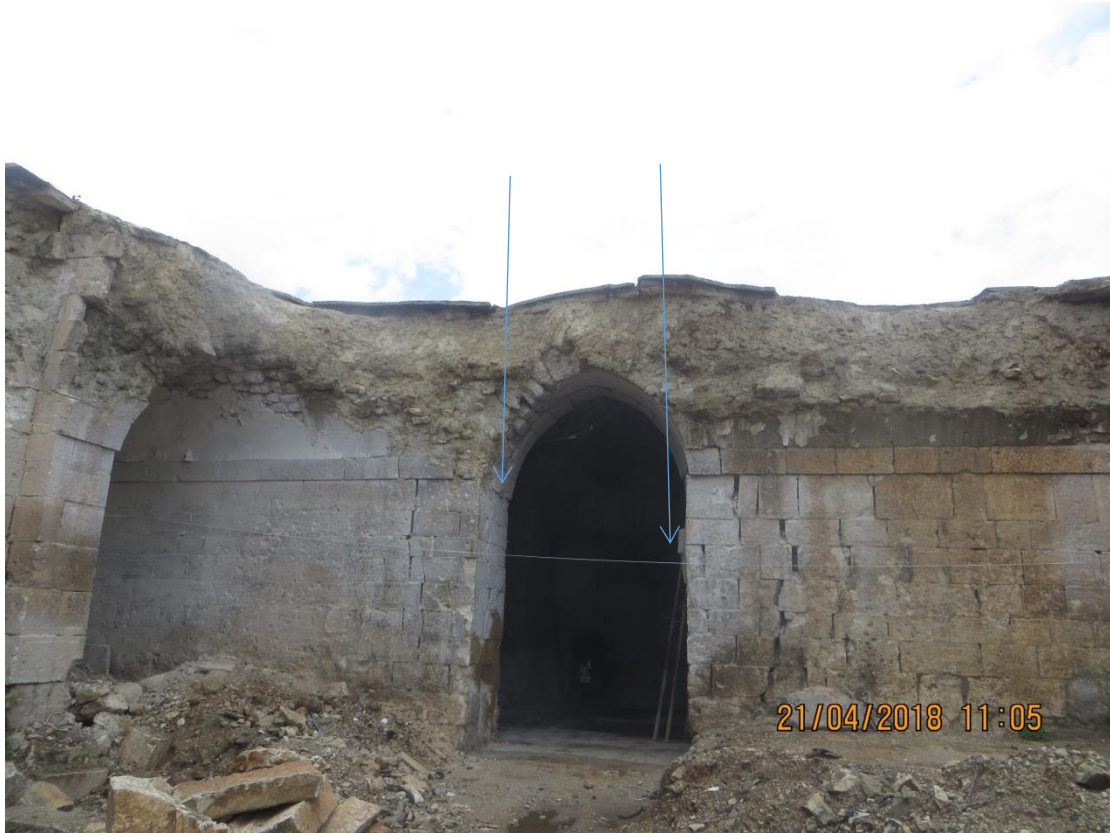
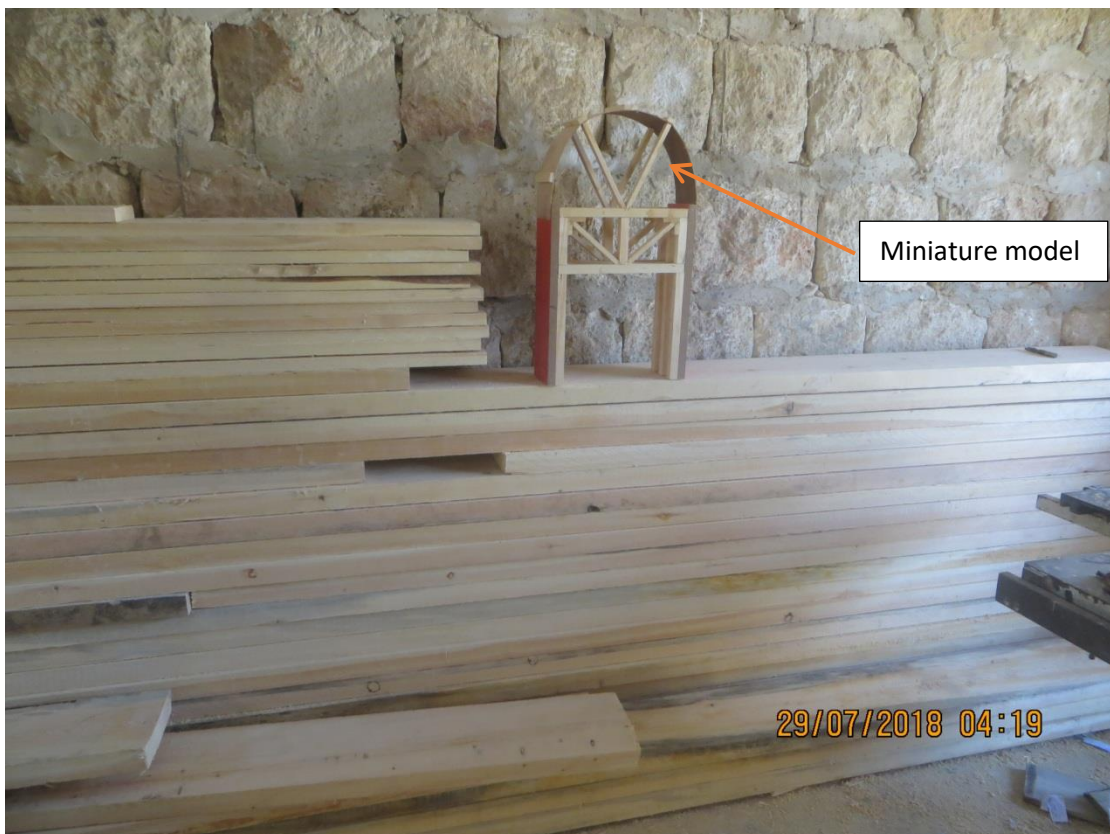
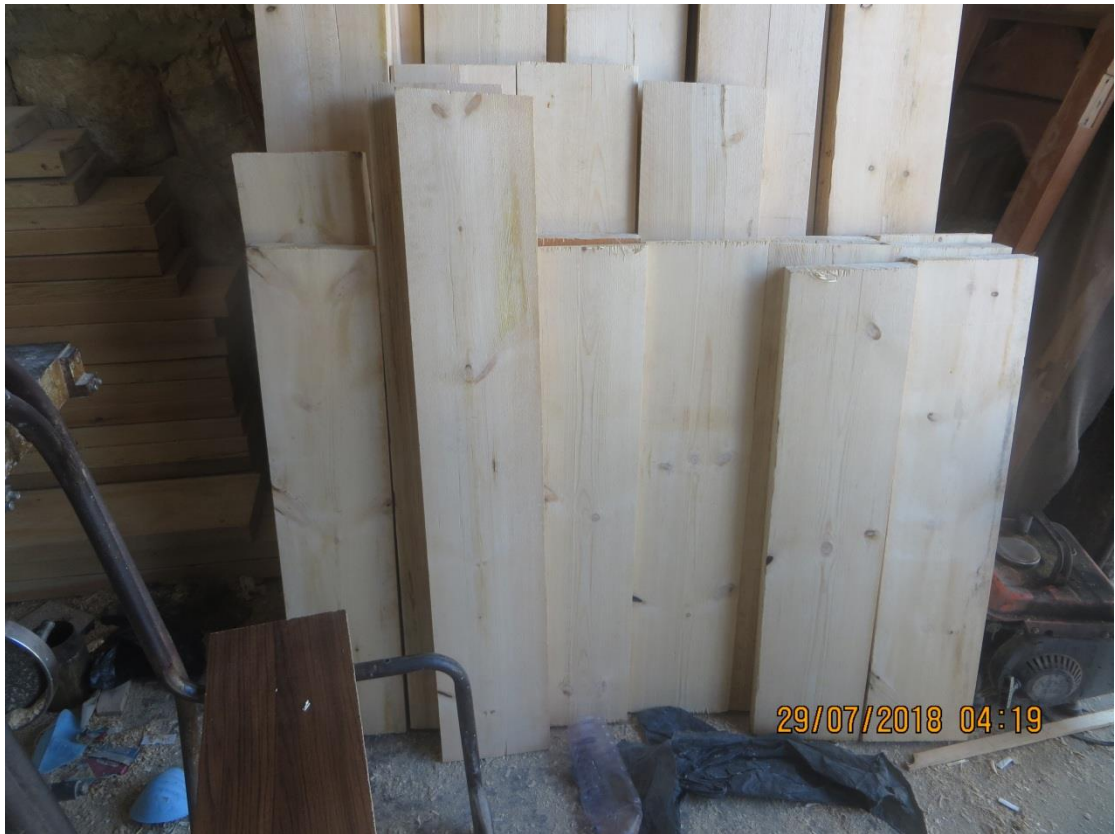
1- Using first grade timber (pine) that is well-seasoned and free of soft knots to make support beams.

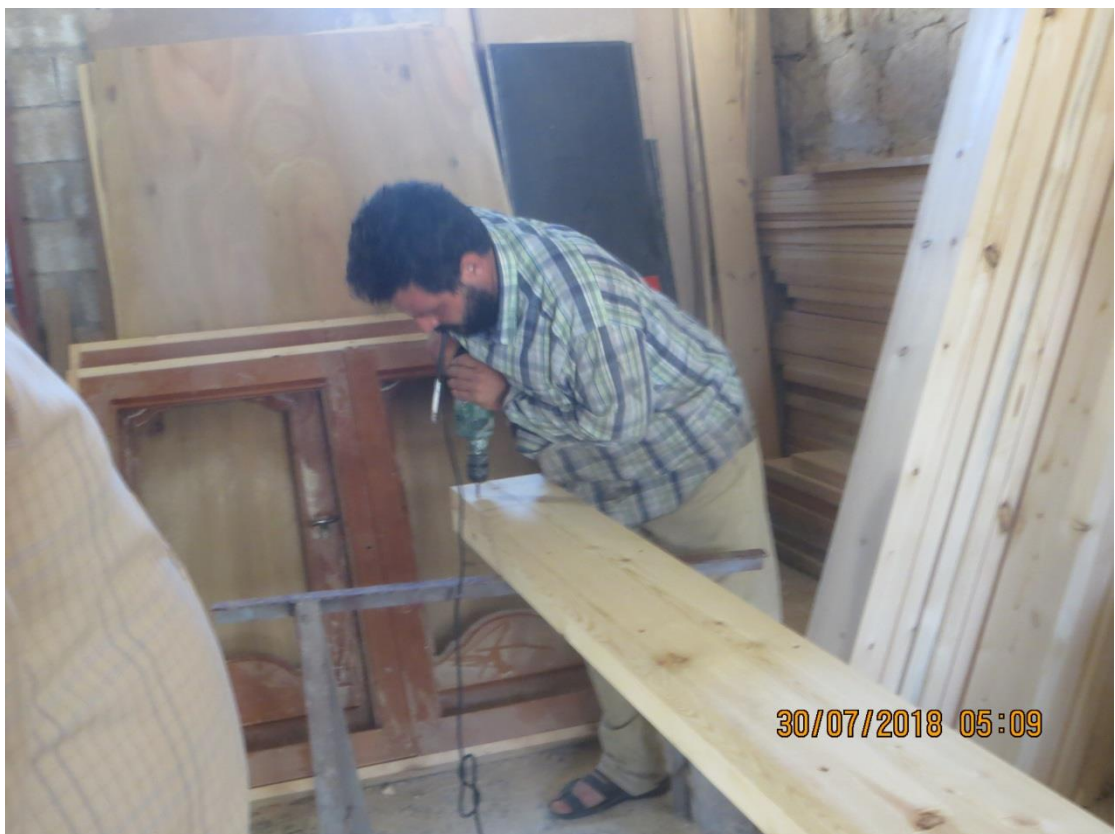
2- Assembling the support beams using glue and screws.

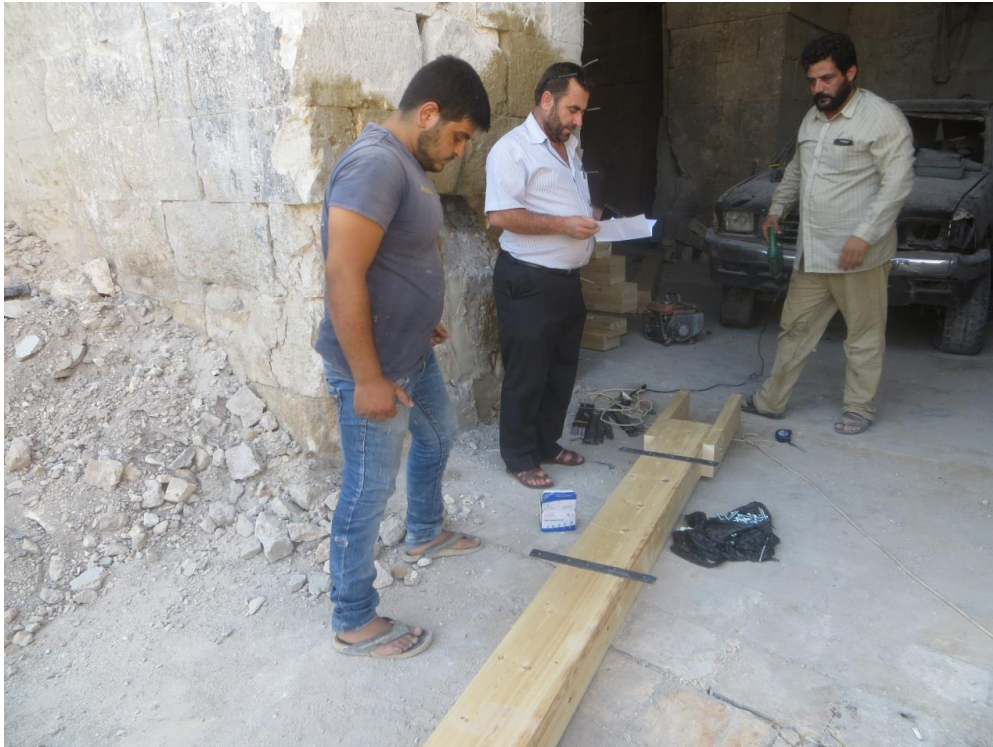
3- Taking accurate measurements to begin the assembly of the metal frame.

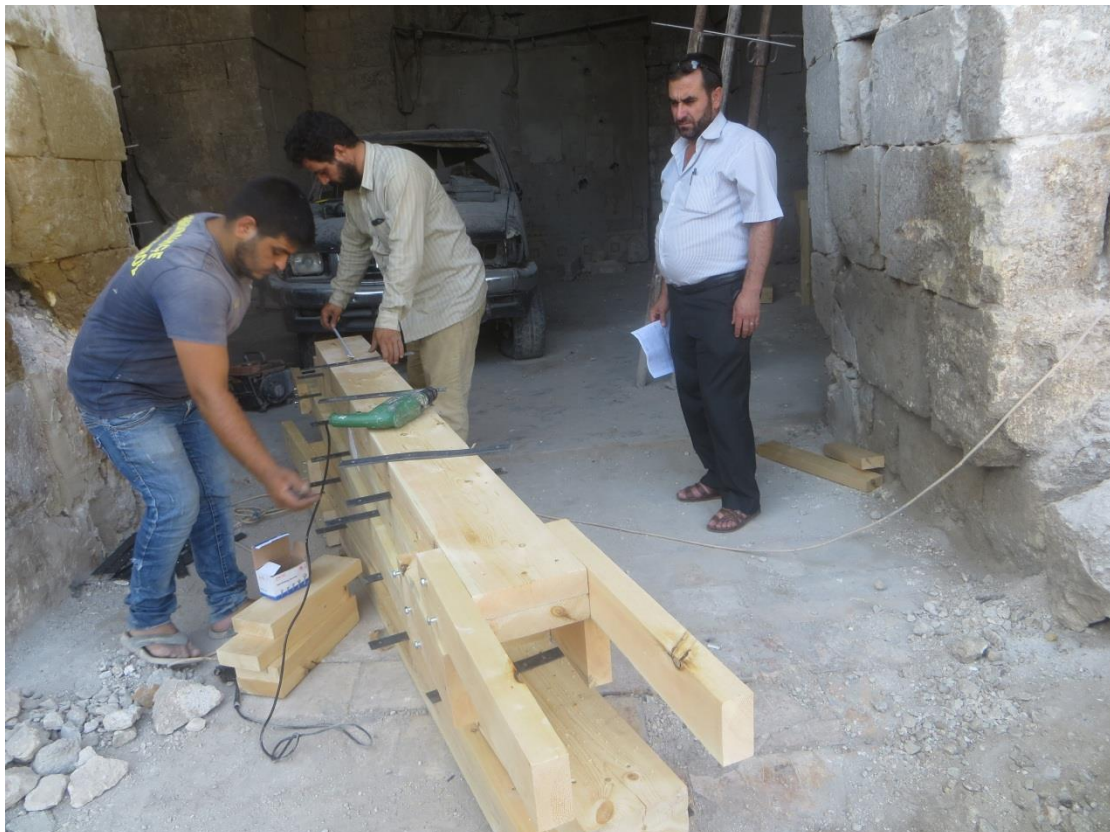
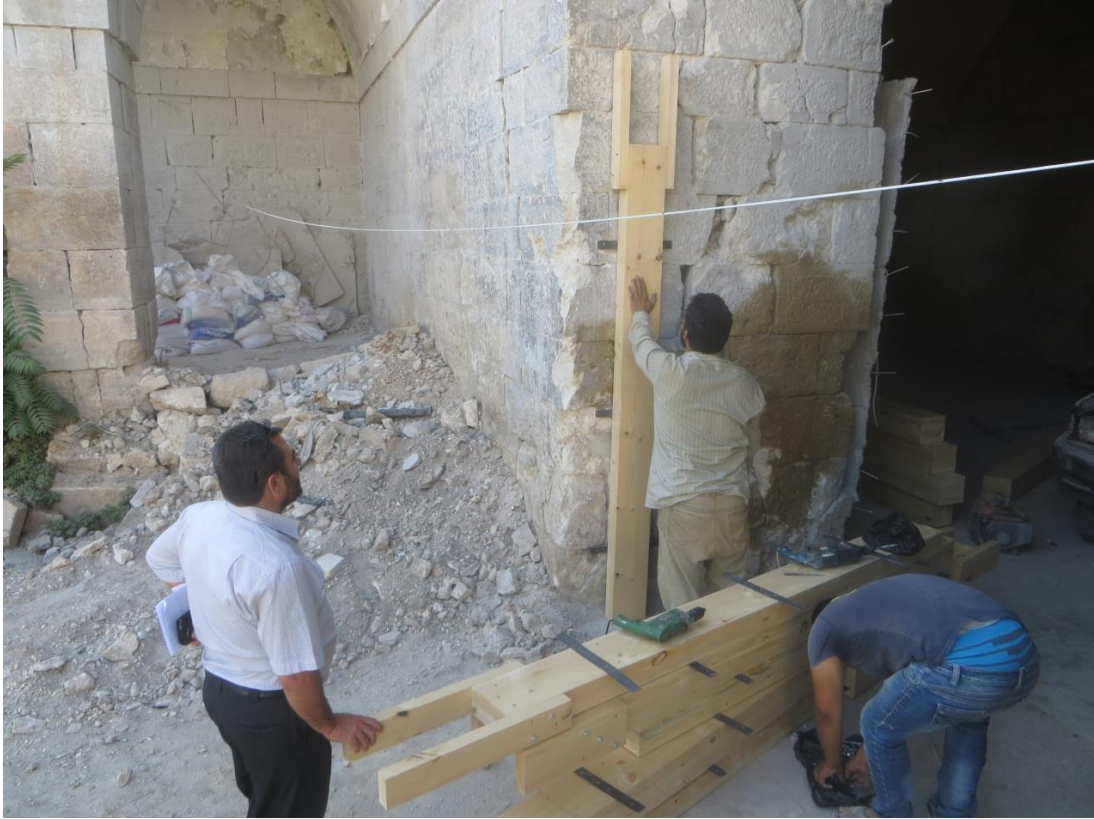
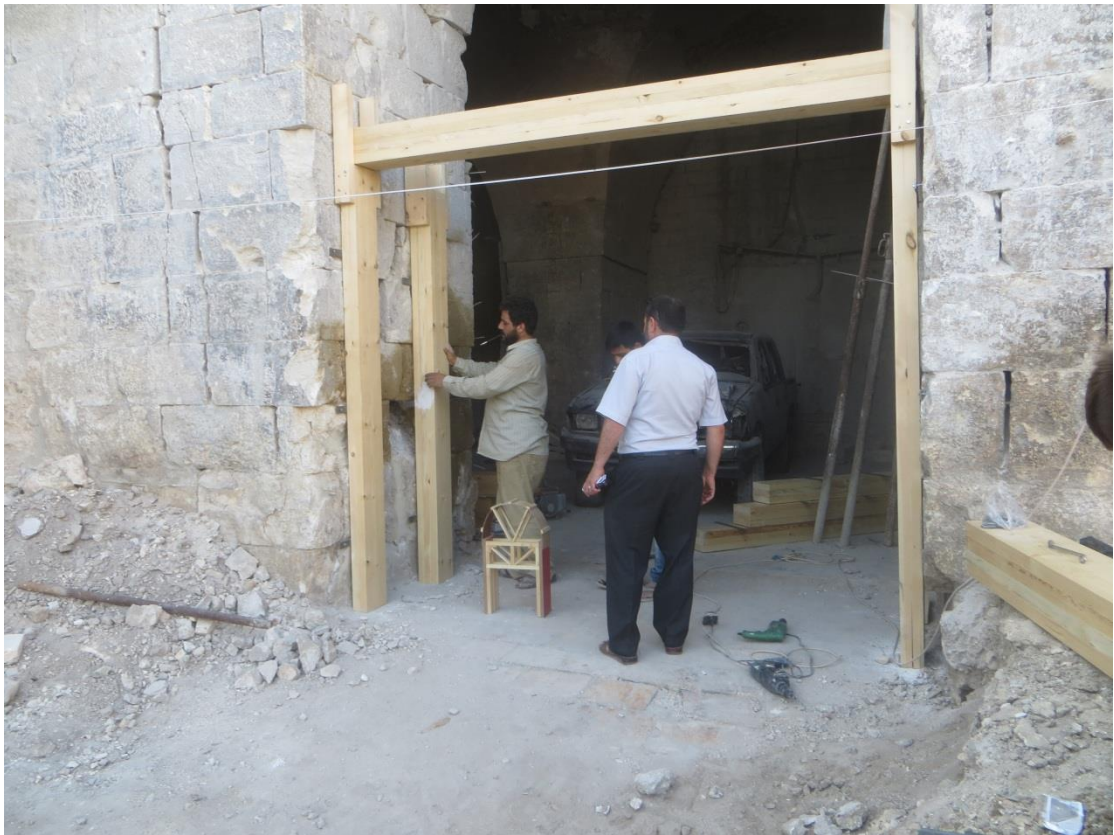
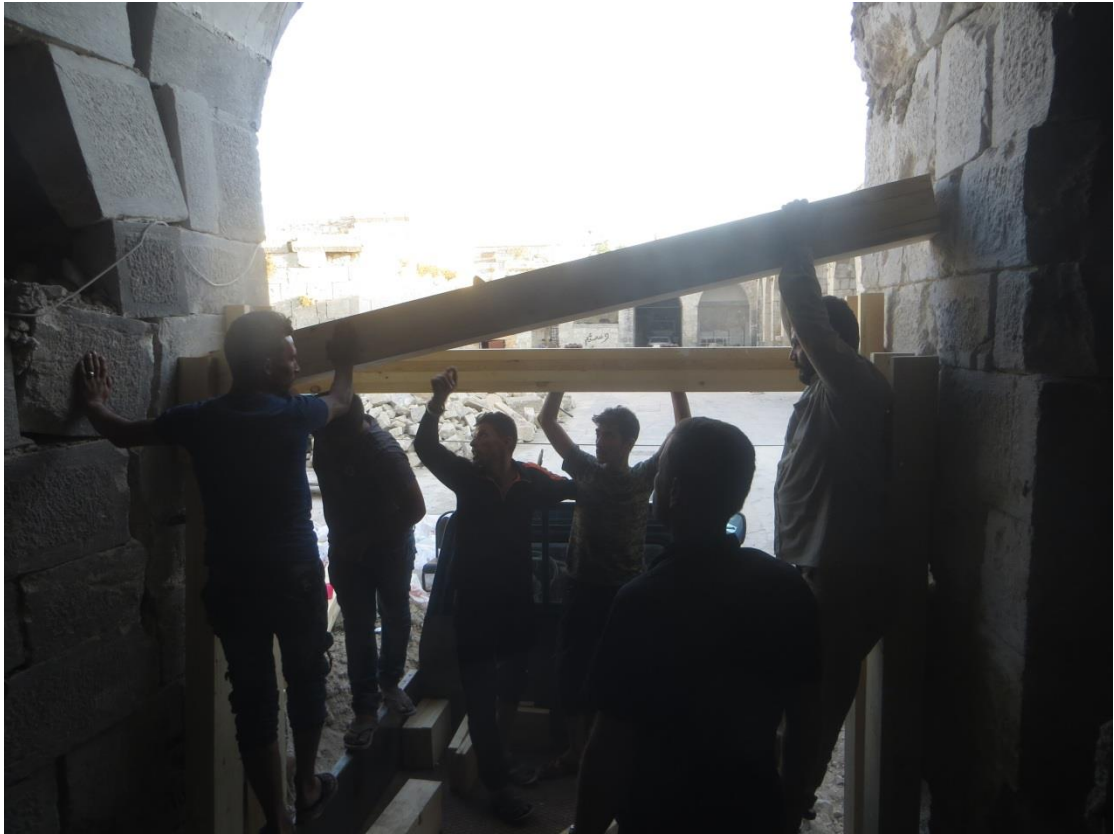
4- Assembling and installing the wooden frame.

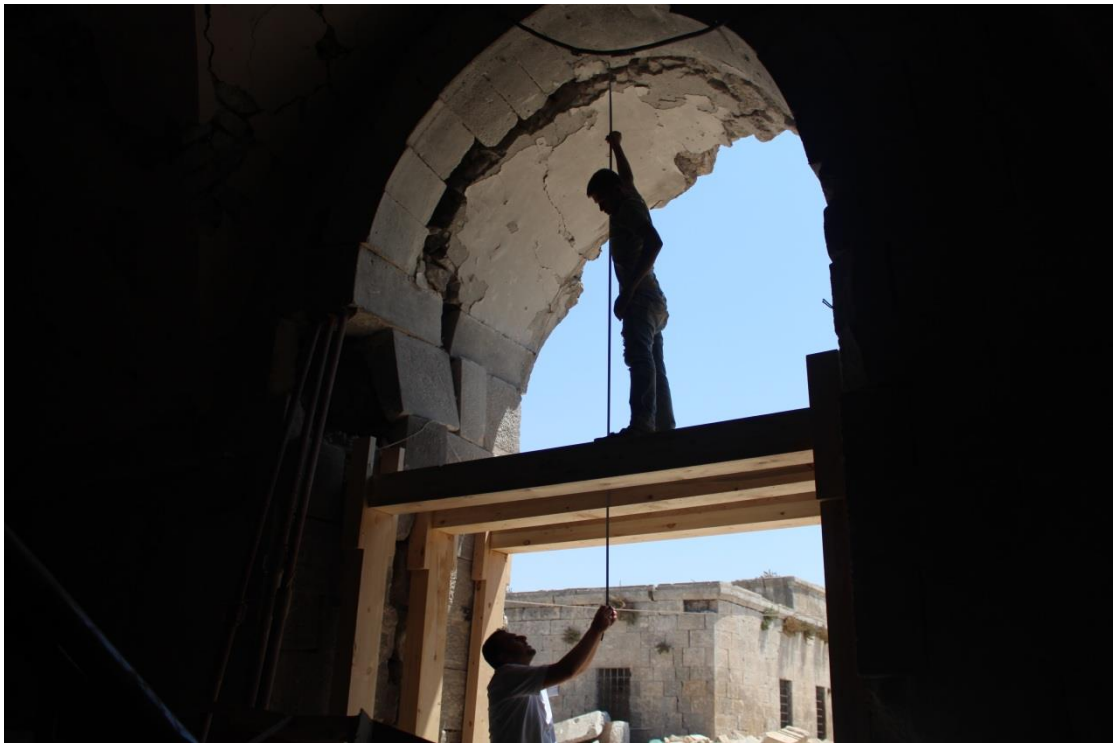
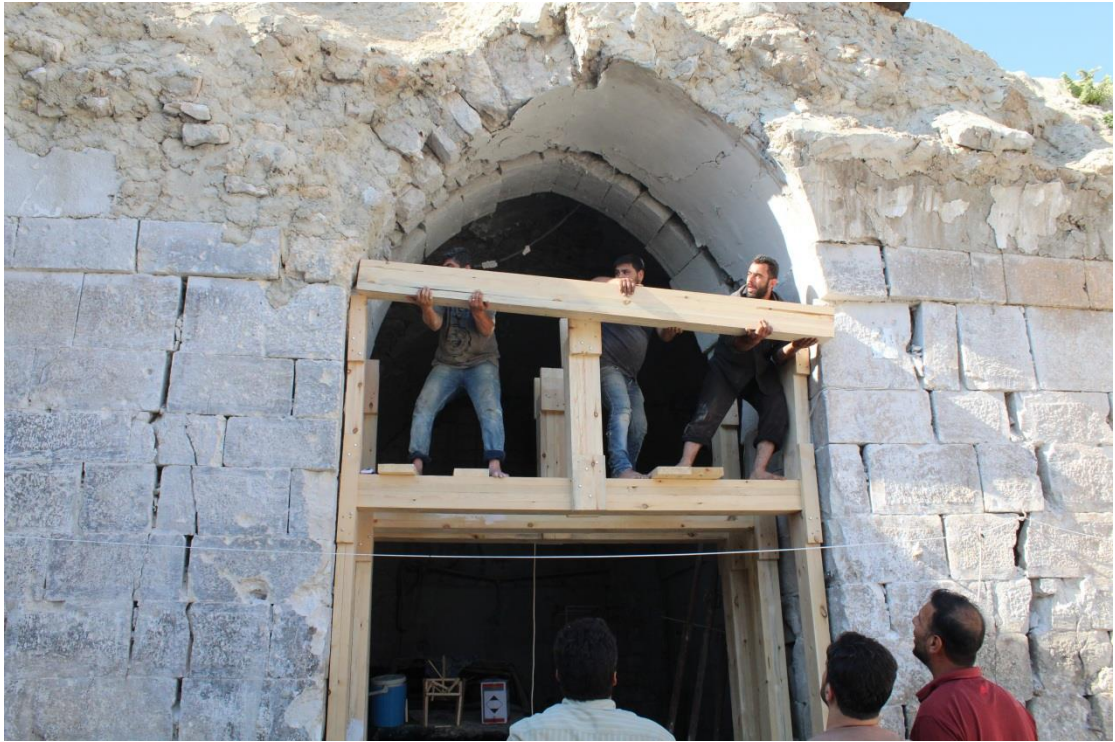
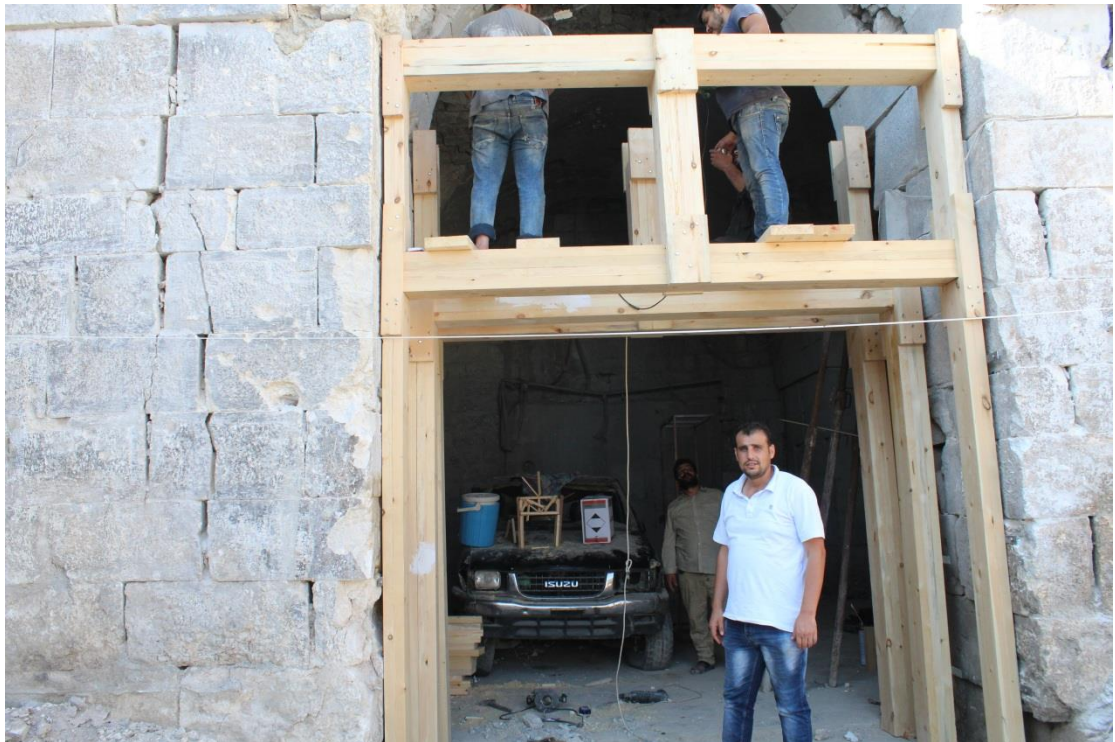
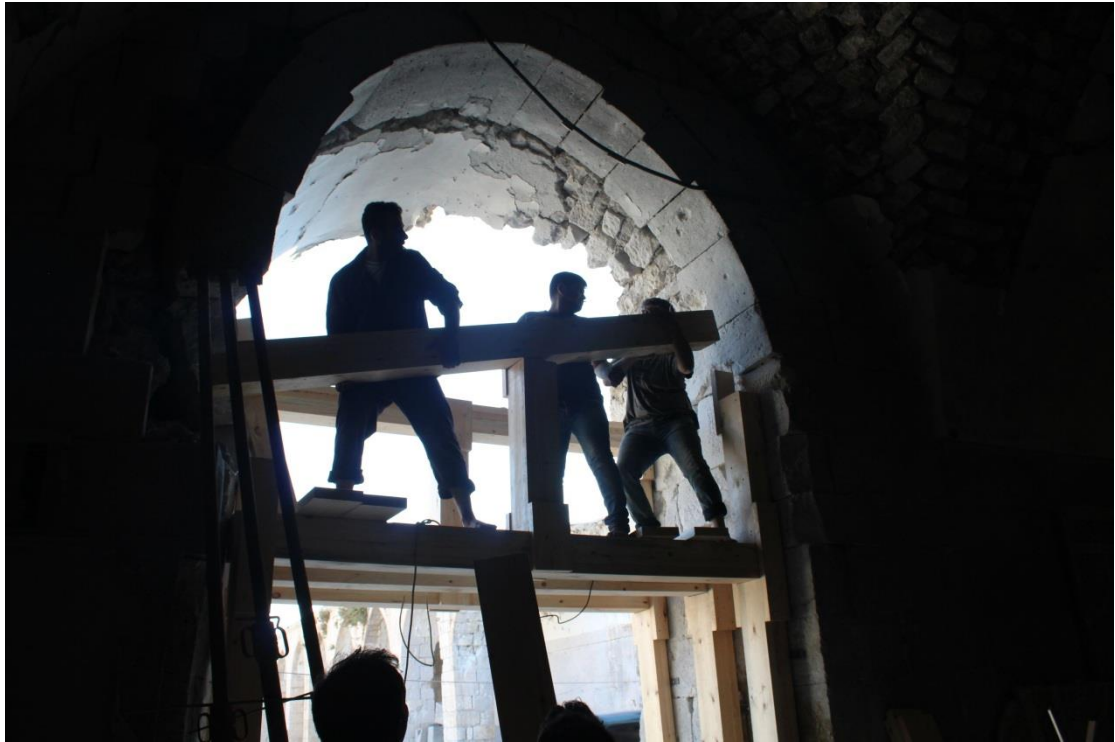
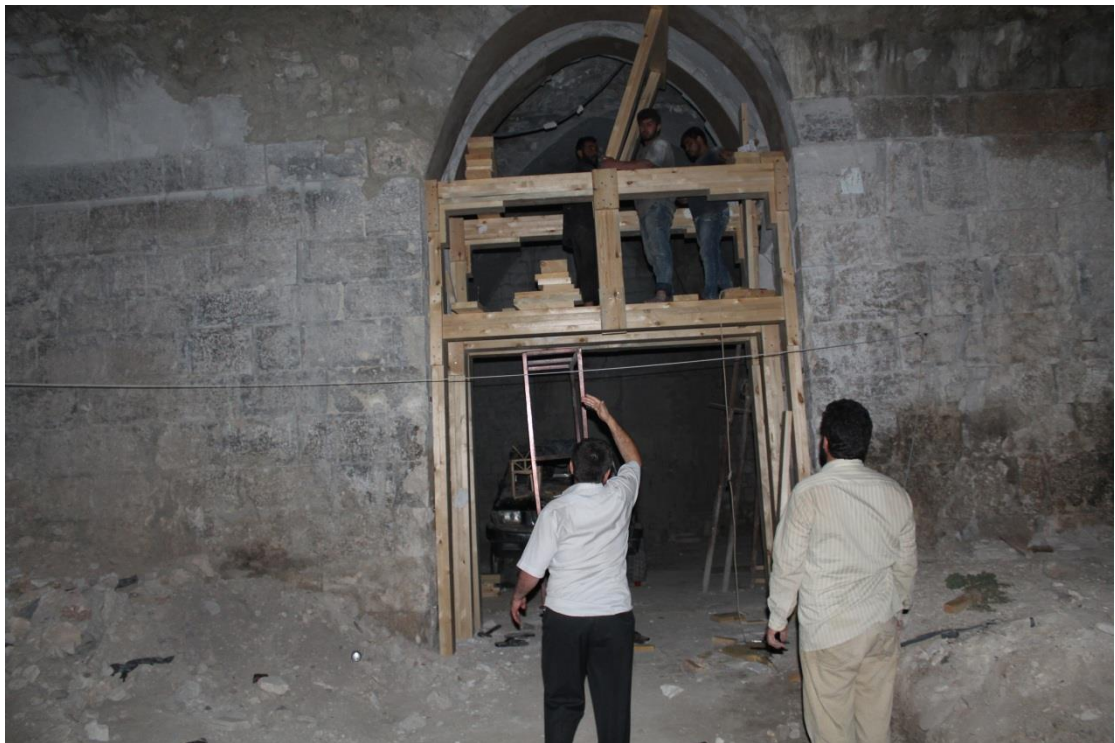
5- Positioning the wooden support beams in place.

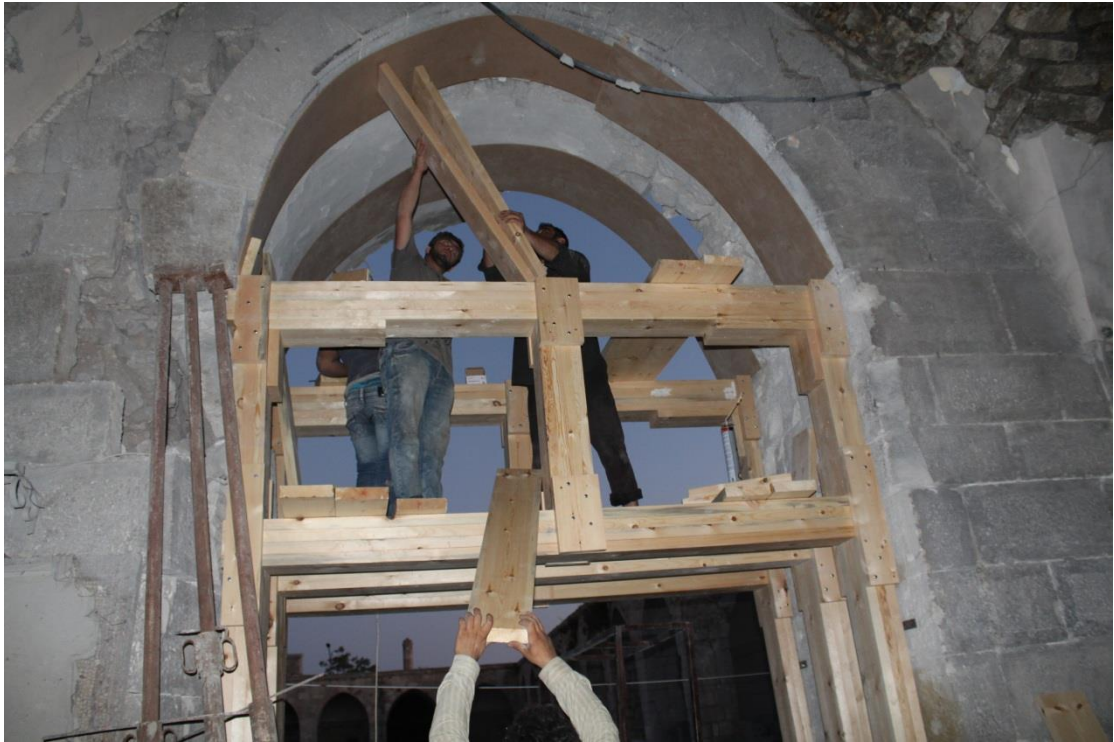
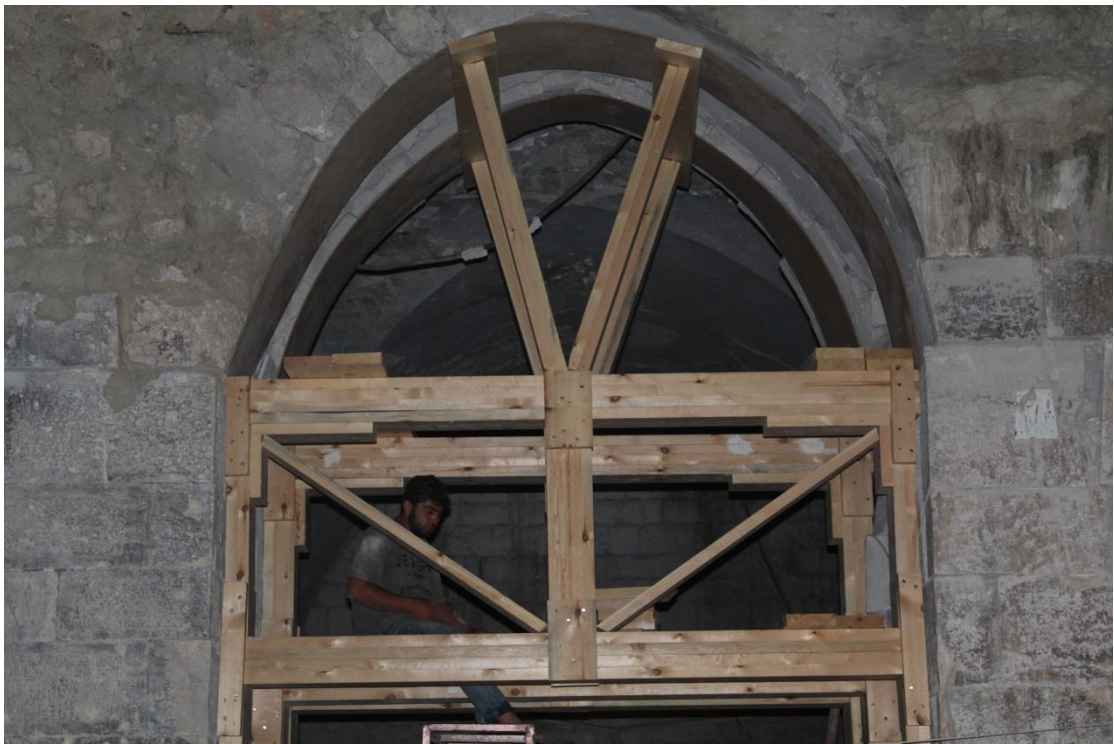
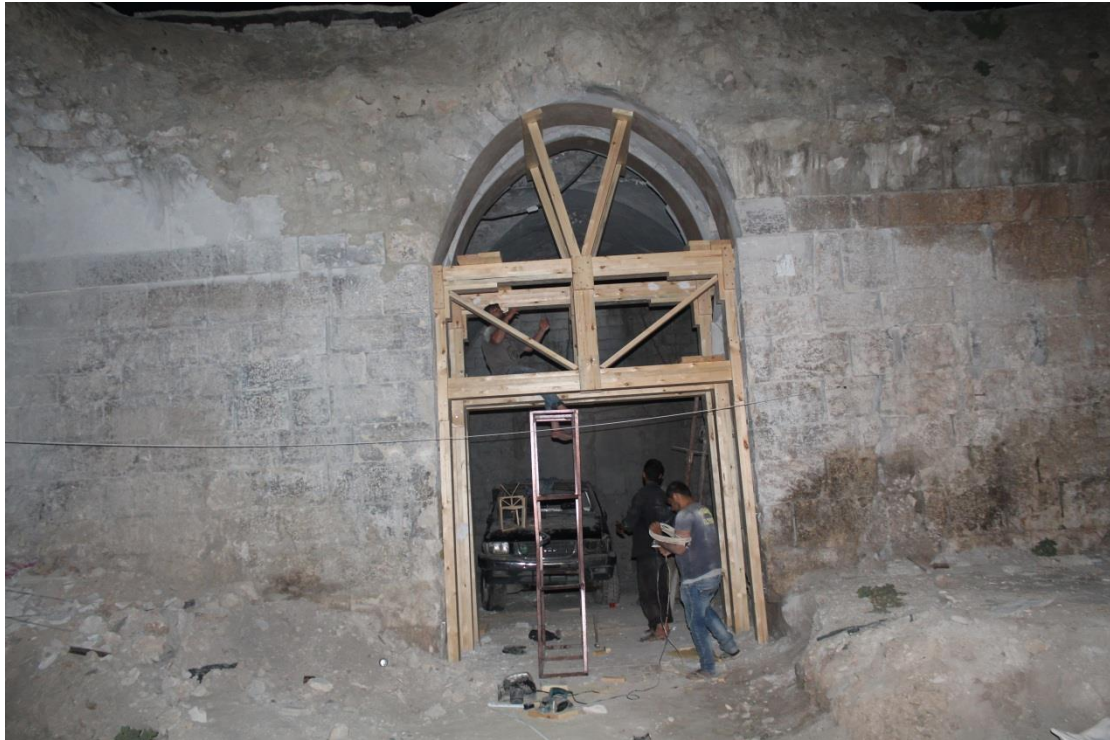
6-Wooden beams being positioned to provide support for the arch.
