Ma'arrat Al-Numan Museum (Khan Asa'ad Pasha)

Mid-Project Progress Report: Stabilization and Reinforcement of the North West Corner (entrance to the third wing)

May 1st 2018 - July 1st 2018

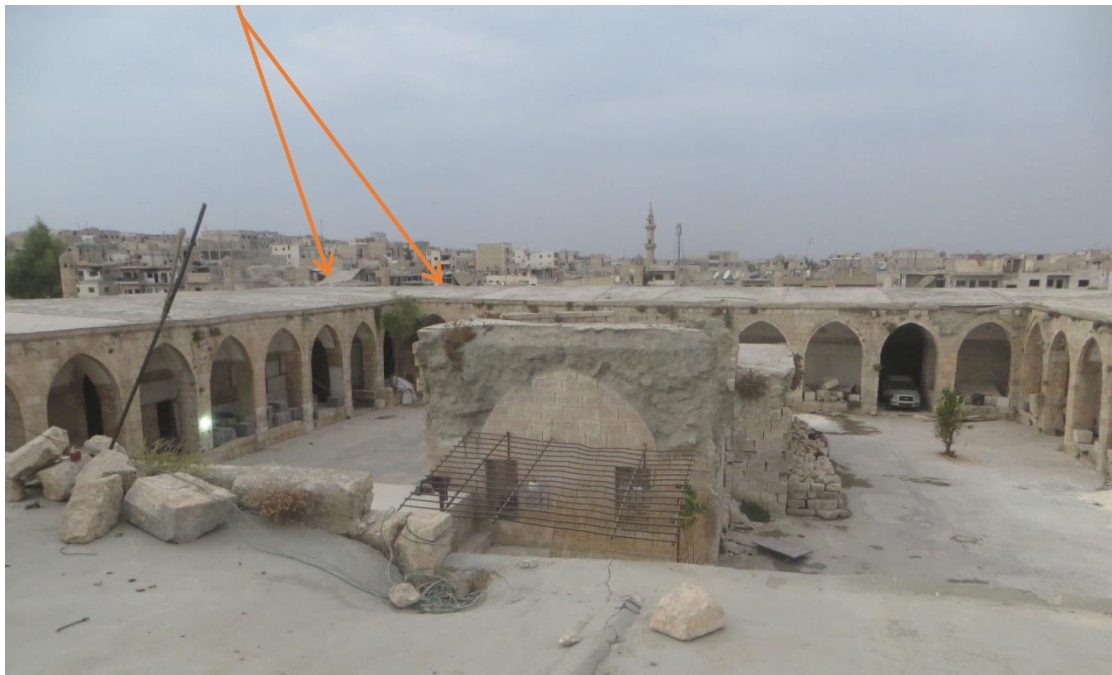
Location of airstrike (2 missiles)

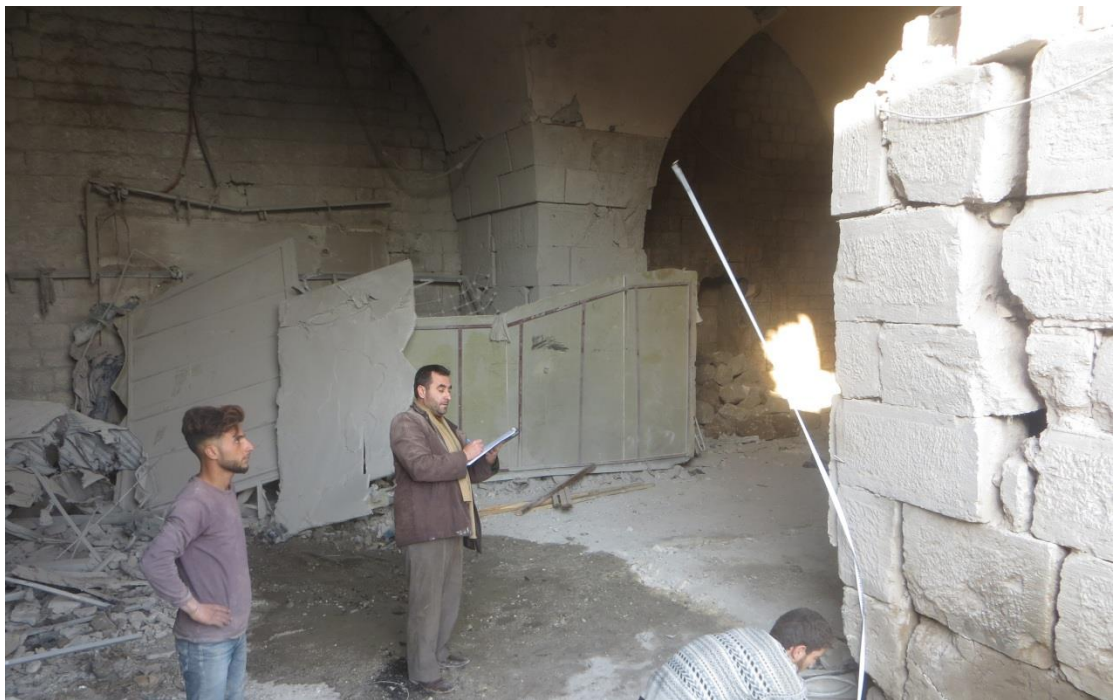
- 1- The north and west hallways of the third section were both destroyed. The two hallways had arched ceilings.

- 2- Three stone beams on the north side, along with two on the west, were destroyed .
- 3- Partial destruction of a sarcophagus placed on display in the courtyard after being transported from an area north of Ma'arrat Al-Numan in 1982.
- 4- The west wall of the hallway leading to the lavatories in the east has collapsed.
- 5- Structural damage in the north end of the third section.
- 6- Some clay amphorae that had been moved into the third section were destroyed.
- 7- Some mural paintings on the north and east sides of the hallway, across from the entrance to the third section from the north, were damaged. One painting near the west entrance fell to the ground.

Documenting the damage

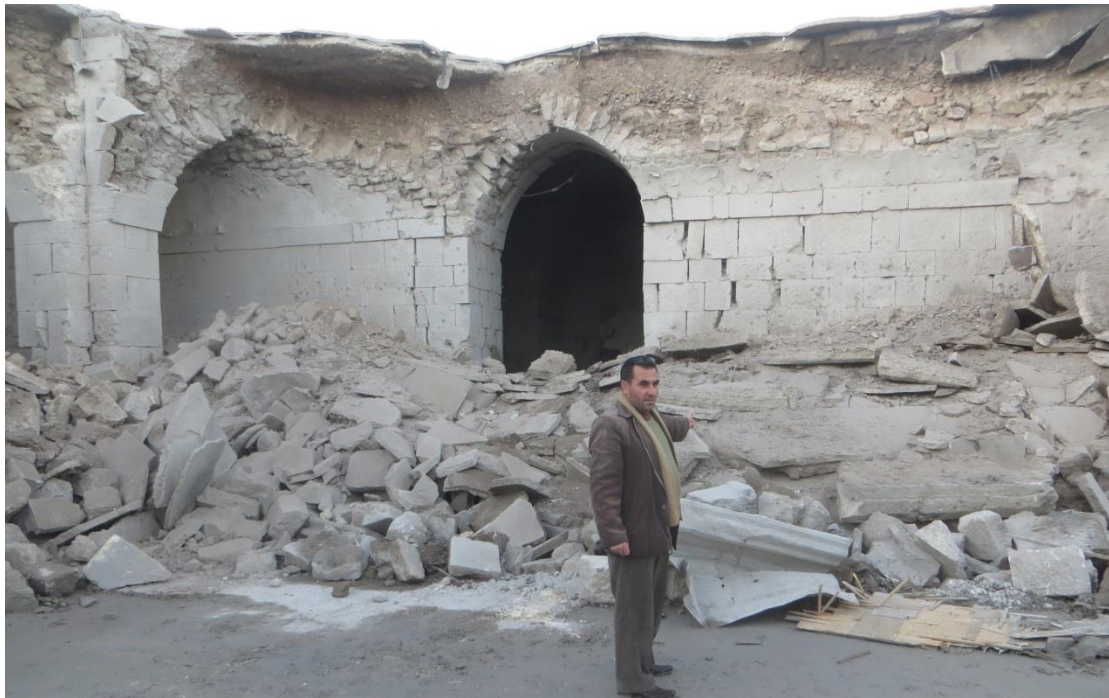
Documenting the damage

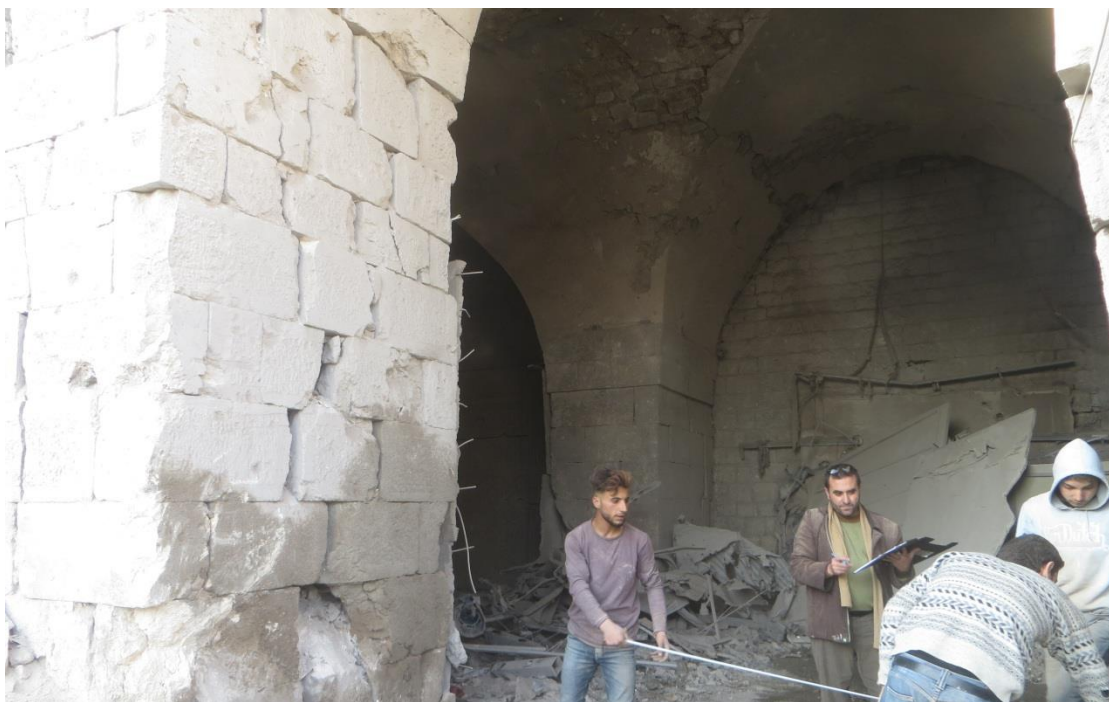
Documenting the damage

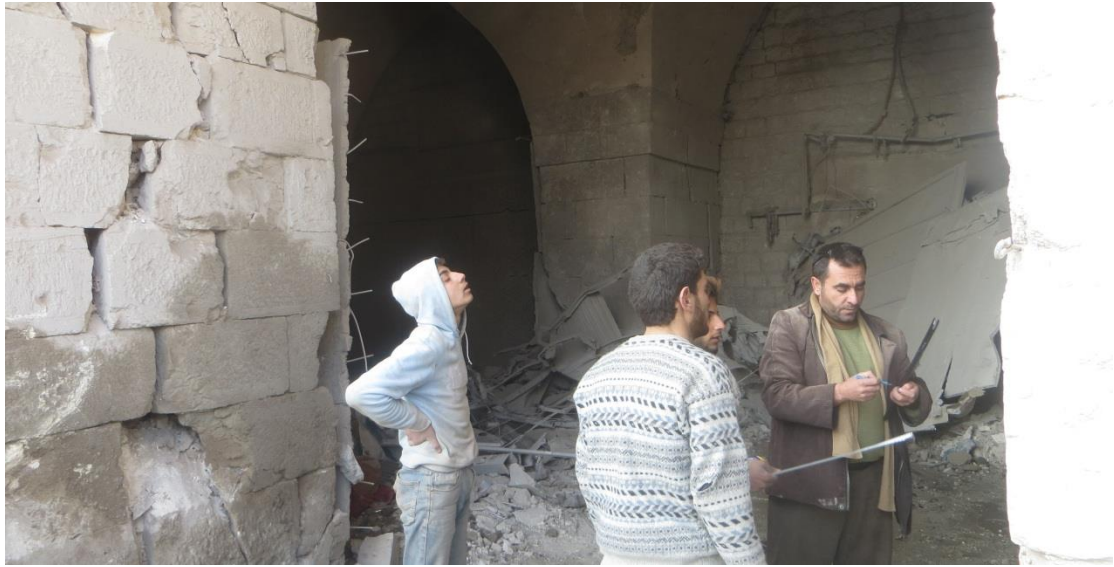
Documenting the damage

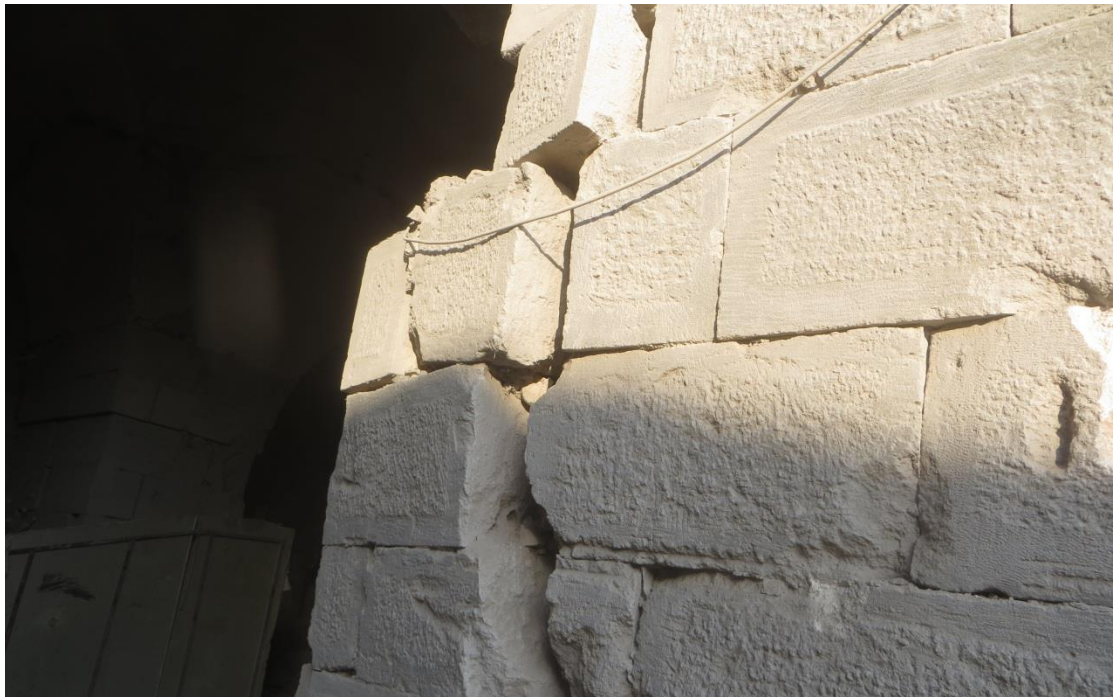
Documenting the damage

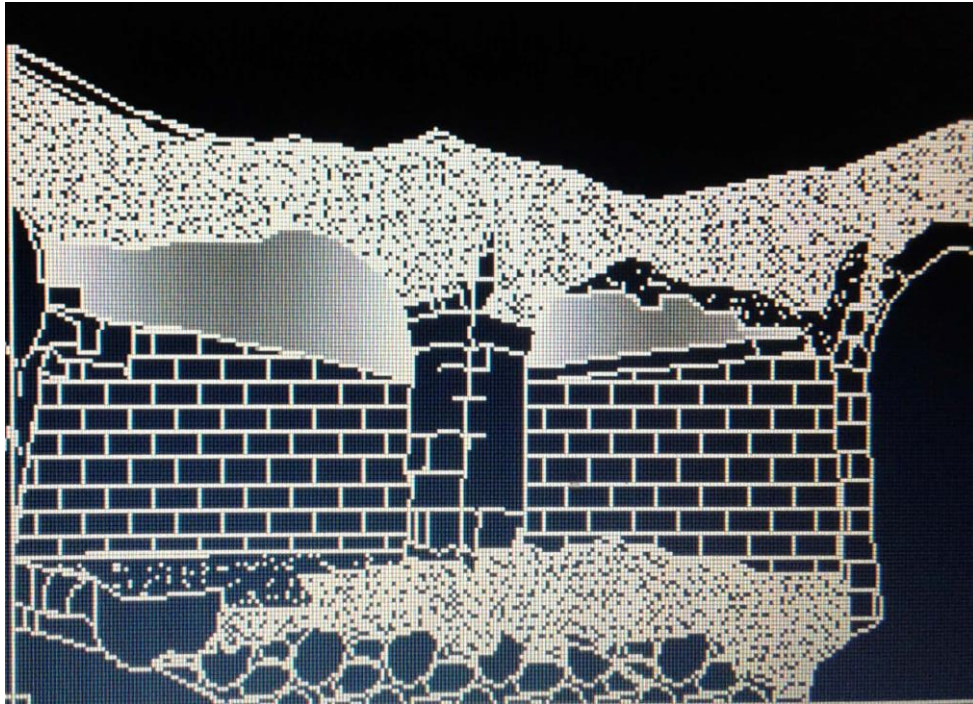
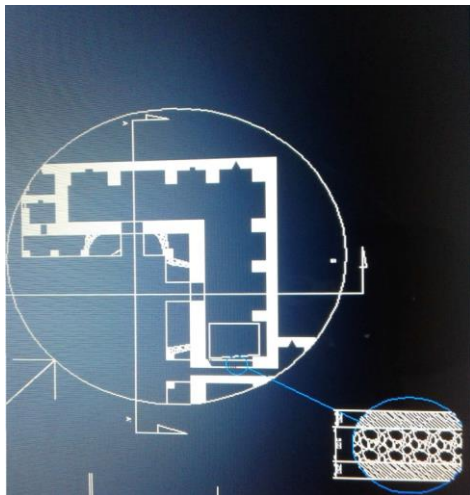
Horizontal and Vertical sections

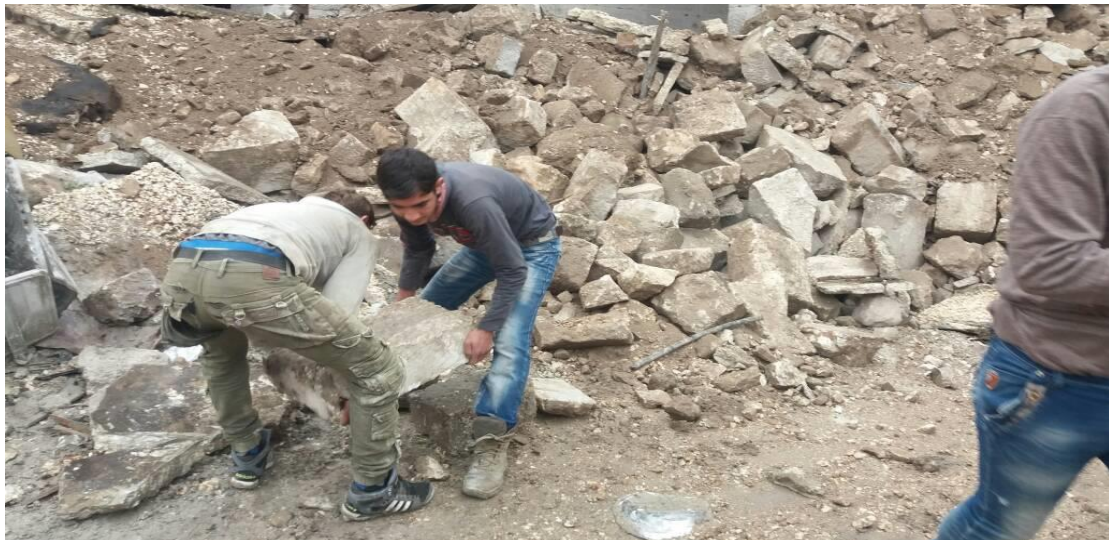
Clearing rubble and sorting out stones

- 1- Clearing rubble and sorting out stones.
- 2- Manufacturing a model of the support system developed by the Ma'arra museum team and the UNESCO expert.
- 3- Begin reinforcing walls the same way that was done in the miniature model where knot-free Swedish whitewood beams, with a diameter of 20X20 cm, were used as well as others measuring 10X20 cm and 10X10 cm as shown in the attached sketch and according to the previously made miniature model.
- 4- Reinforce vulnerable areas and disassemble and reassemble some walls while adhering to scientific and artistic principles.

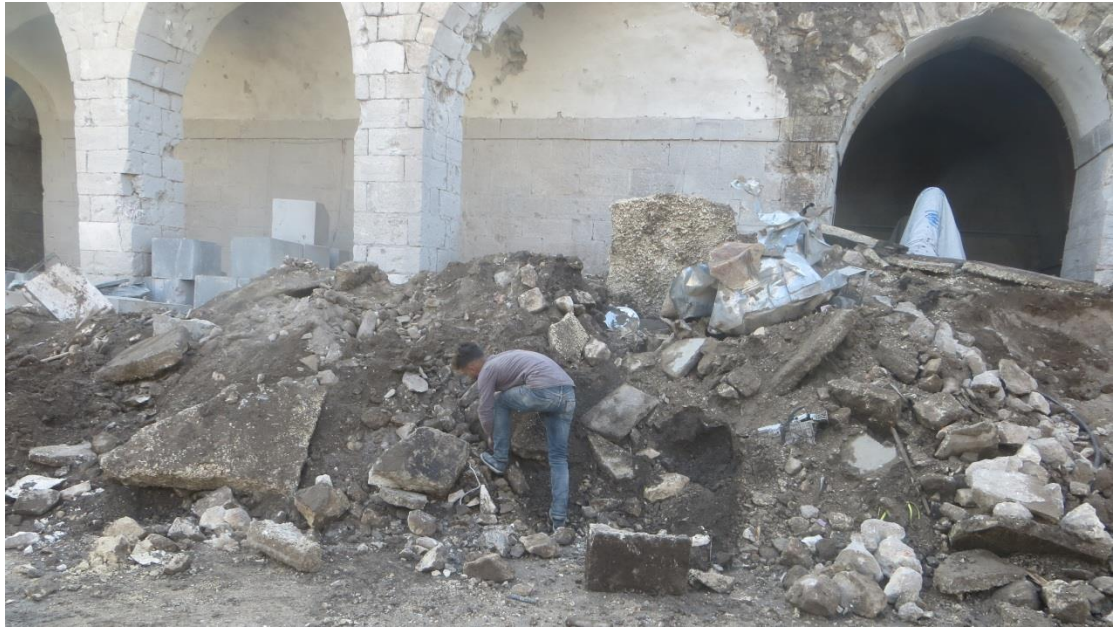
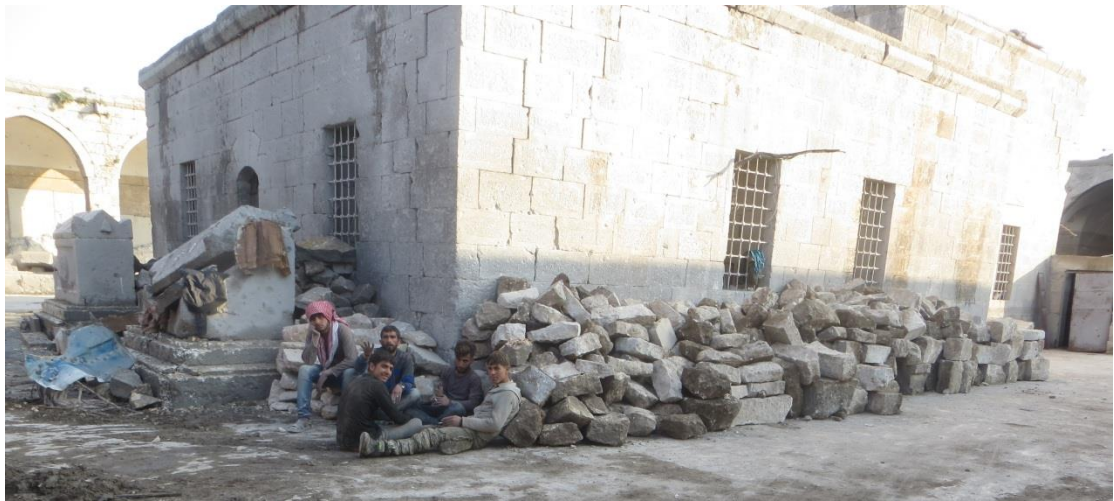
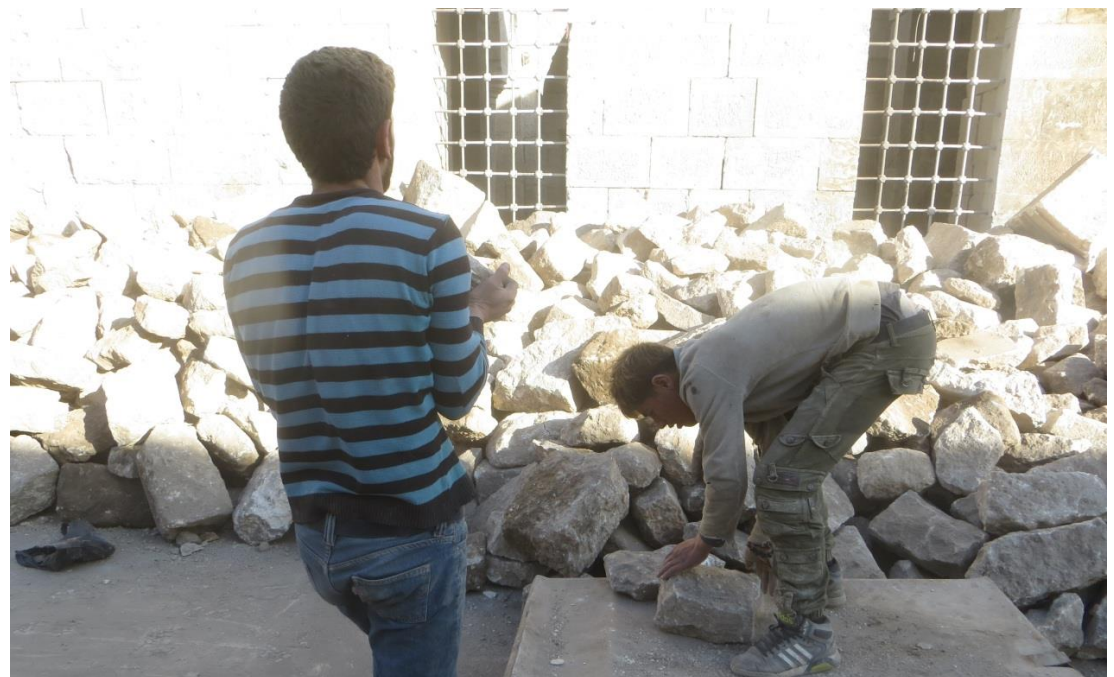
Reinforcing damaged walls

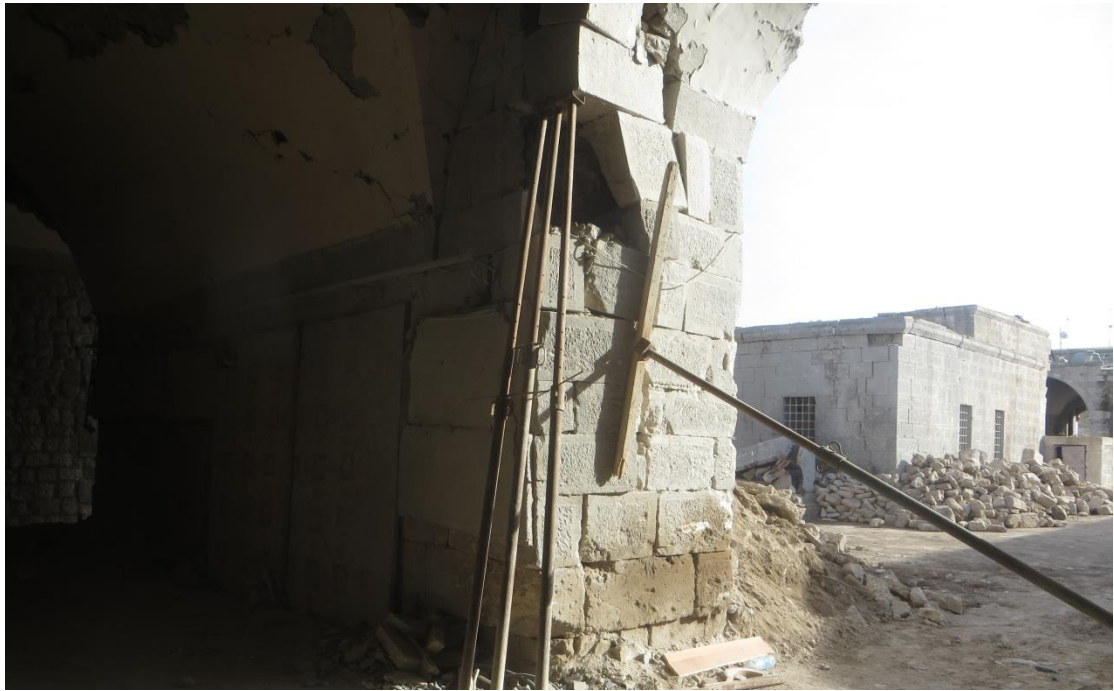
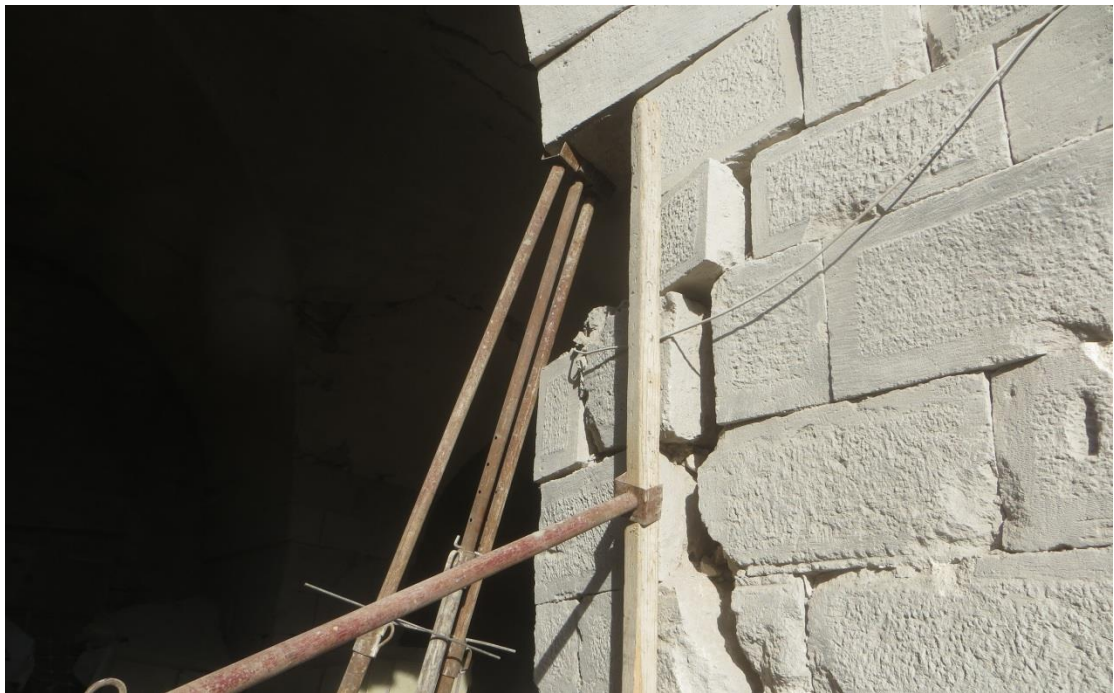
Manufacturing the intervention model

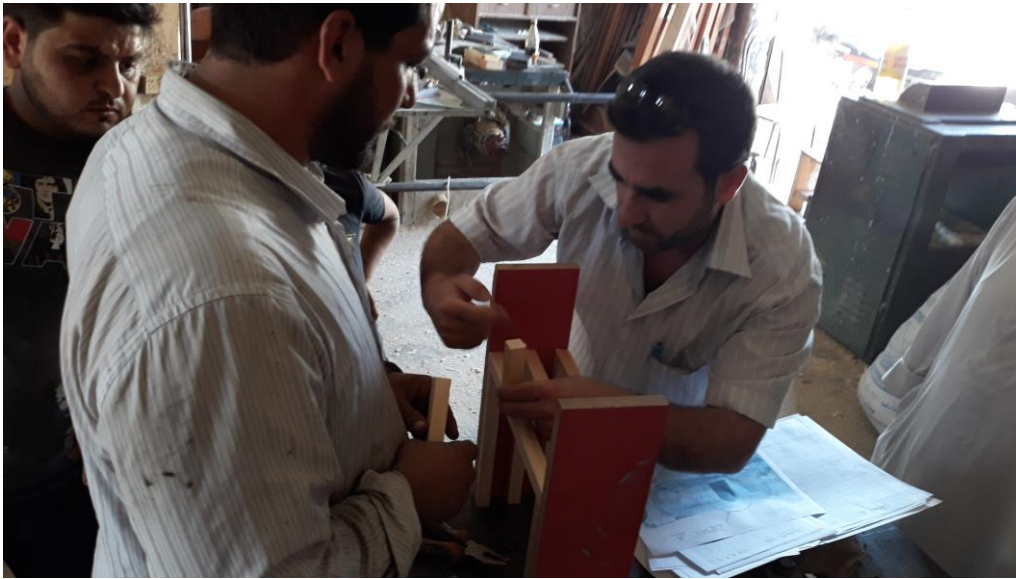
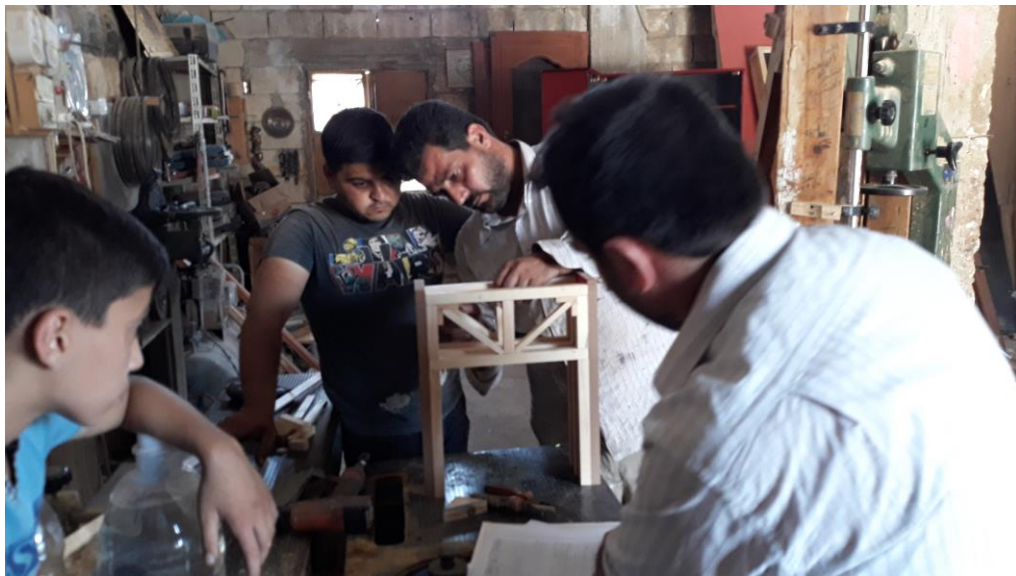
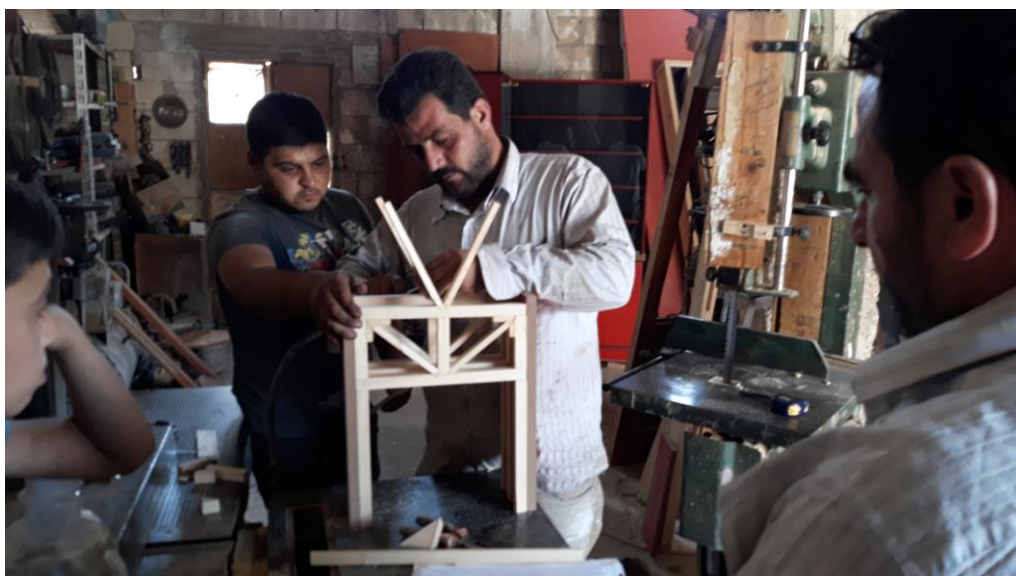
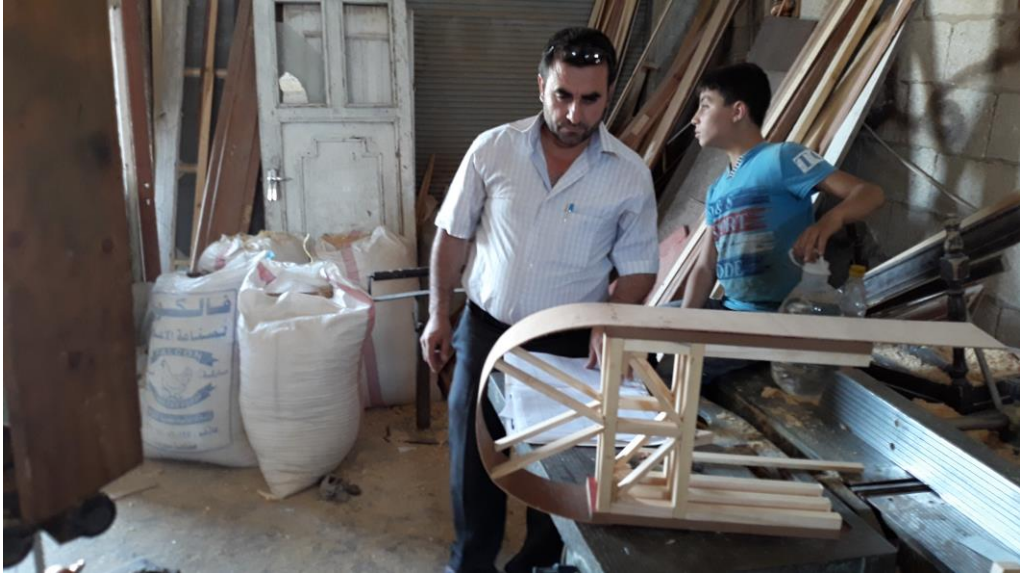
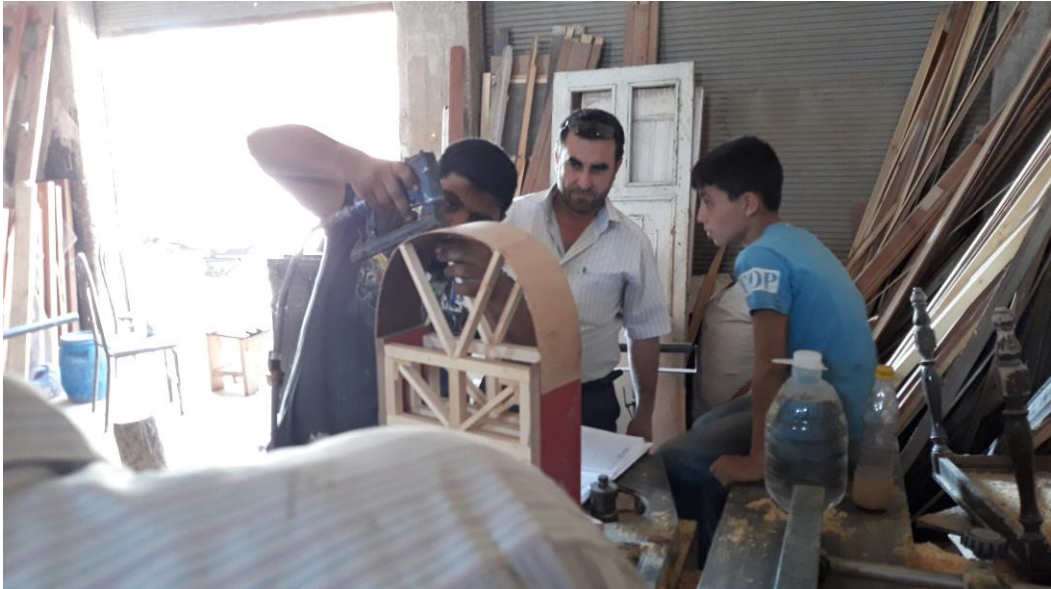
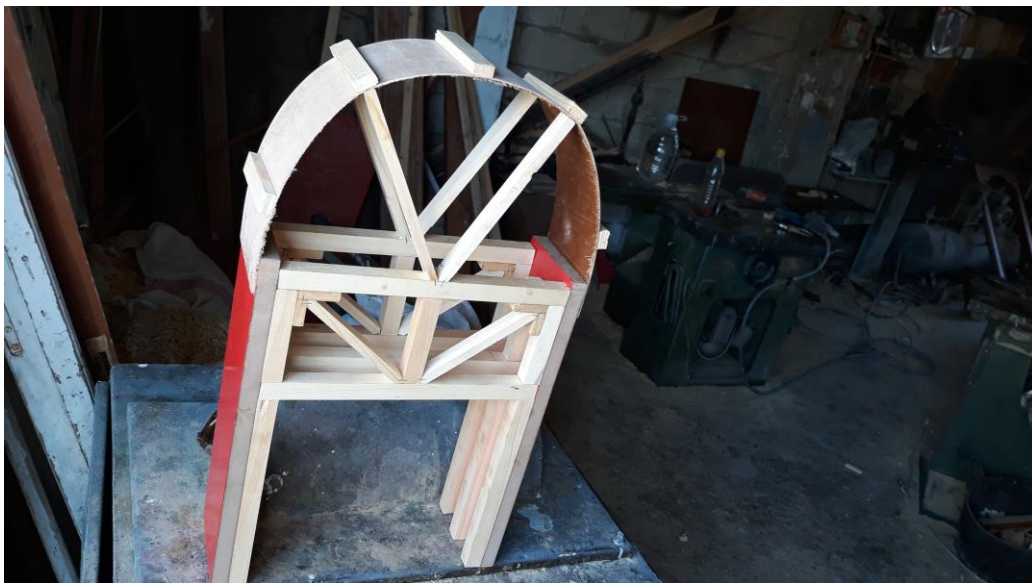
Reinforcing and stabilizing damaged areas
