## The Day After Heritage Protection Initiative

### Site Monitors Project

#### Emergency Intervention: Reinforcing the North Wall and Repairing Damage to the Roof at Ma'arrat al-Numan Museum

15<sup>th</sup> October 2018

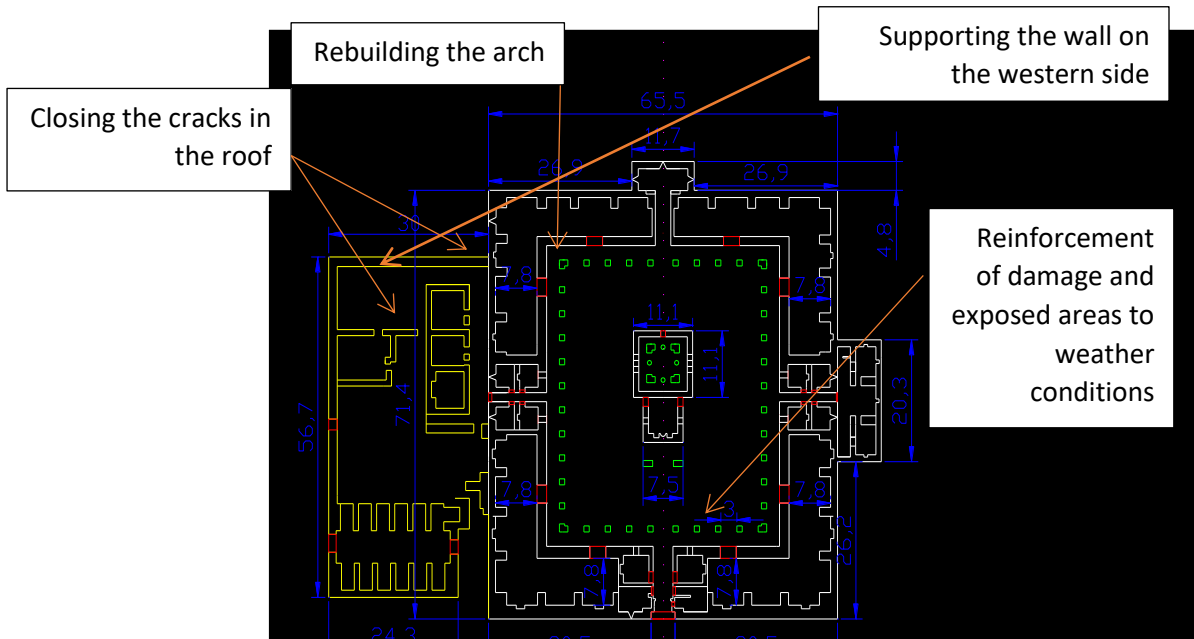
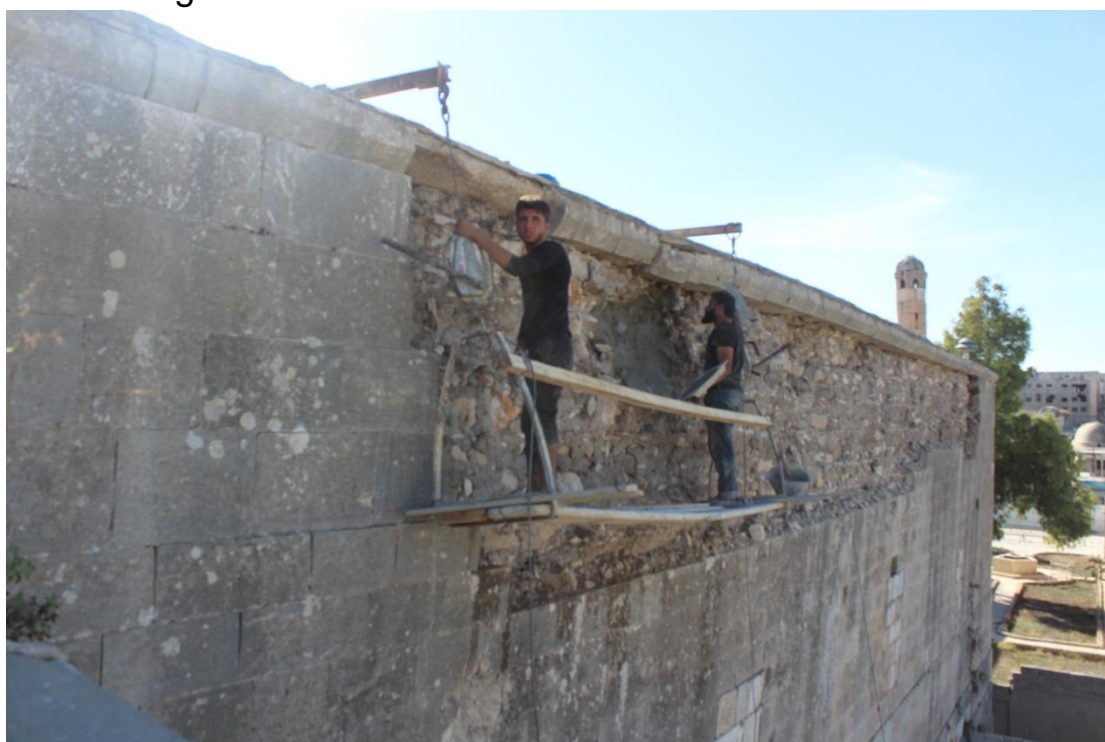
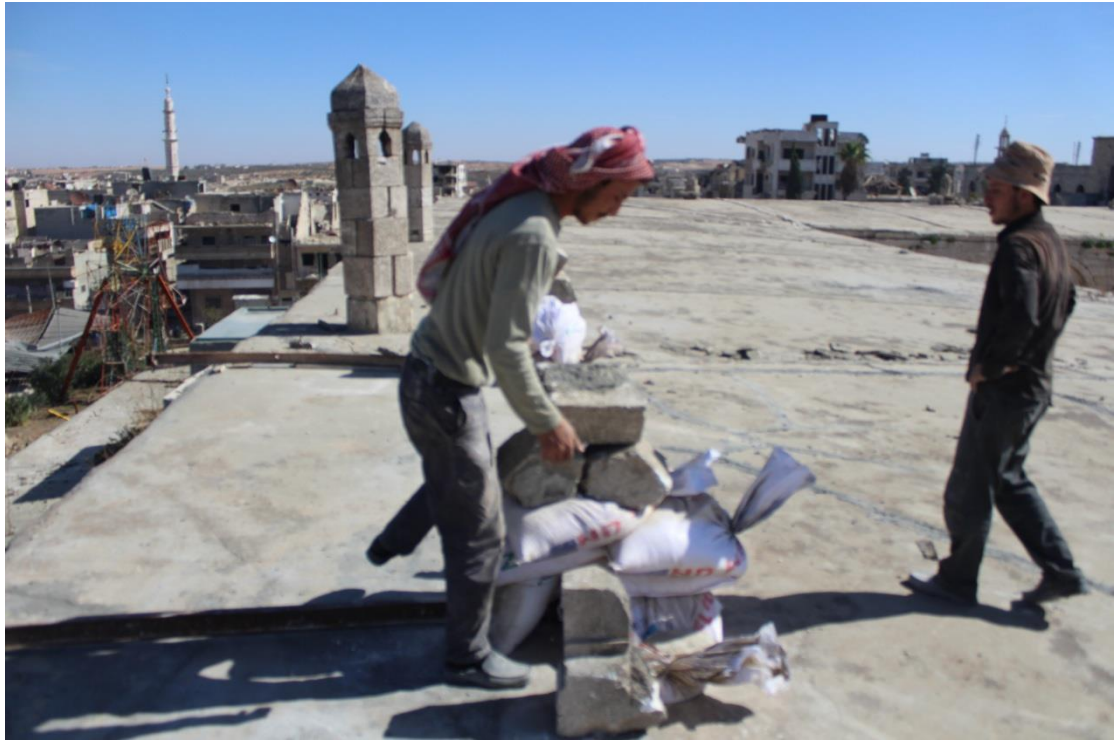
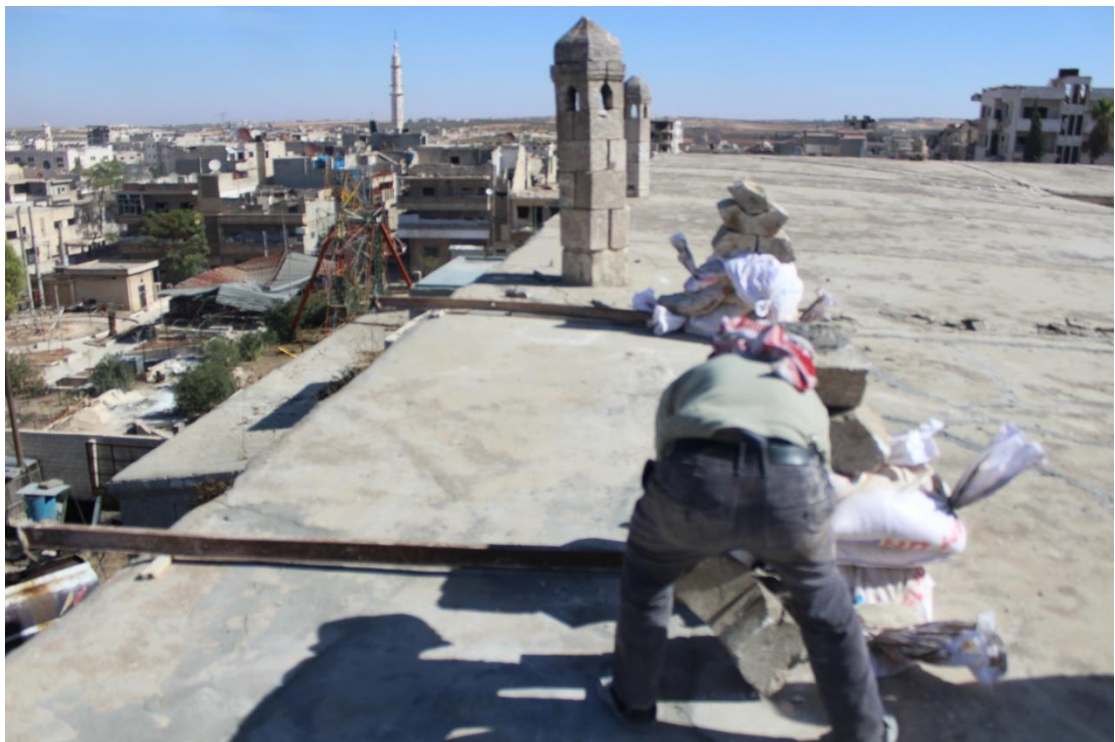
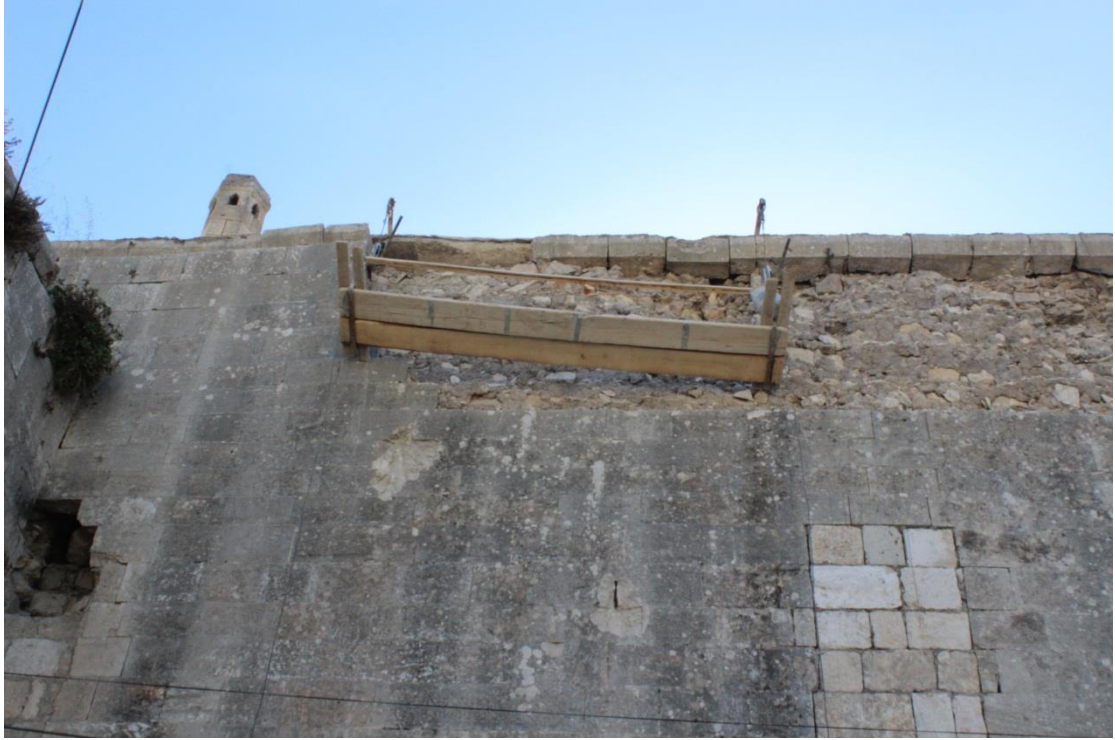
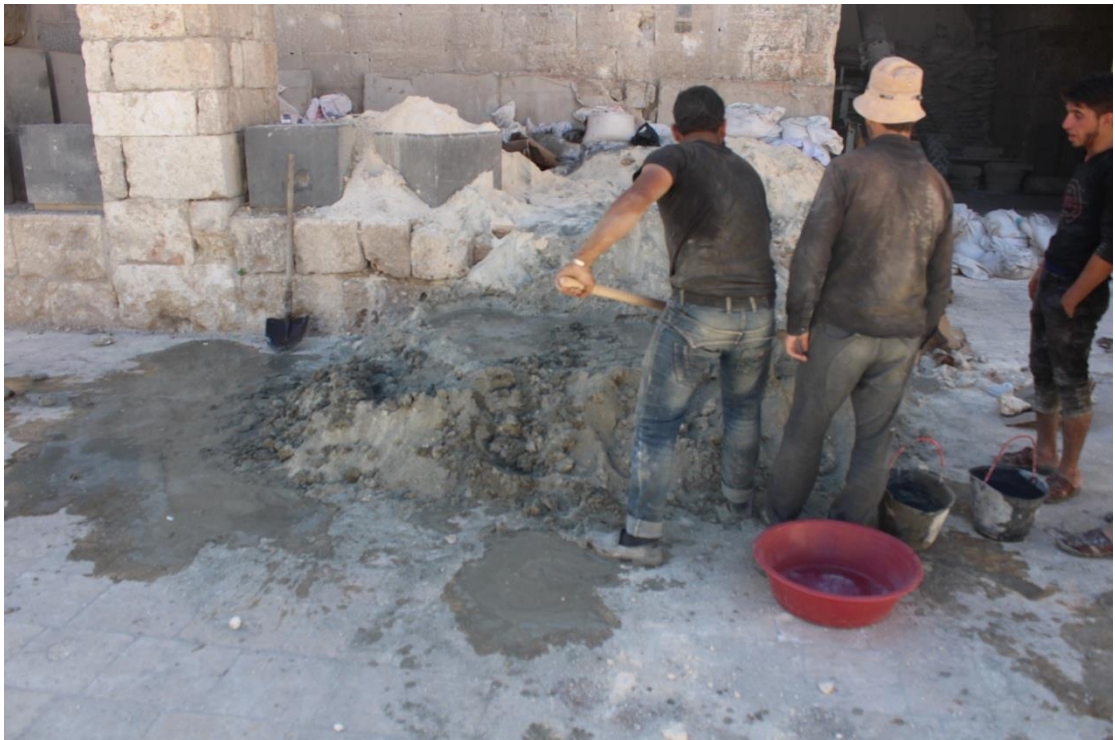
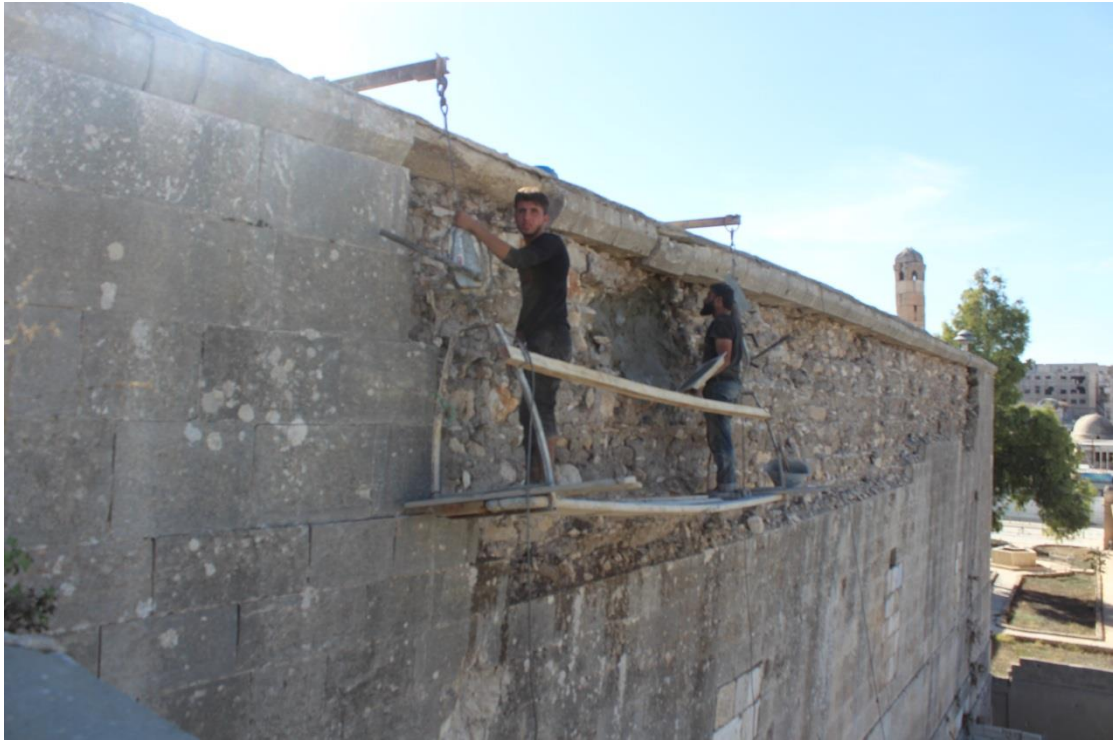
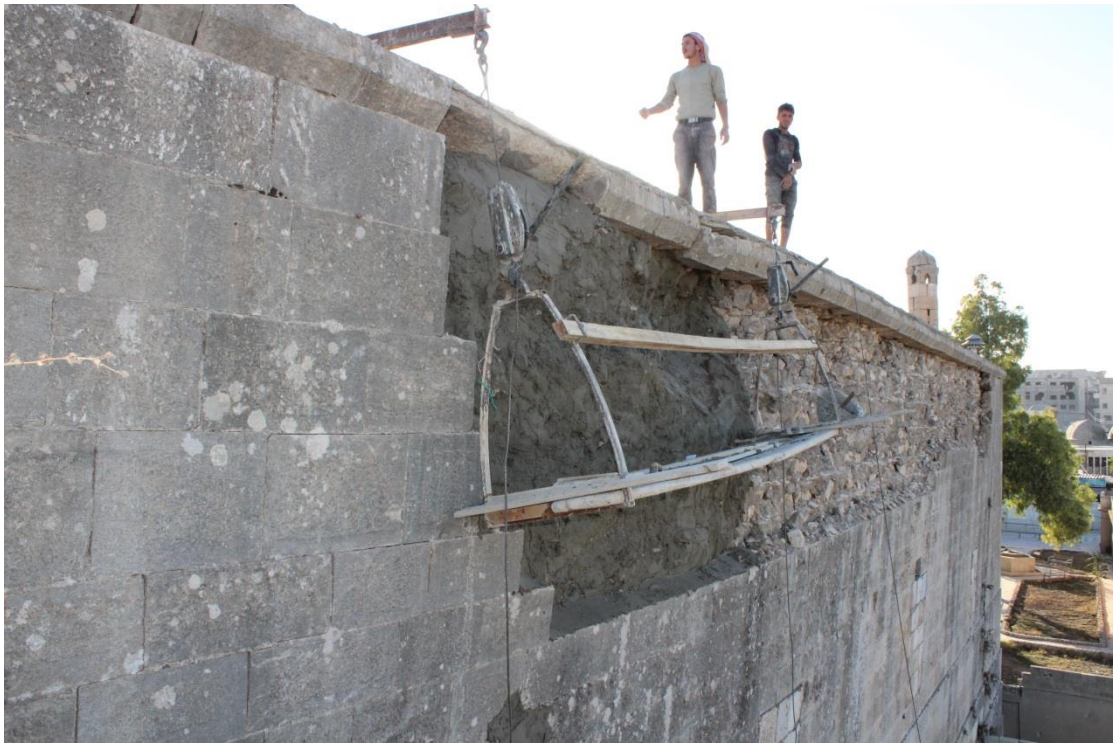
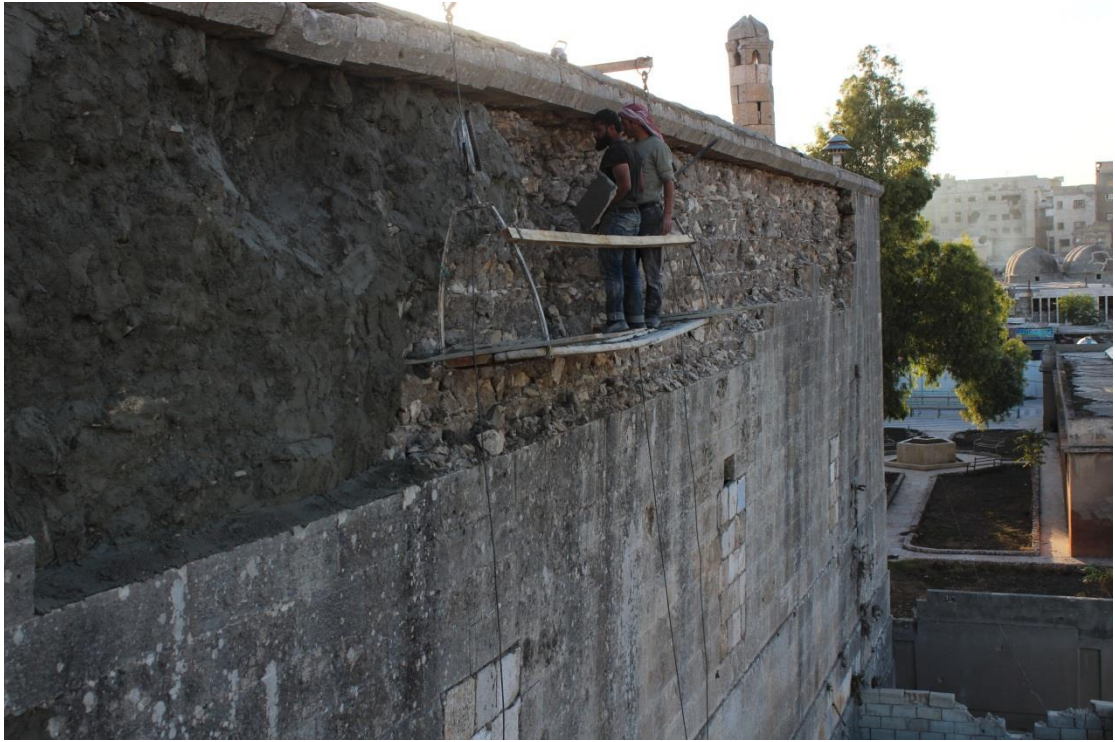
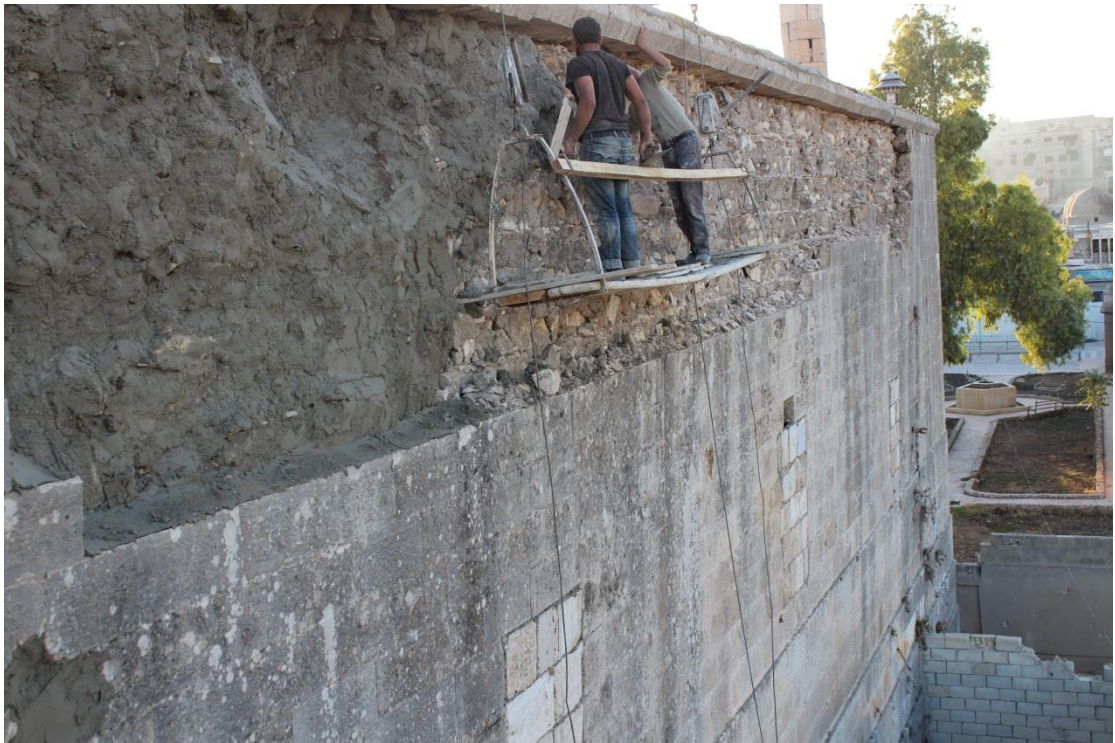
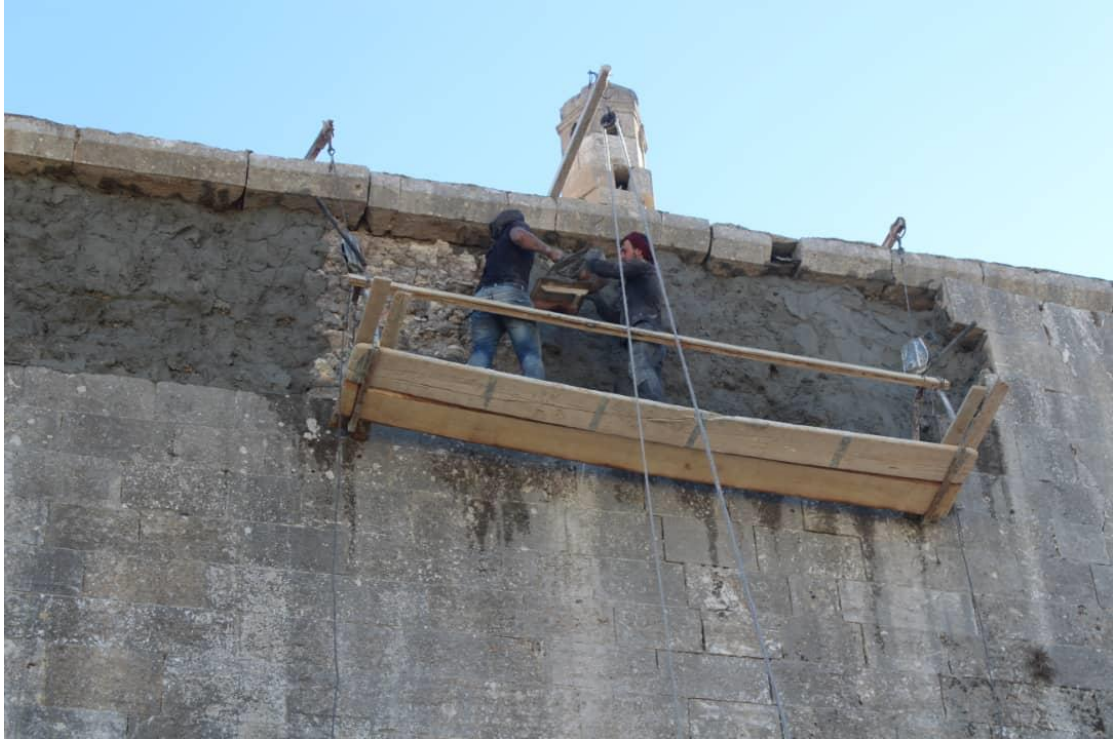
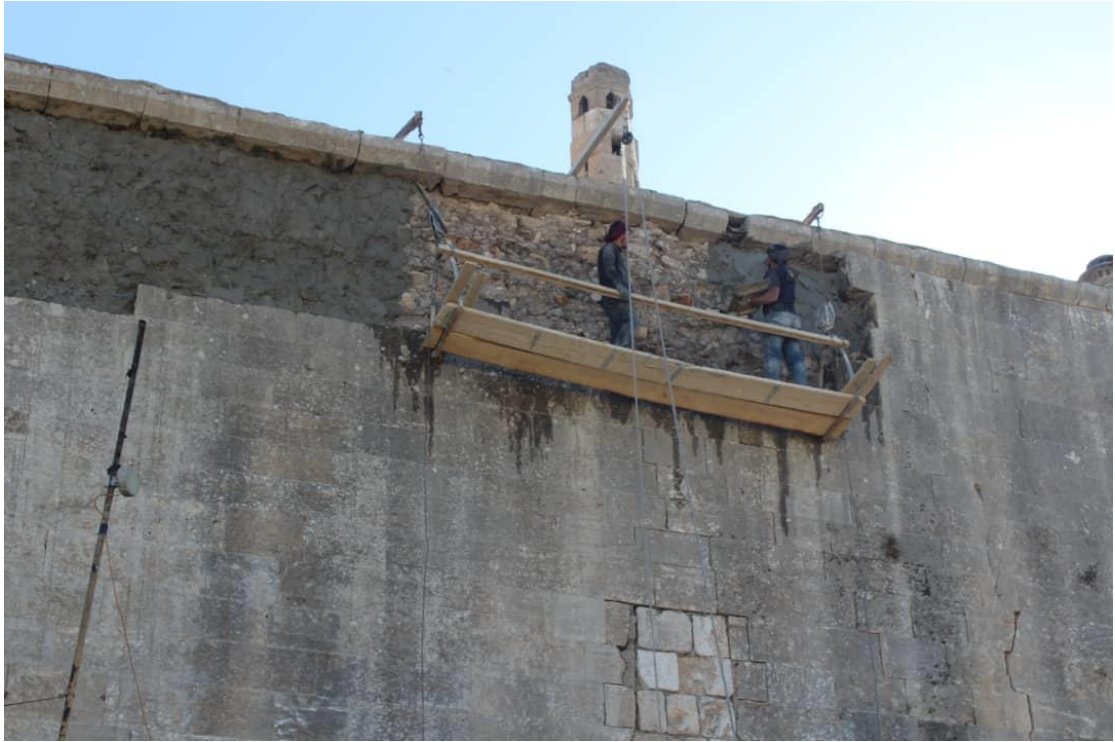
Reinforcing the wall from the north side

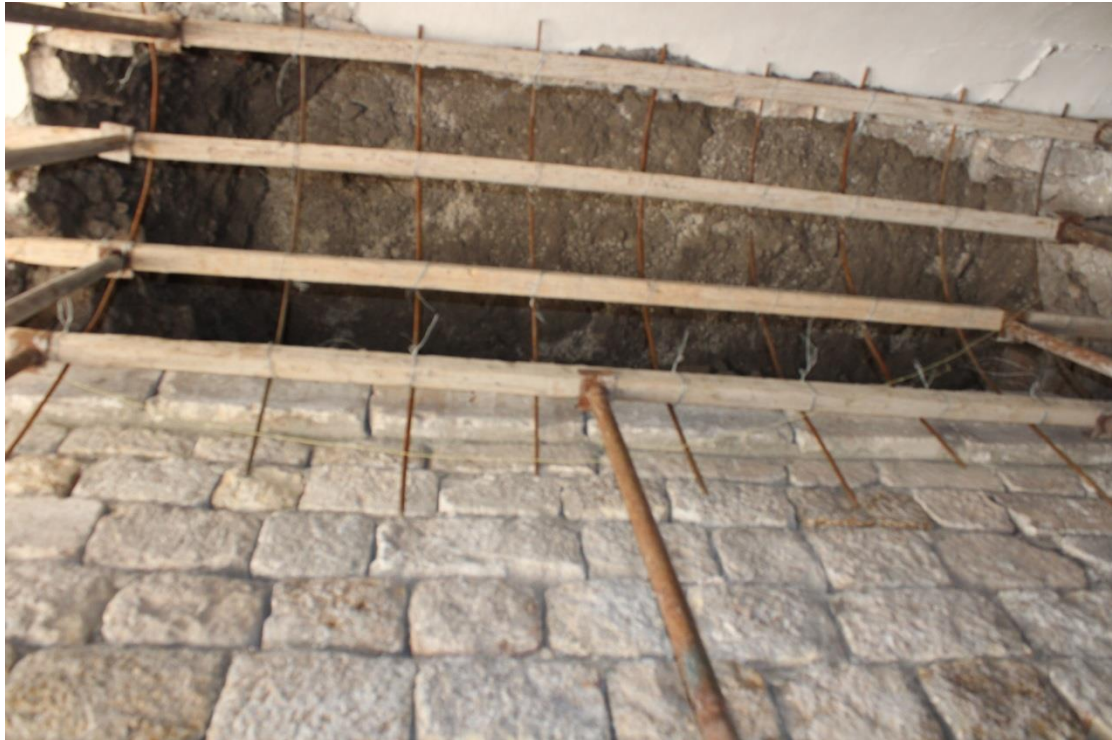
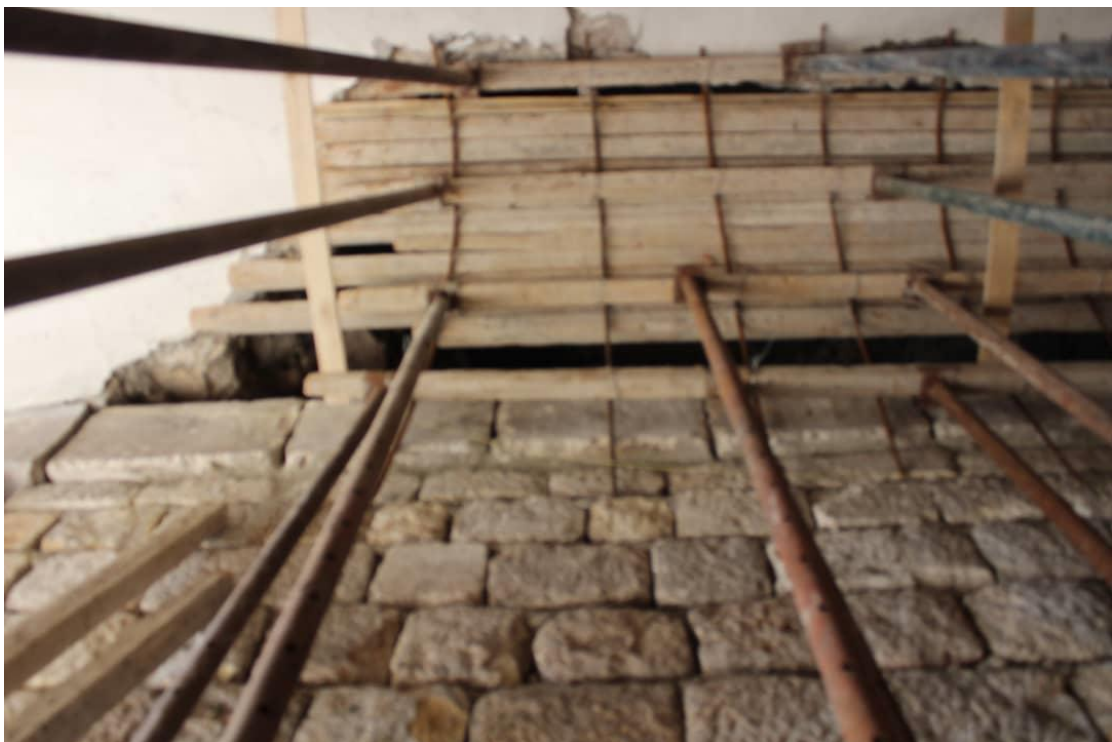
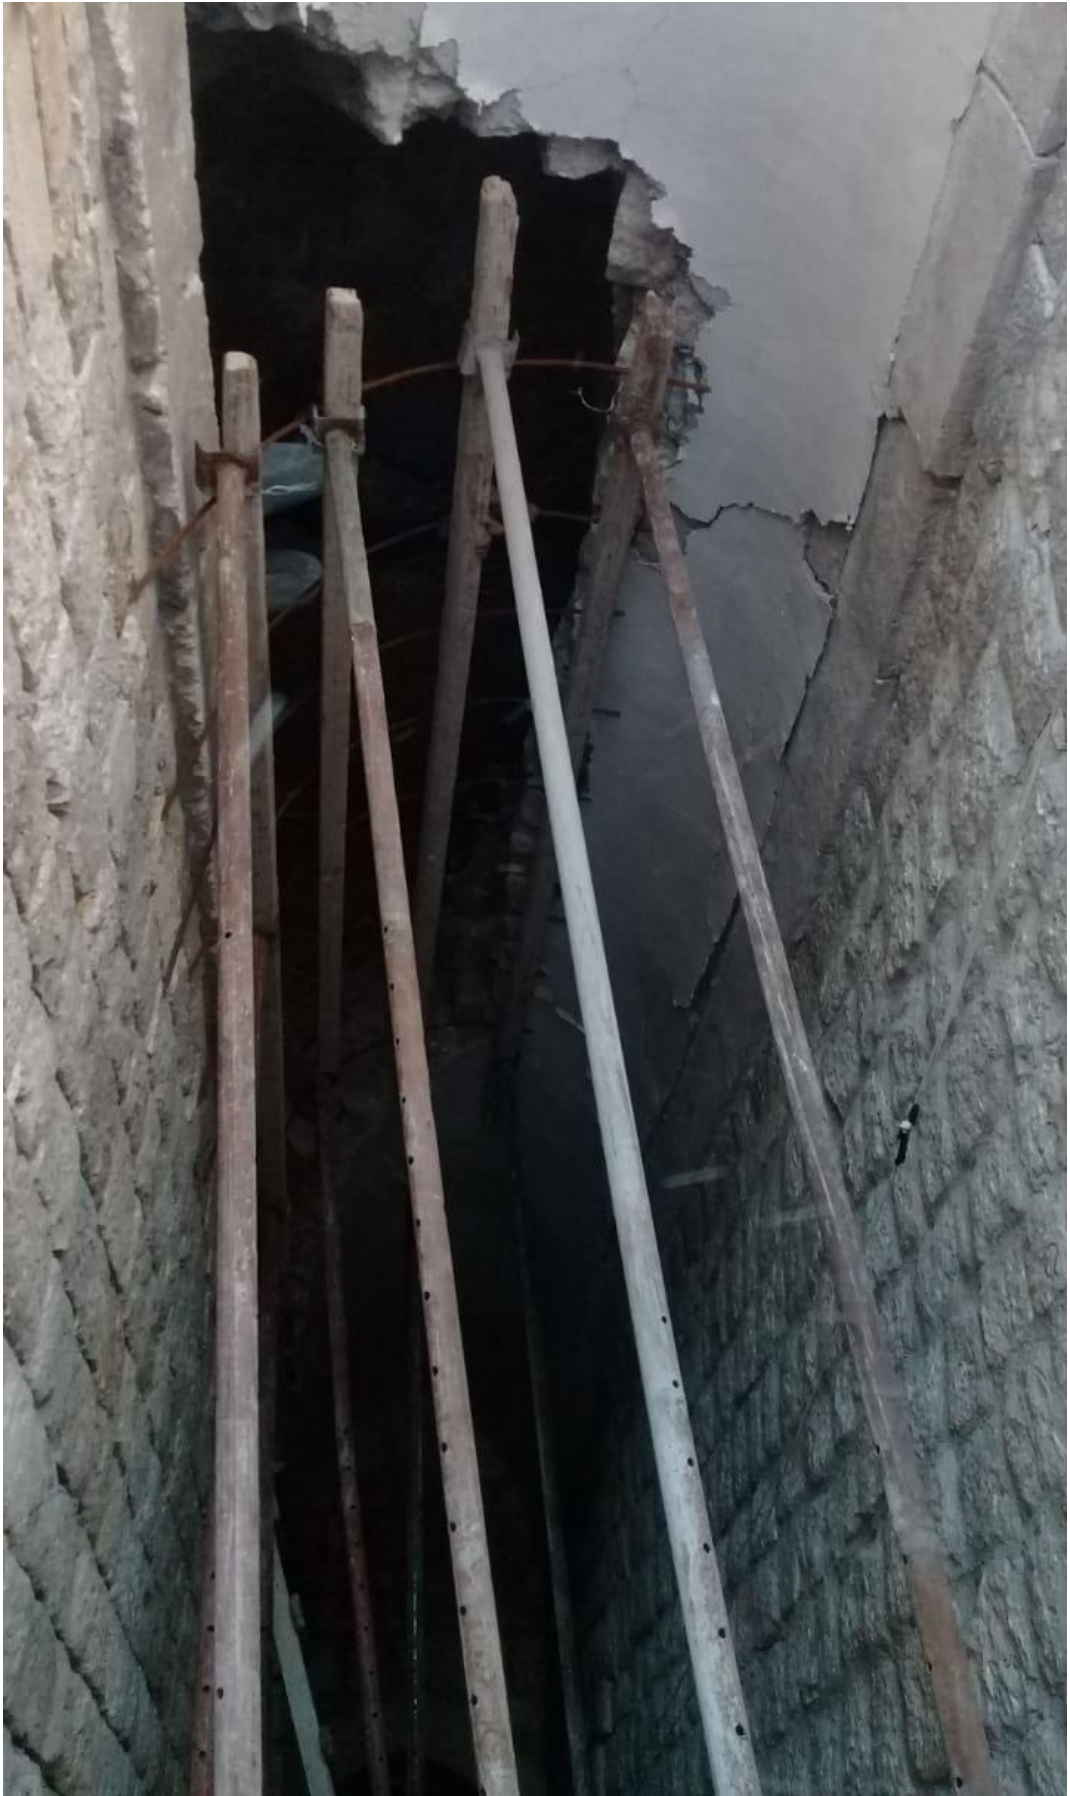
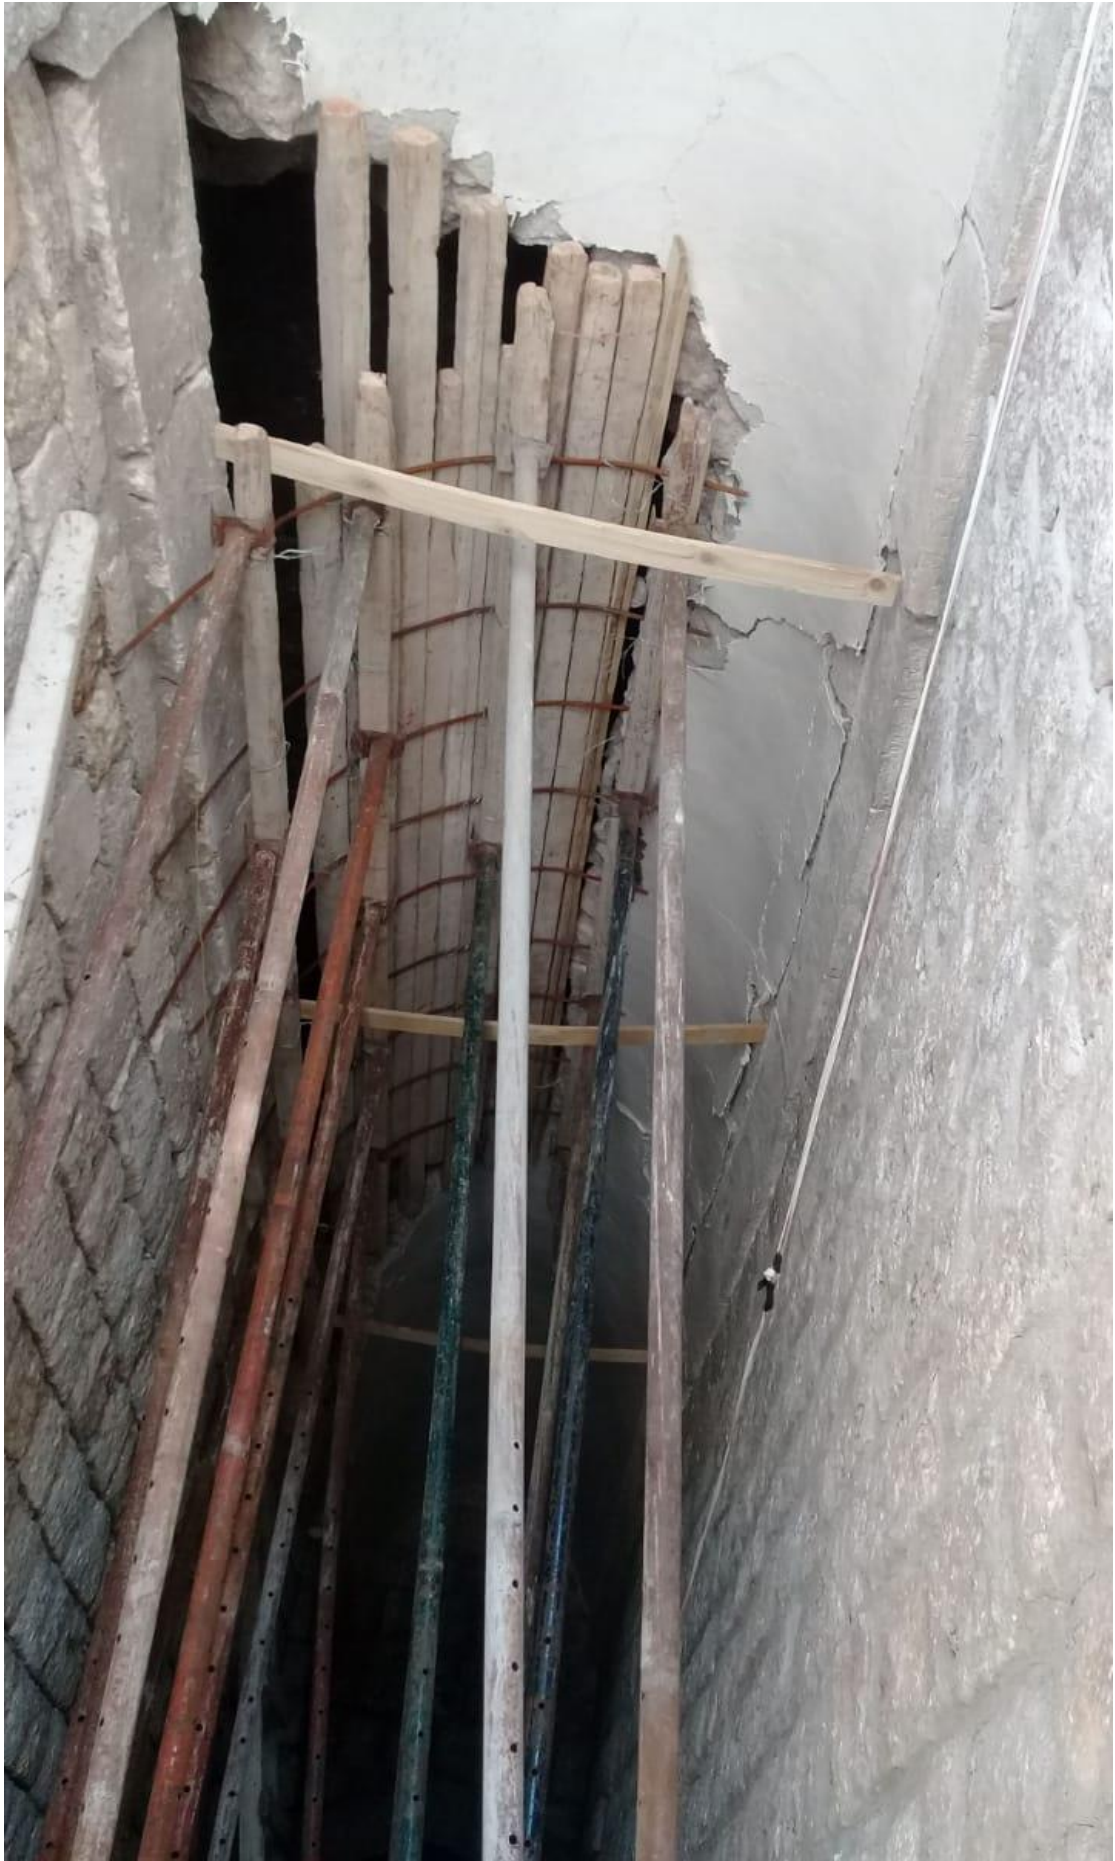
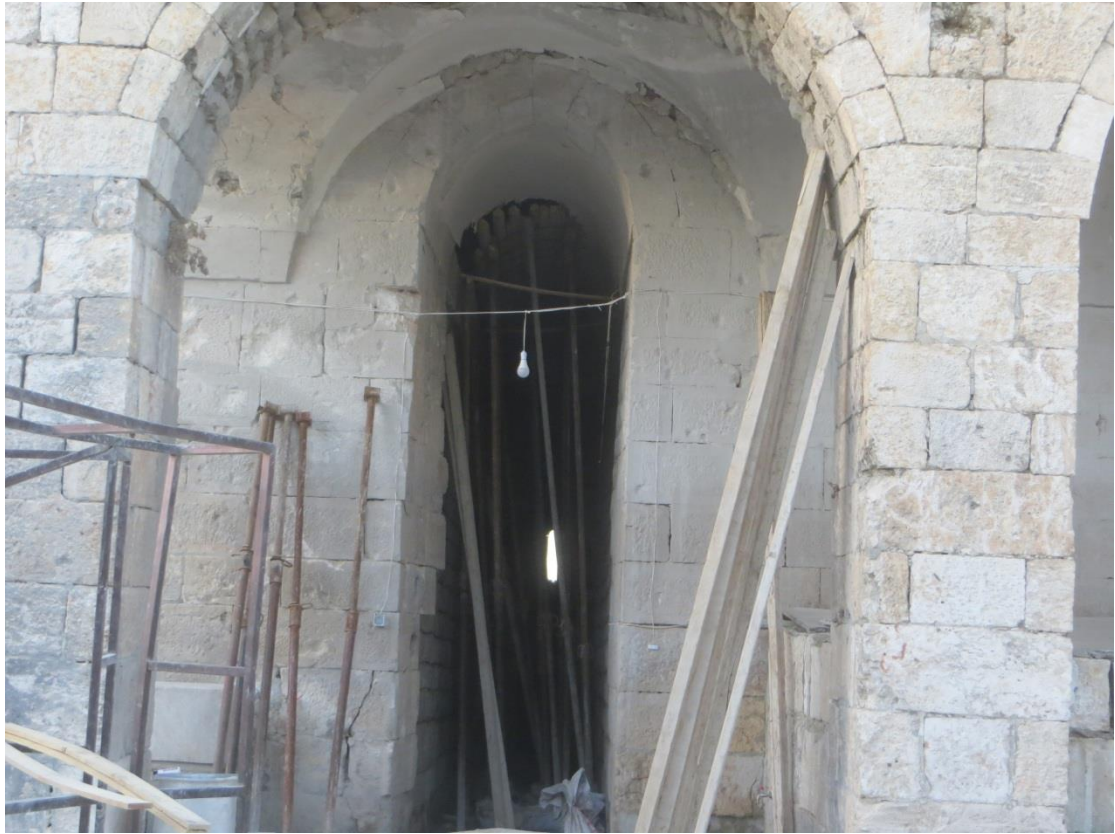
The work of supporting the arch within the corridor leading to the toilets

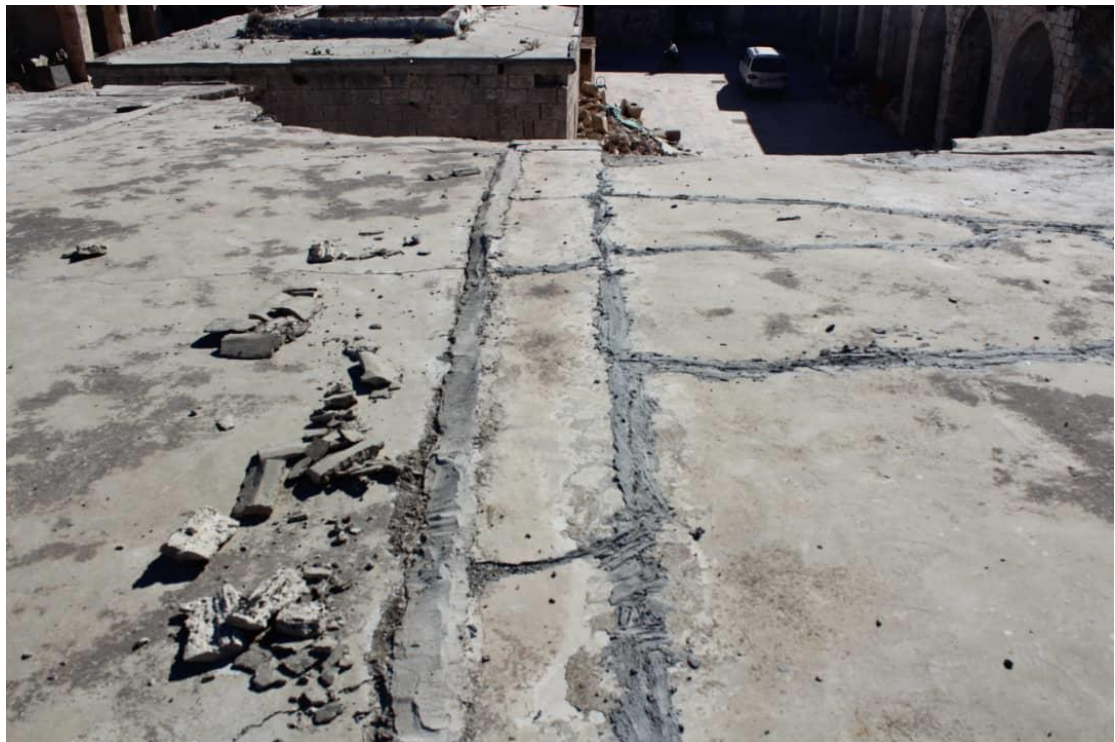
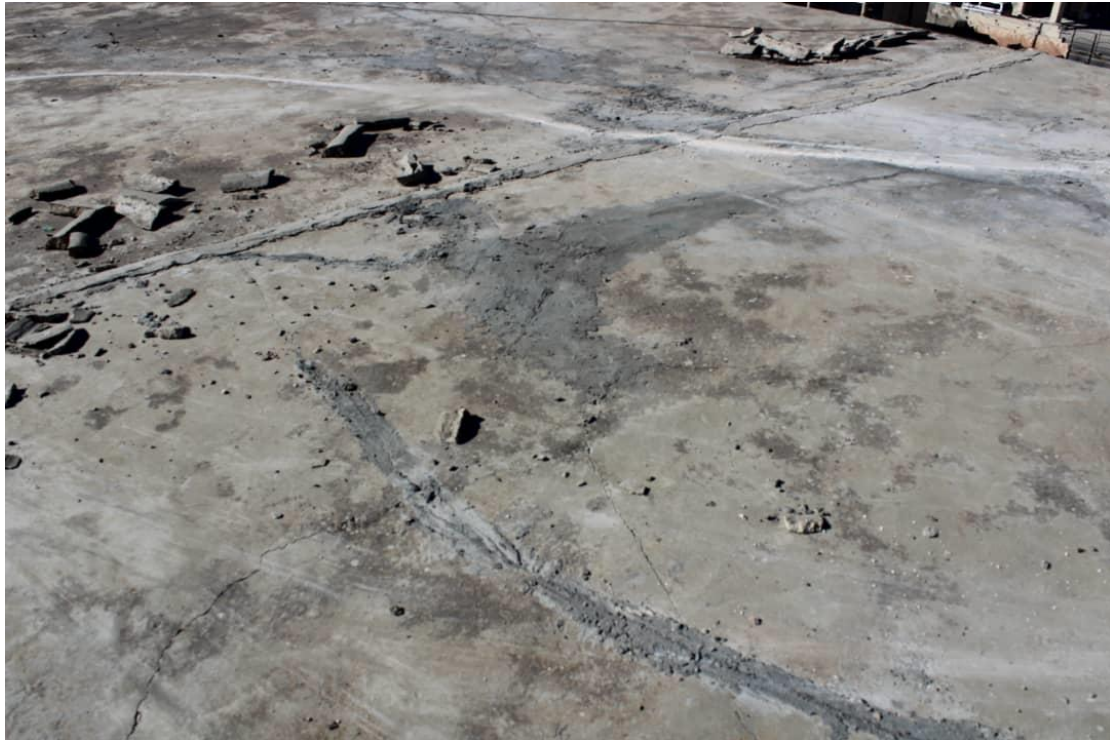
closing the roof cracks are the most exposed to the weather
