The Day After Heritage Protection Initiative

Mitigation Project 2

Safeguarding the Ma'ara Museum Phase II: Stabilization and Emergency Building Repairs

Project: Mitigation Project 2, Safeguarding the Ma'ara Museum:
Stabilization and Emergency Repairs.

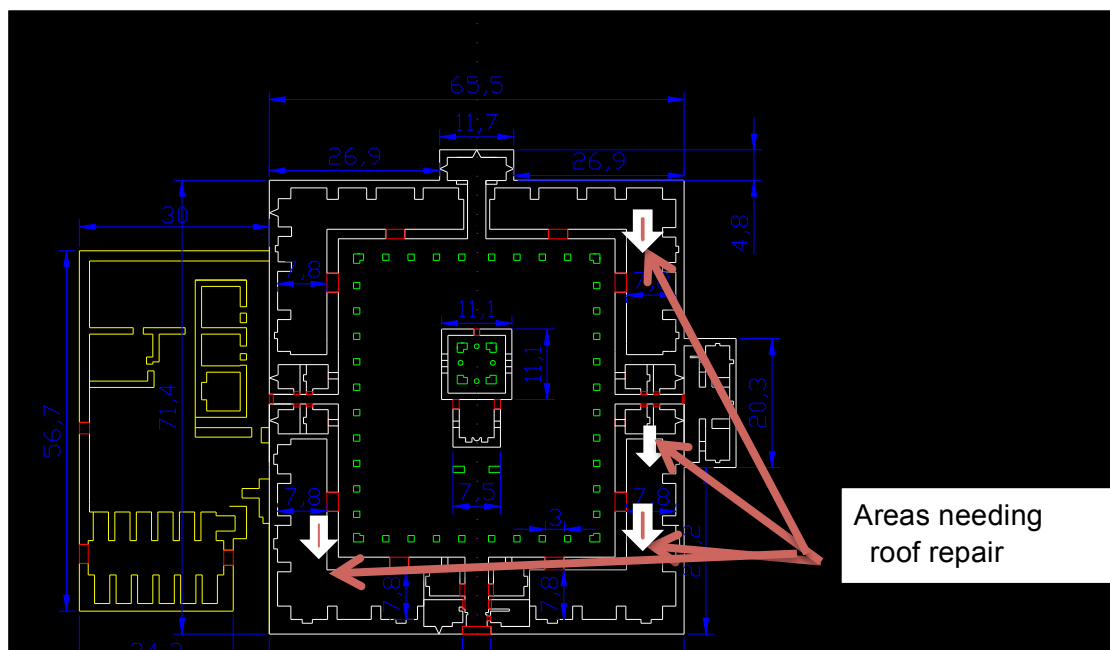
Figure 3: Plan of the museum showing the areas on the roof in need of urgent repair.

Repairing the parts of the roof that are leaking to prevent collapse (see figs 3, 6 and 7).

1. Completely cleaning the roof
2. Inject the cracks with silicon or acrylic or any other wax like material.
3. Breaking up and removing the affected layers of the damaged areas on the roof.
4. Repairing the uncovered damage by reinforcing the area using an iron frame/grid 10mm, 15x15cm and concrete cement mix 350kg/m³ (10cm thick).
5. Ensure that the repaired area is properly smoothed and correctly sloping toward the gutters to prevent the pooling of water on the roof.
6. Seal the repaired parts of the roof completely with acrylic.

NB: Urgent roof repair is critical to prevent water seeping into the building structure which causing the collapse of the ceilings on to the rooms and their contents.

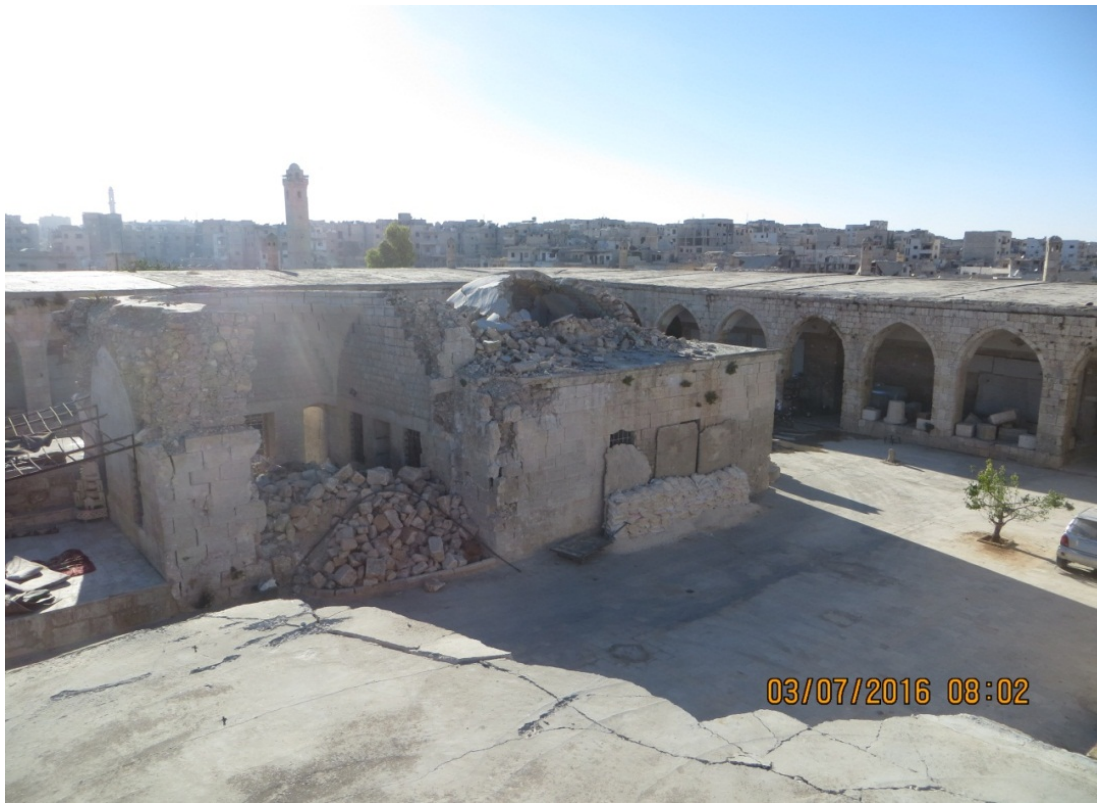
East side of the mosque prior to removal of the remainder of the dome.

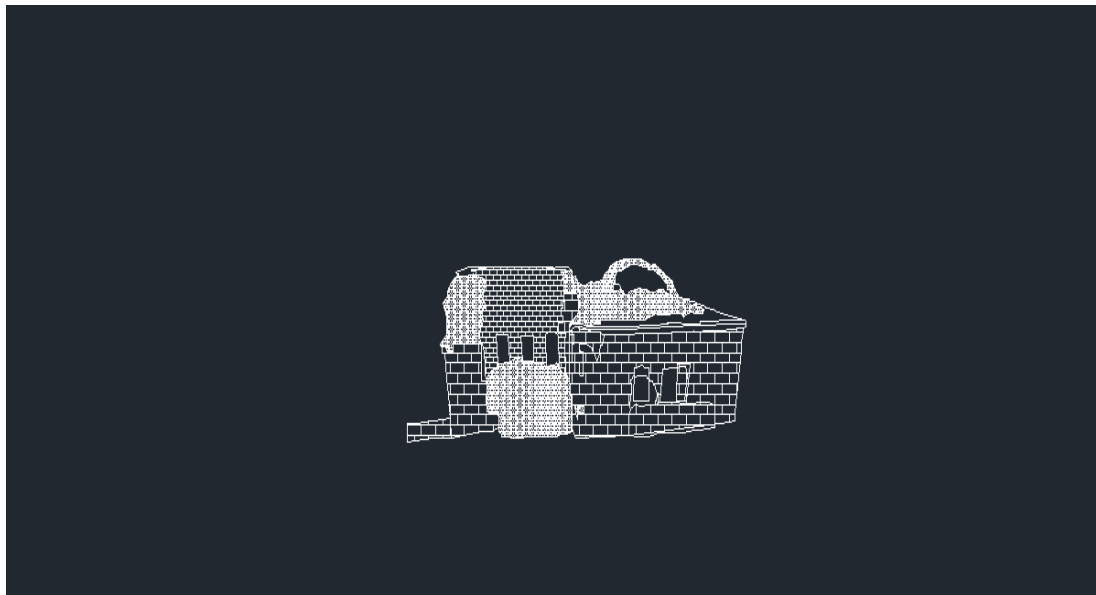
South side of the mosque (facing north) prior to removal of the dome.

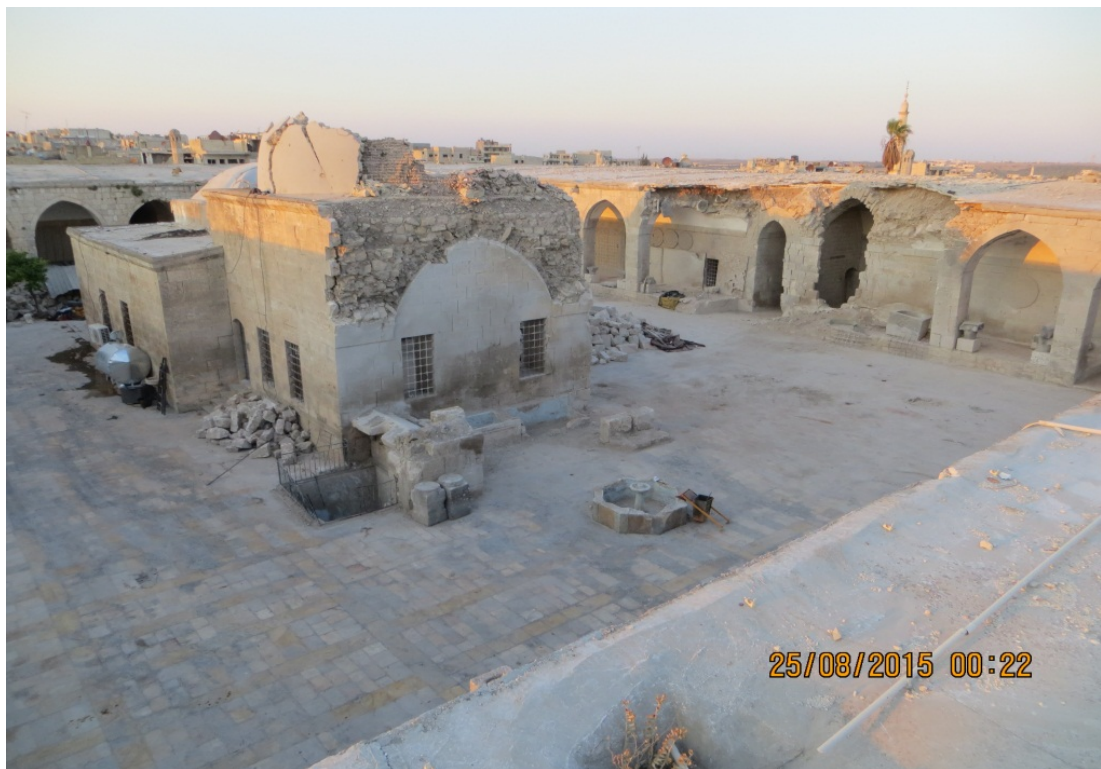
South side of the mosque (facing north east) prior to removal of the dome.

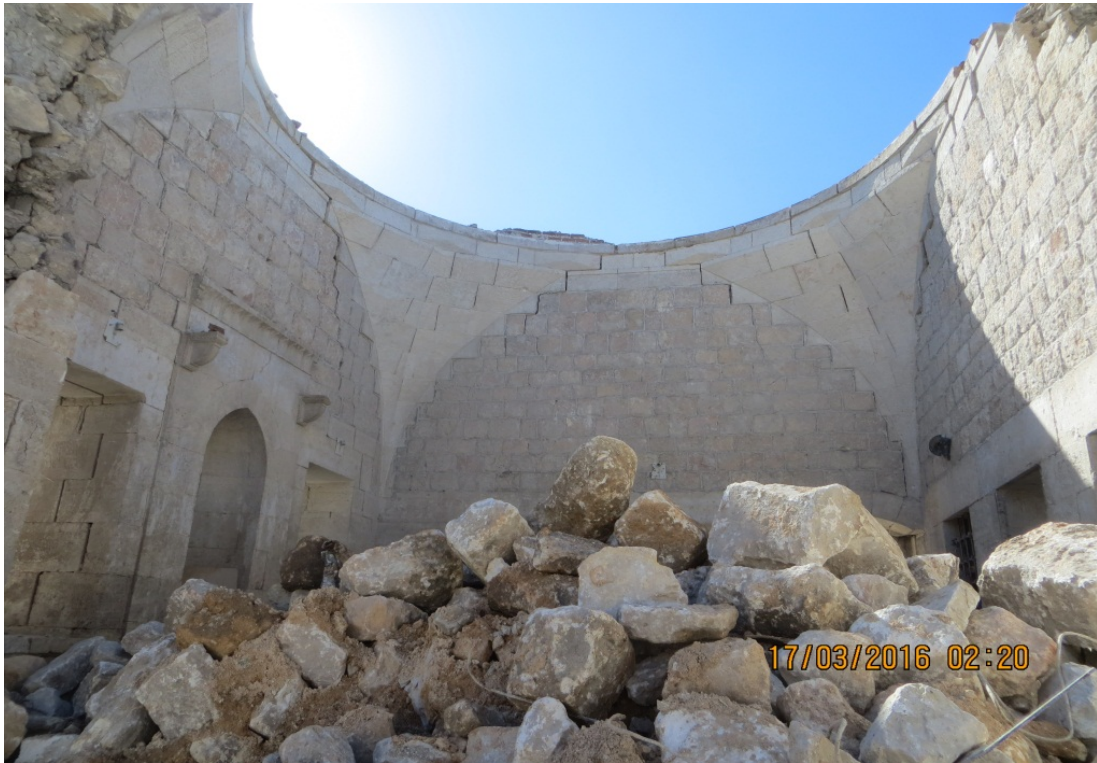
View from inside the mosque looking up at where the dome used to be

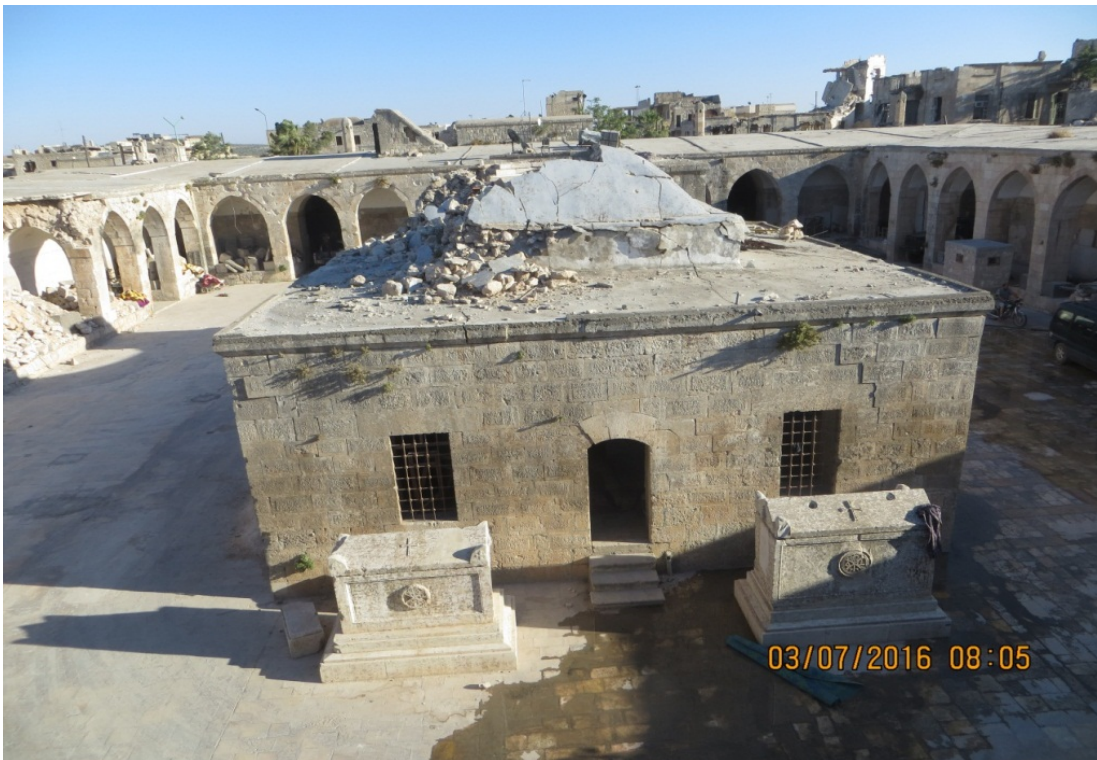
North side of the mosque (facing south) prior to removal of the dome

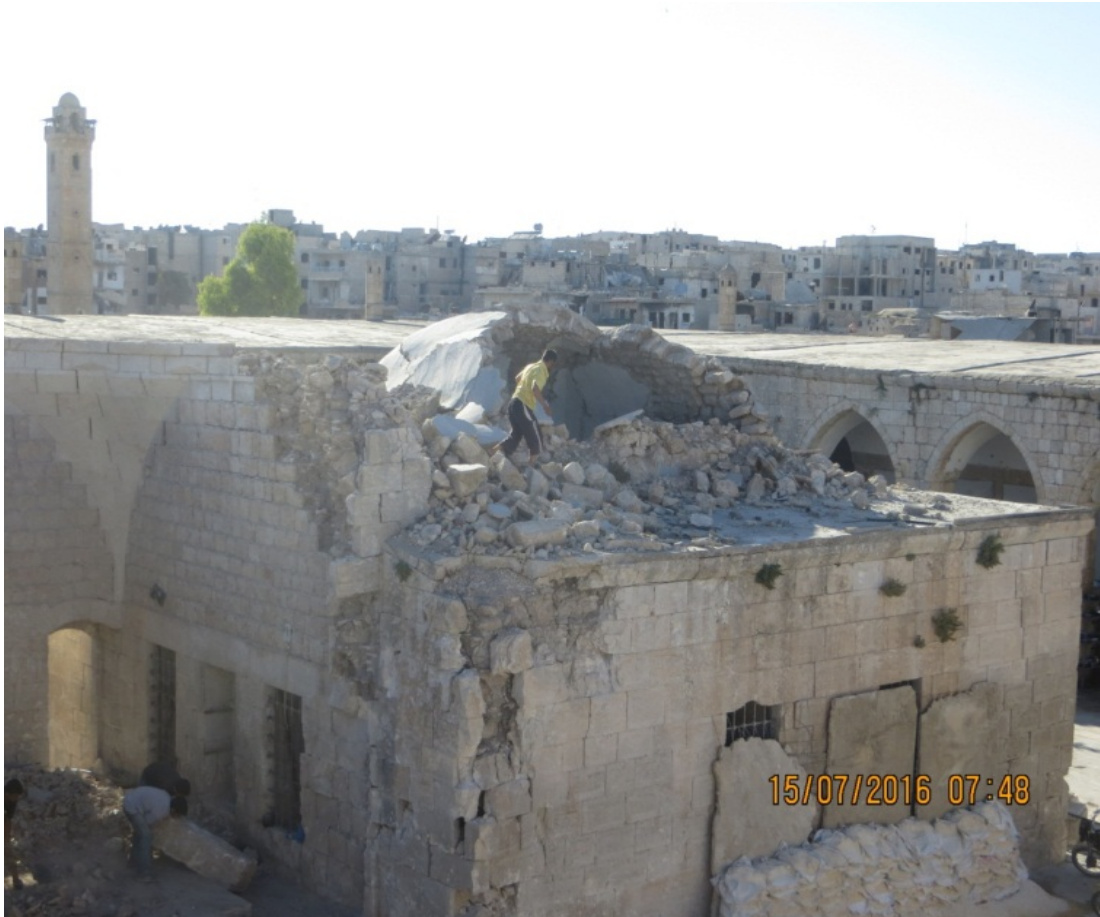
View of the damaged dome of the Tekkiye

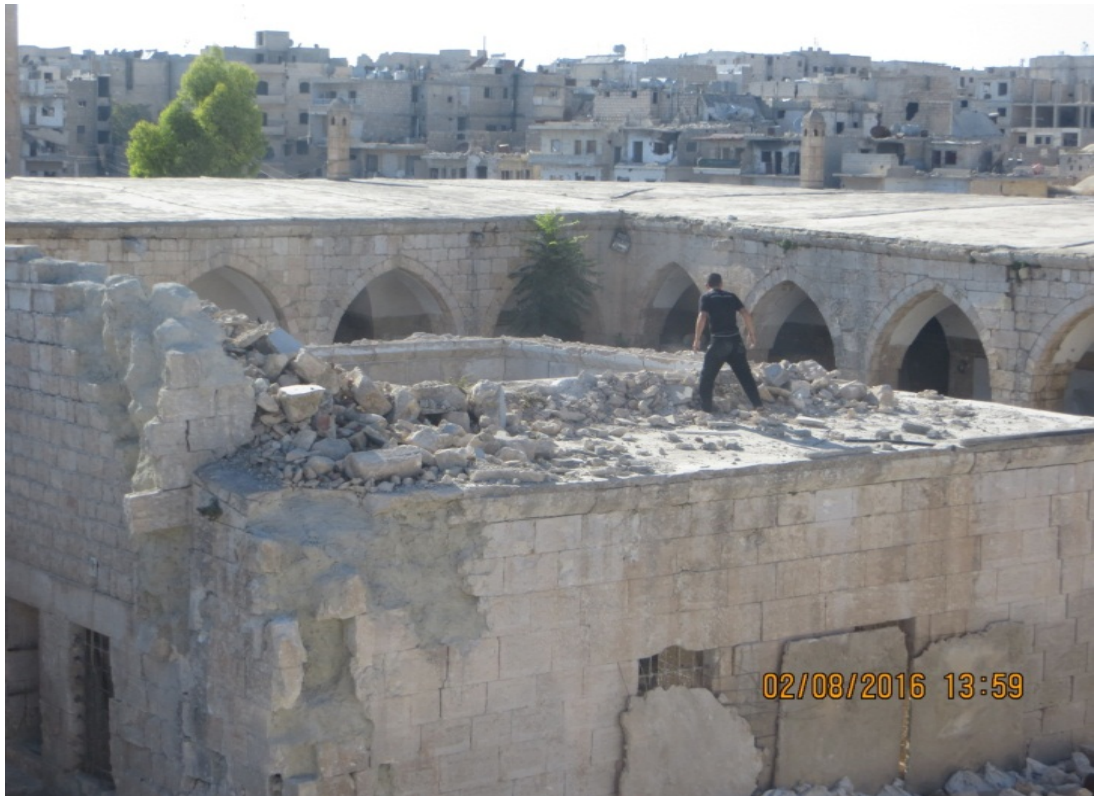
Gradual removal of the Tekkiye stone masonry

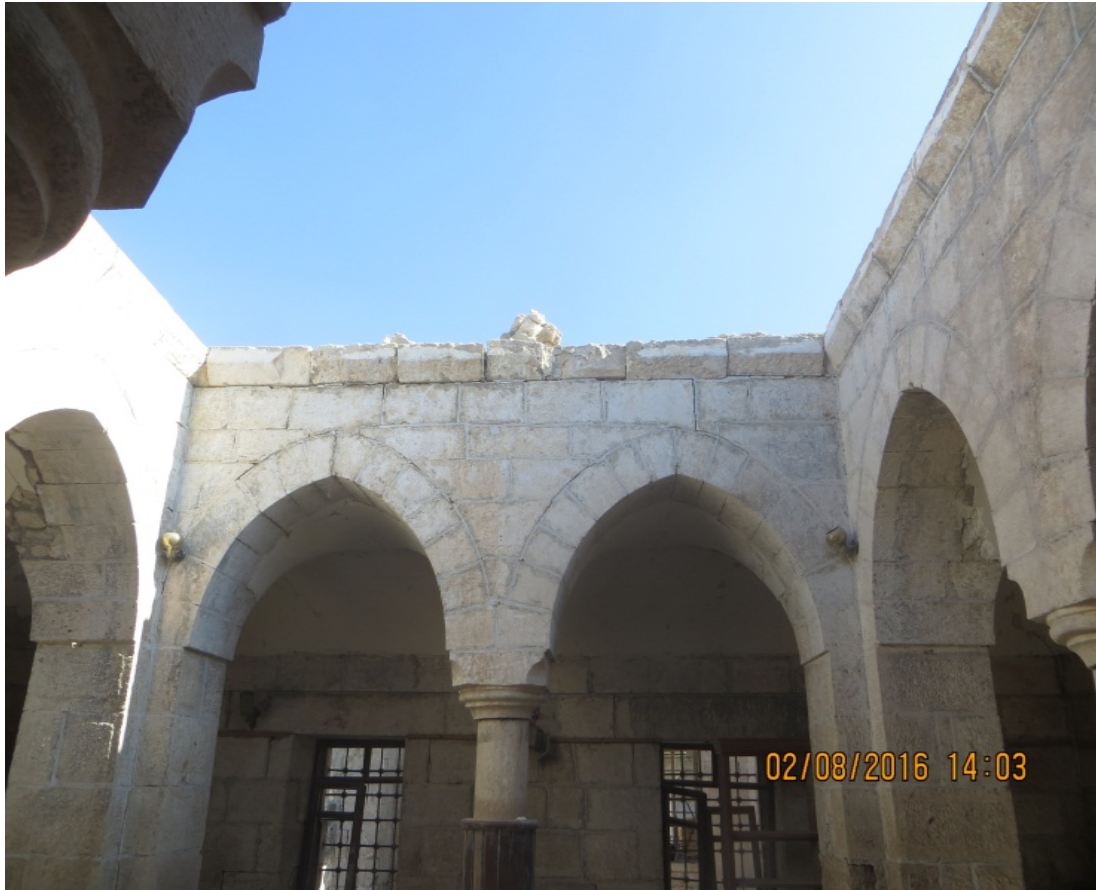
The Tekkiye after the removal of the damaged dome

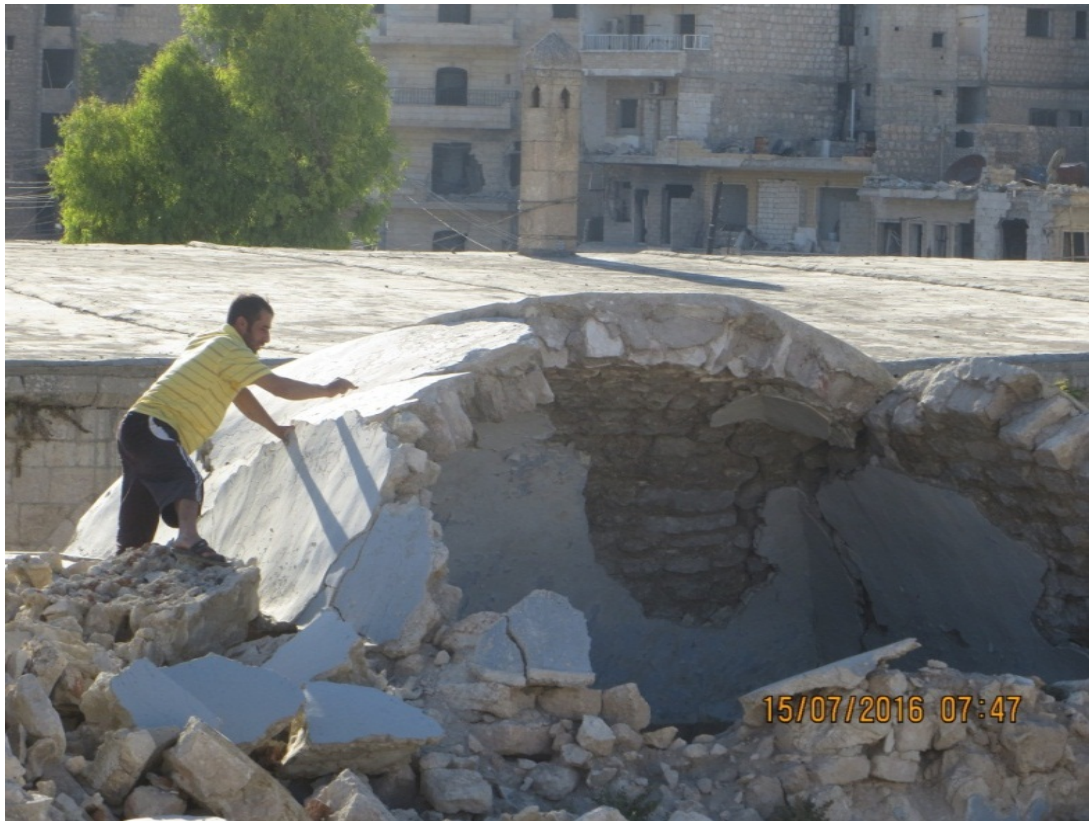
Labeling stones in the Tekkiye prior to removal

NB. The mapping, numbering of the stones and their care in storage is to ensure that it will be possible to restore the damaged historic parts of the museum in the future.

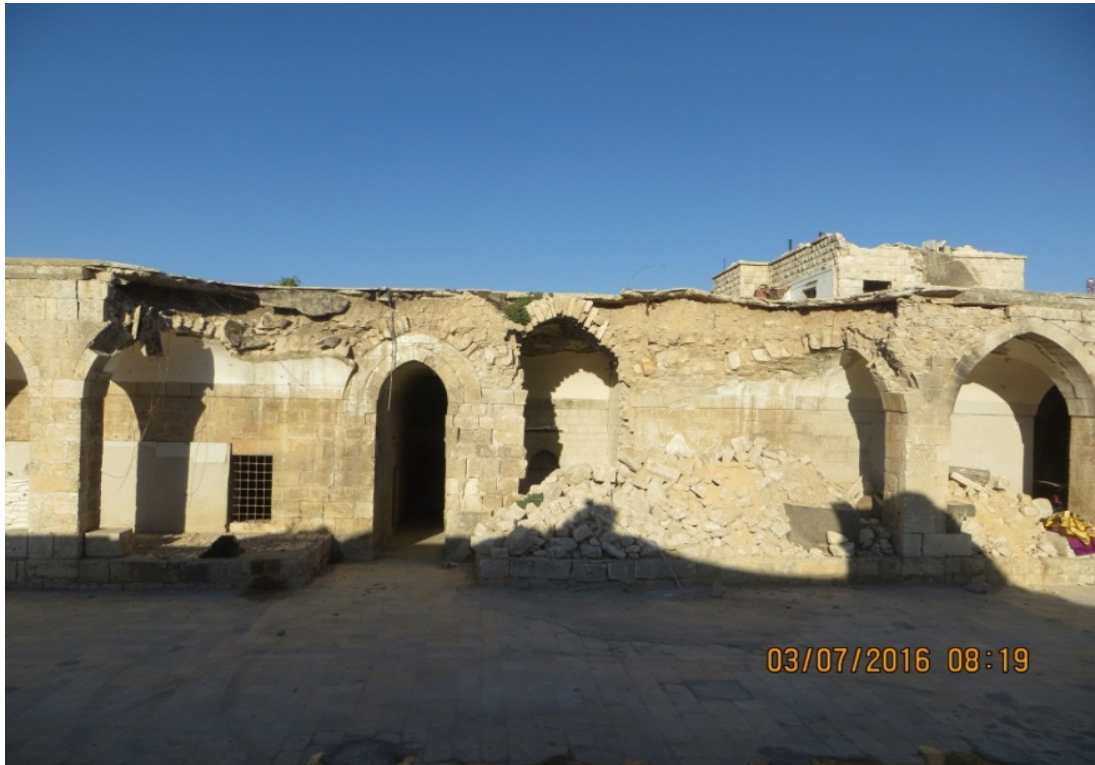
East side façade and gallery showing damage from 2015 airstrike

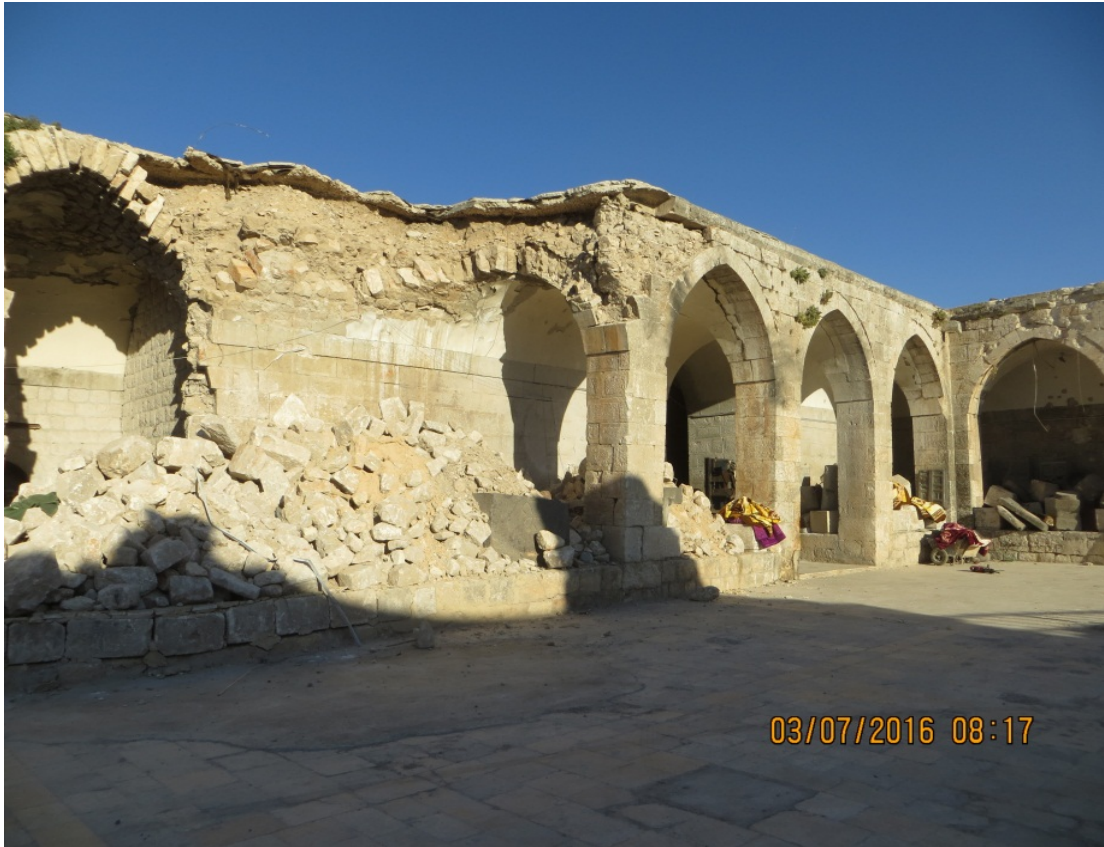
Damage to east side gallery

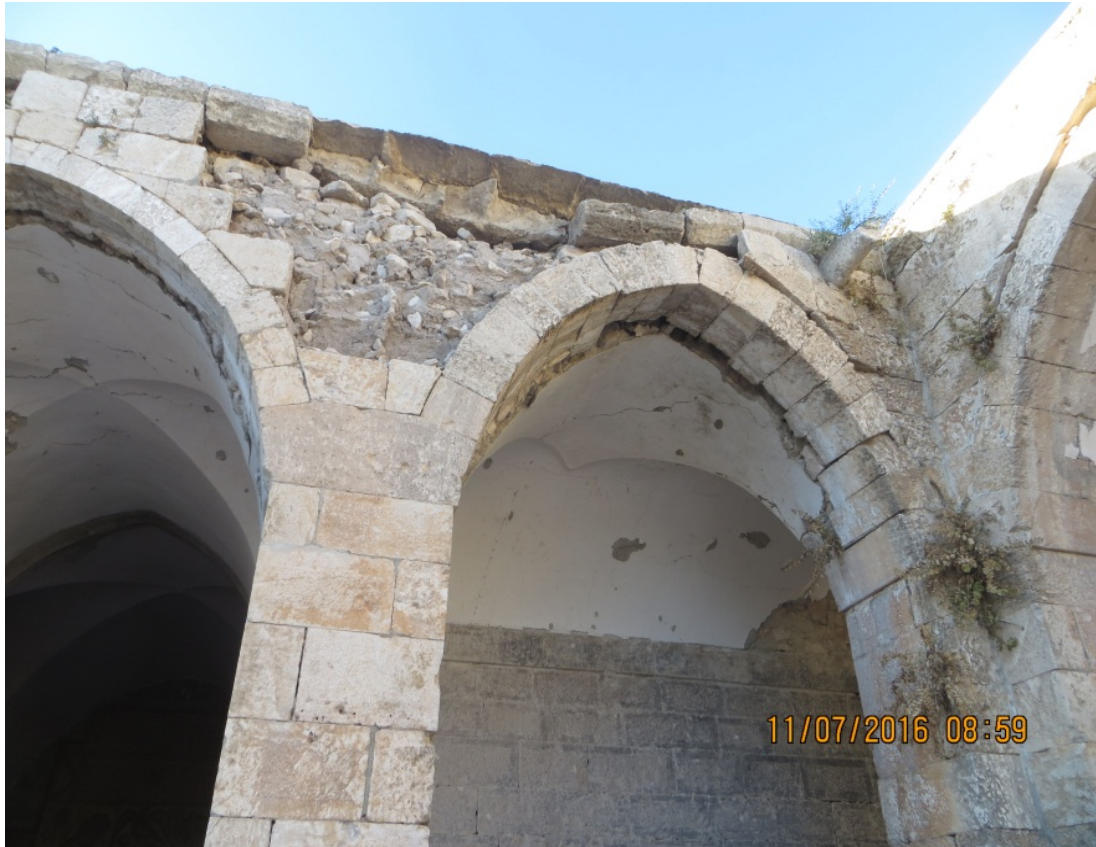
Damage to the arches and the ceiling in the east gallery

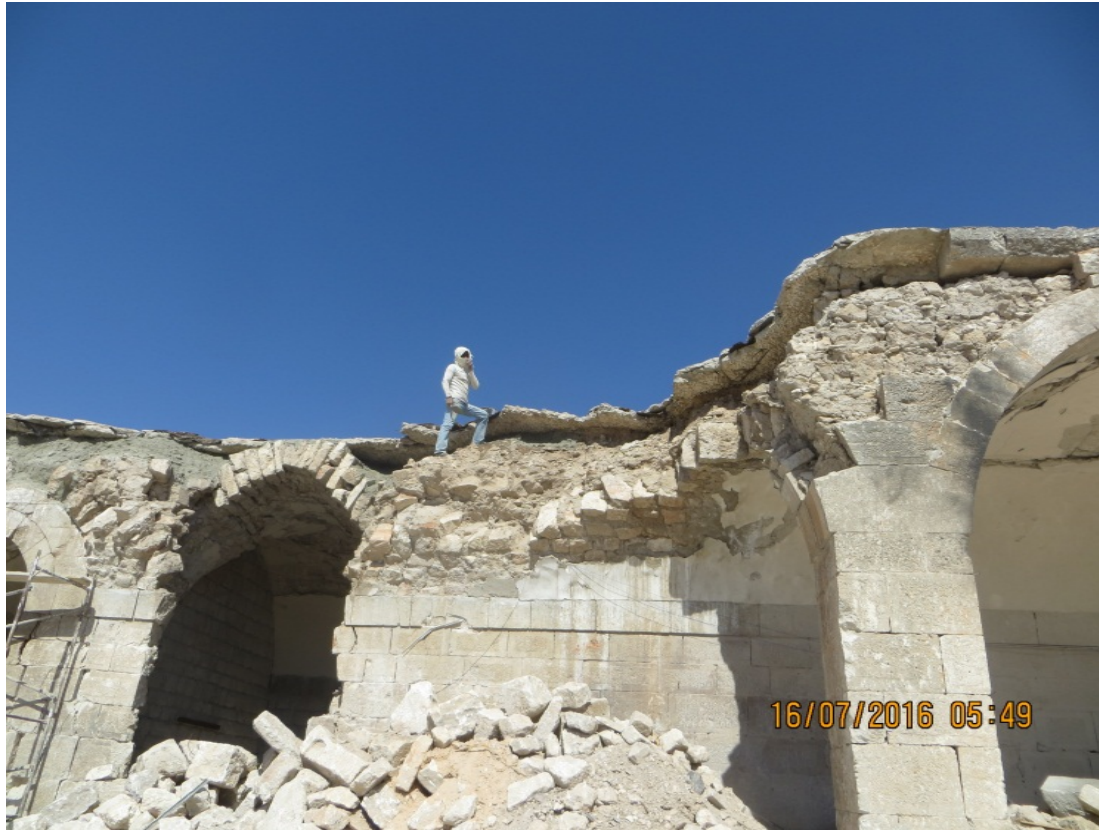
Loose masonry and exposed roof/wall fill

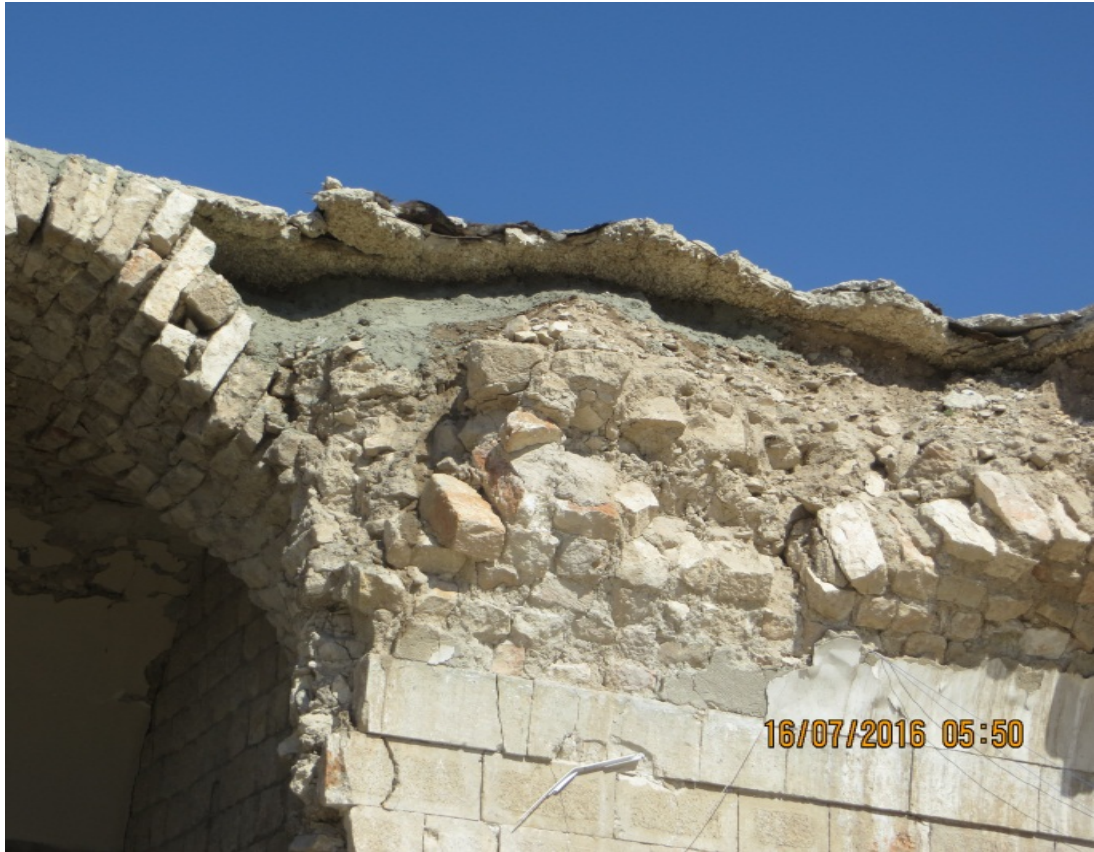
Loose masonry and exposed roof/wall fill (continued)

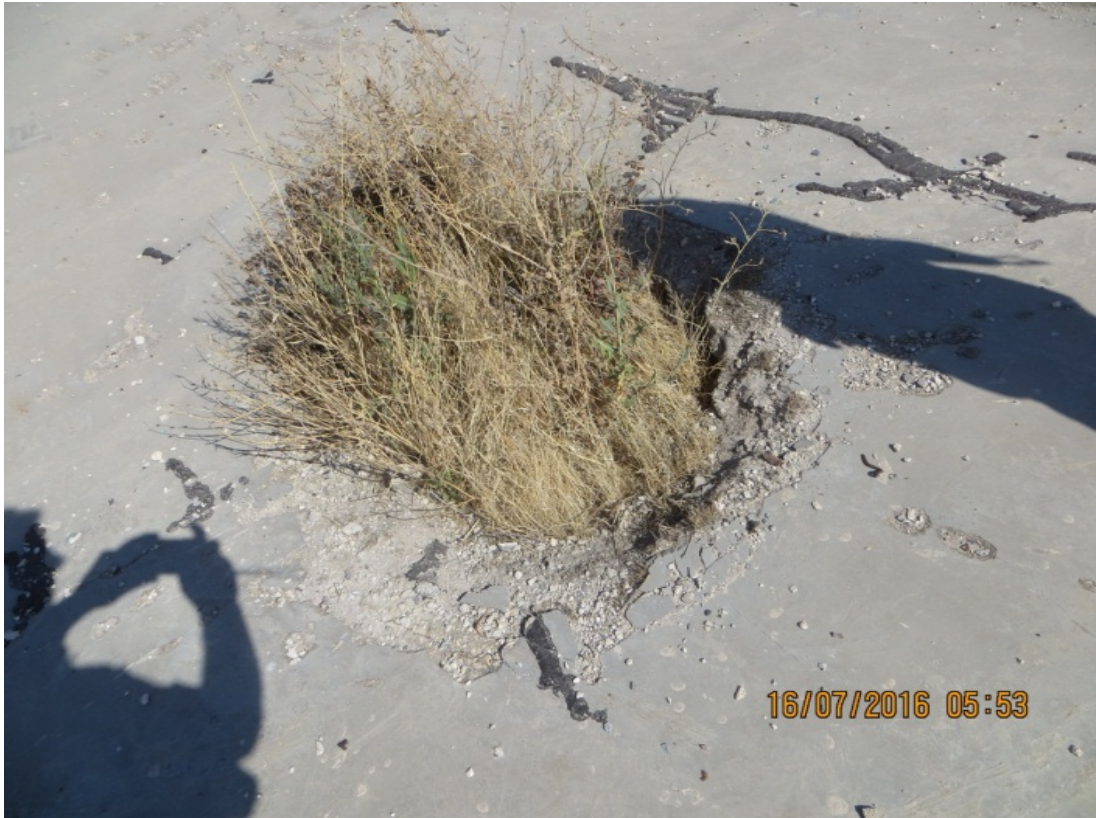
Cleaning roof and preparing it for resurfacing and repair

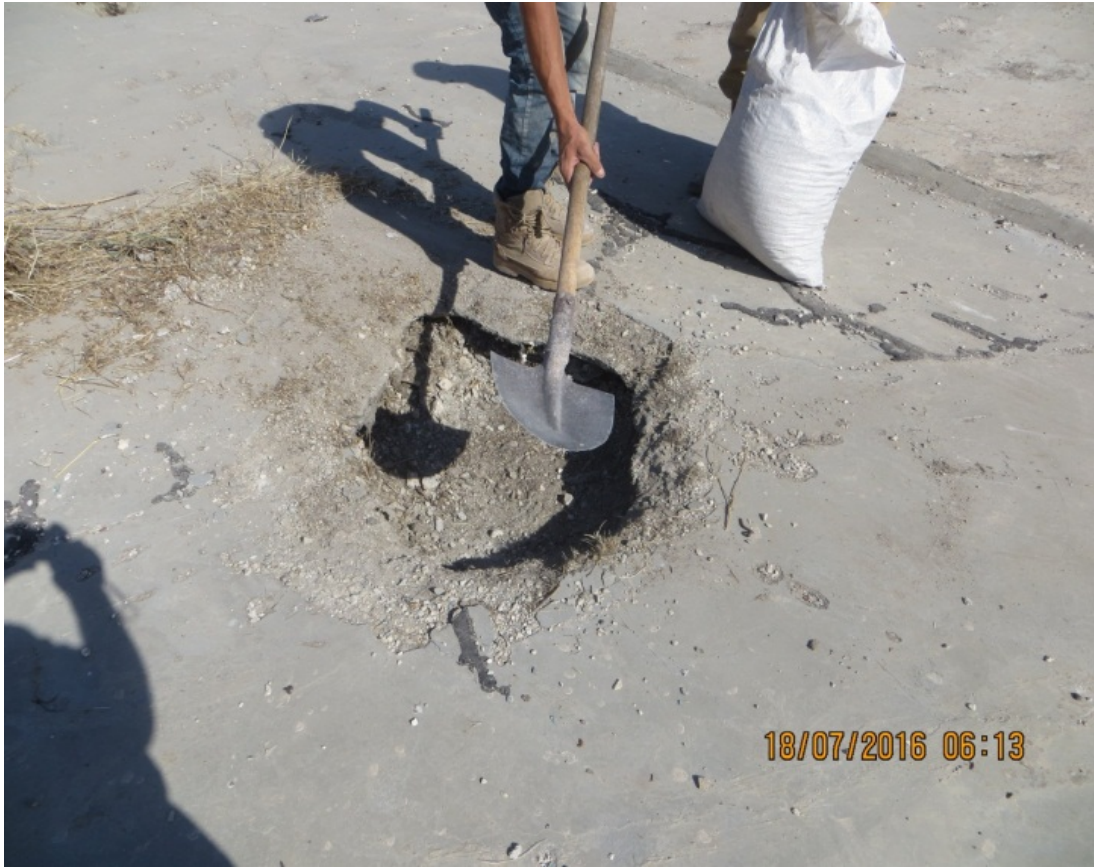
Repairing damaged area on the roof

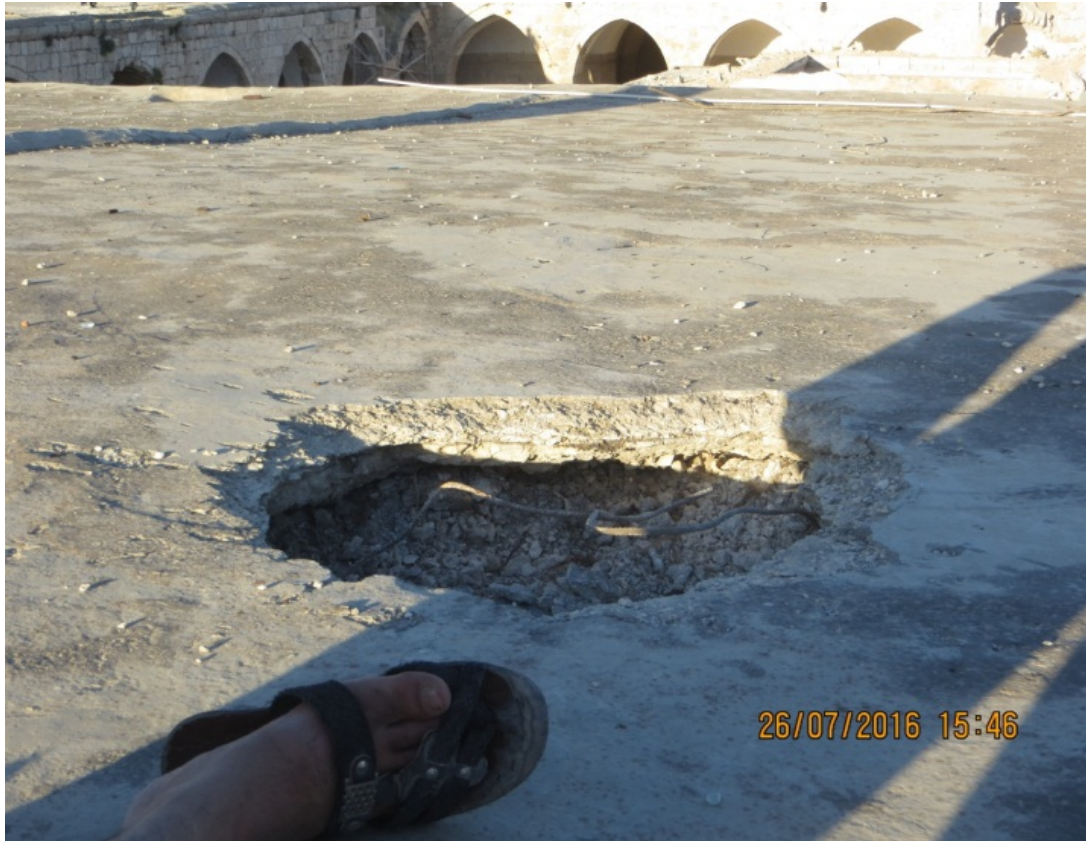
Repairing holes in the roof

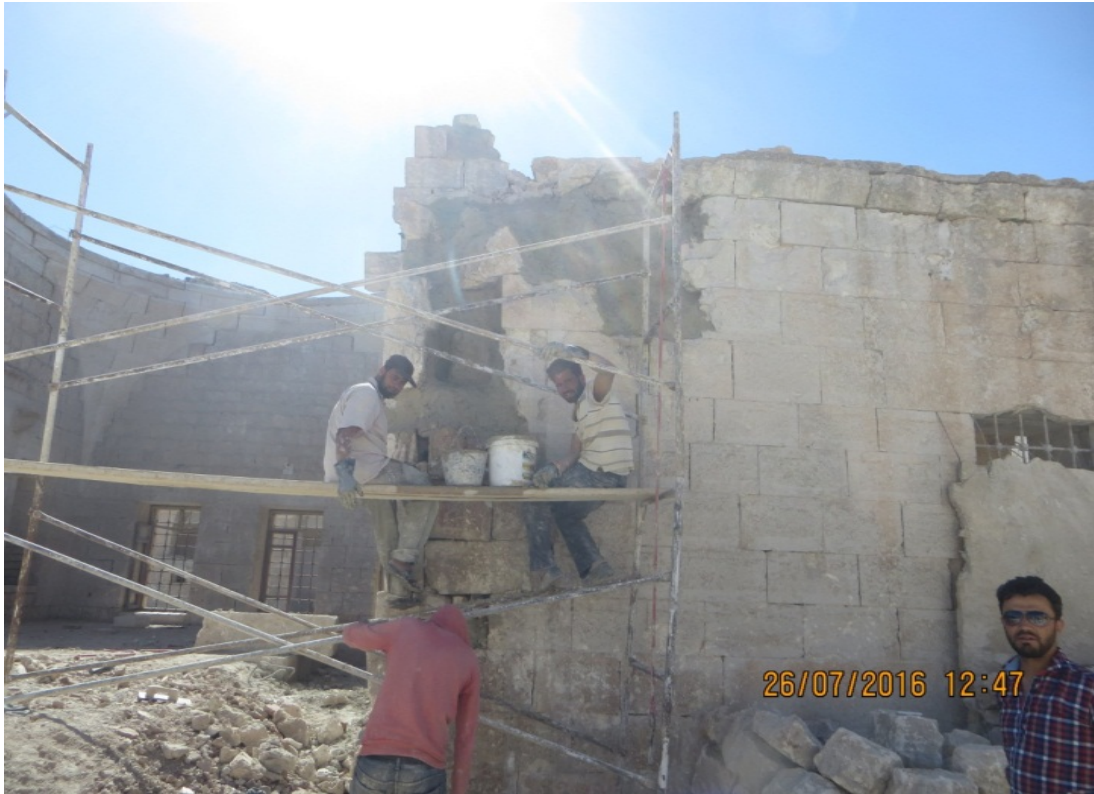
Repairing and stabilizing walls using a cement mortar

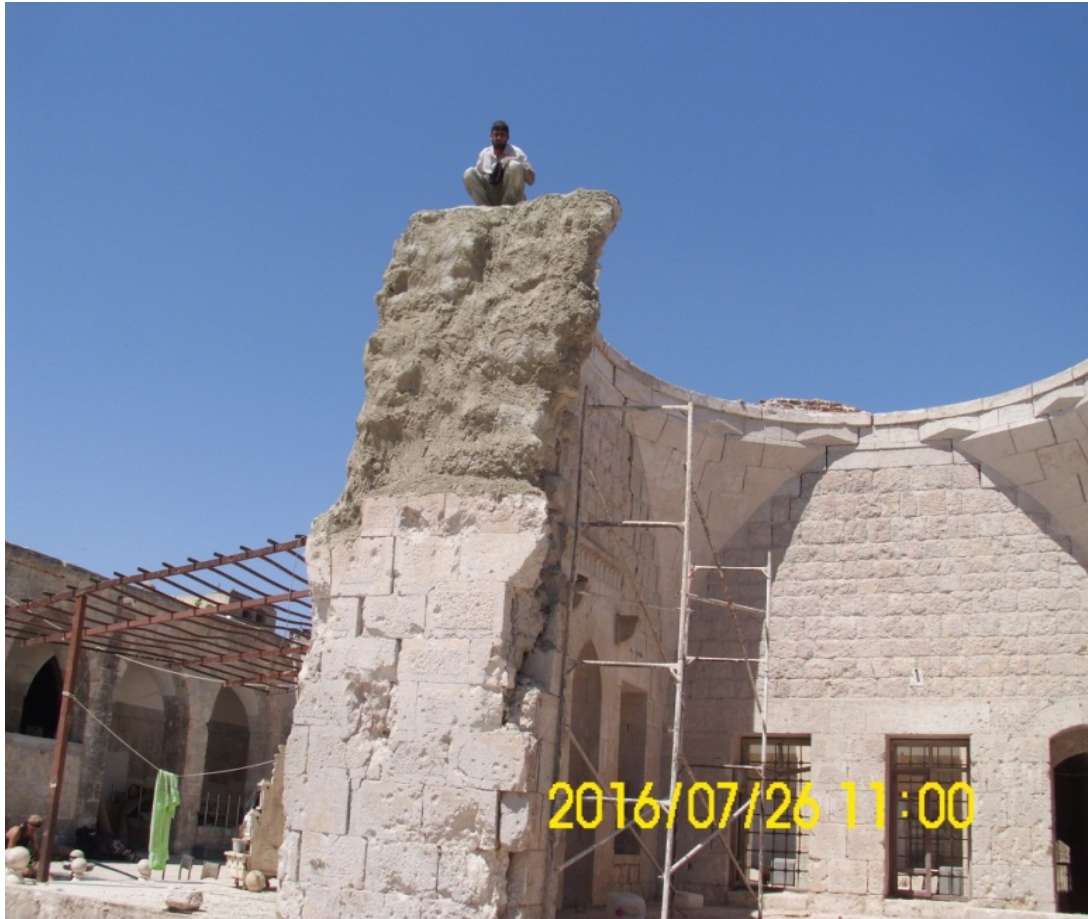
Damaged areas patched with a cement mortar

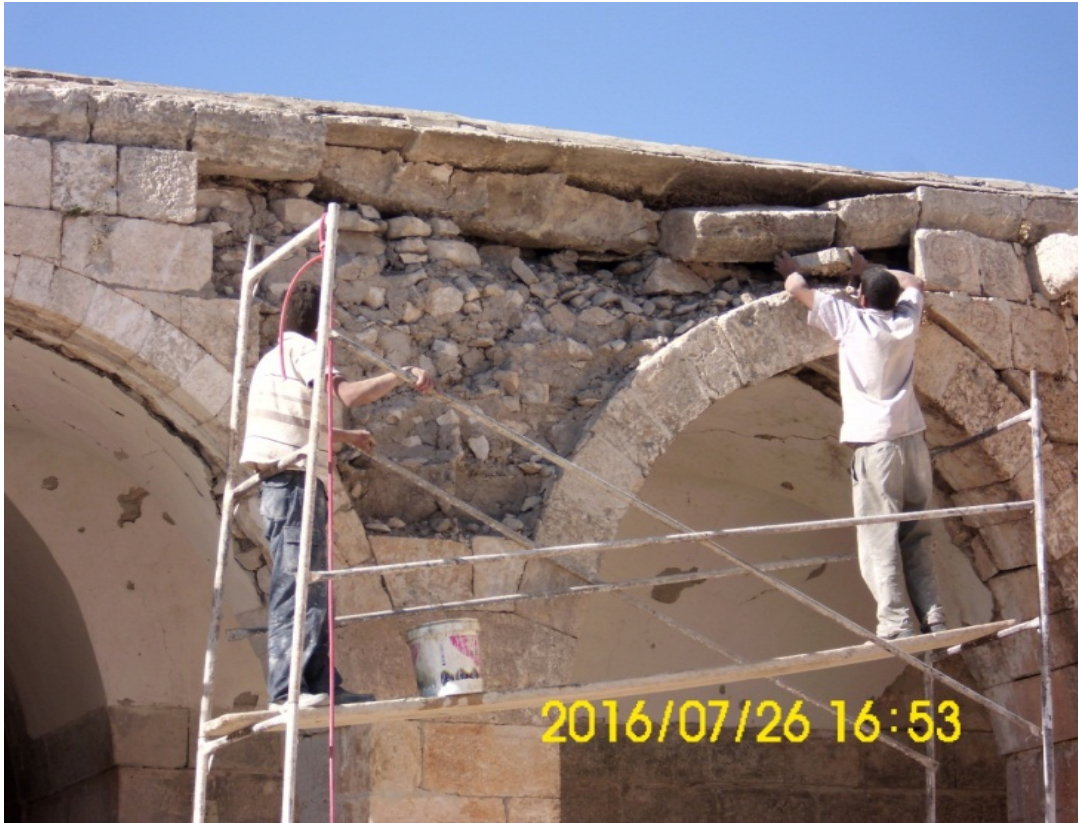
Patching the exposed damage area around the supporting arch with cement mortar

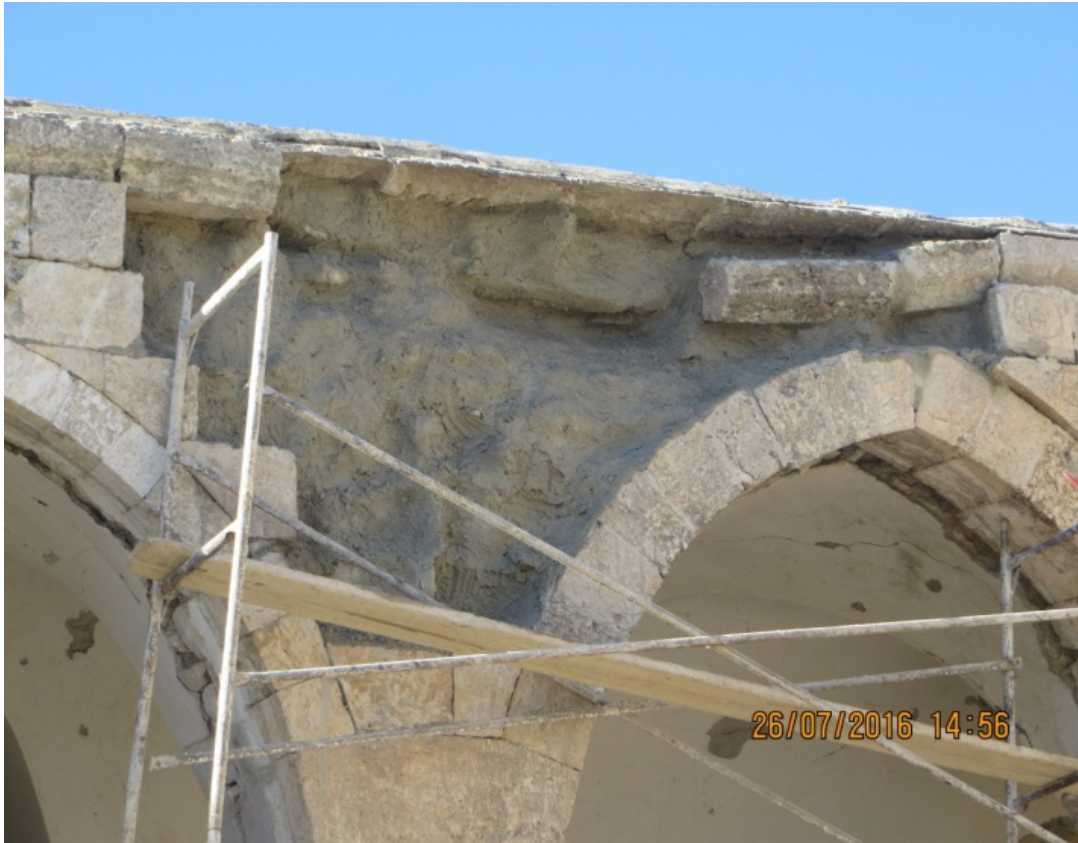
Cement mortar patch
