The Day After Heritage Protection Initiative

Documenting Damage and Protecting the Contents of the Apamea Museum Phase: I

Project: Documenting Damage and Protecting the Contents of the Apamea Museum 2016

Location: Apamea Museum located in the city of the Citadel of Al-Madeeq, Hama Governorate.

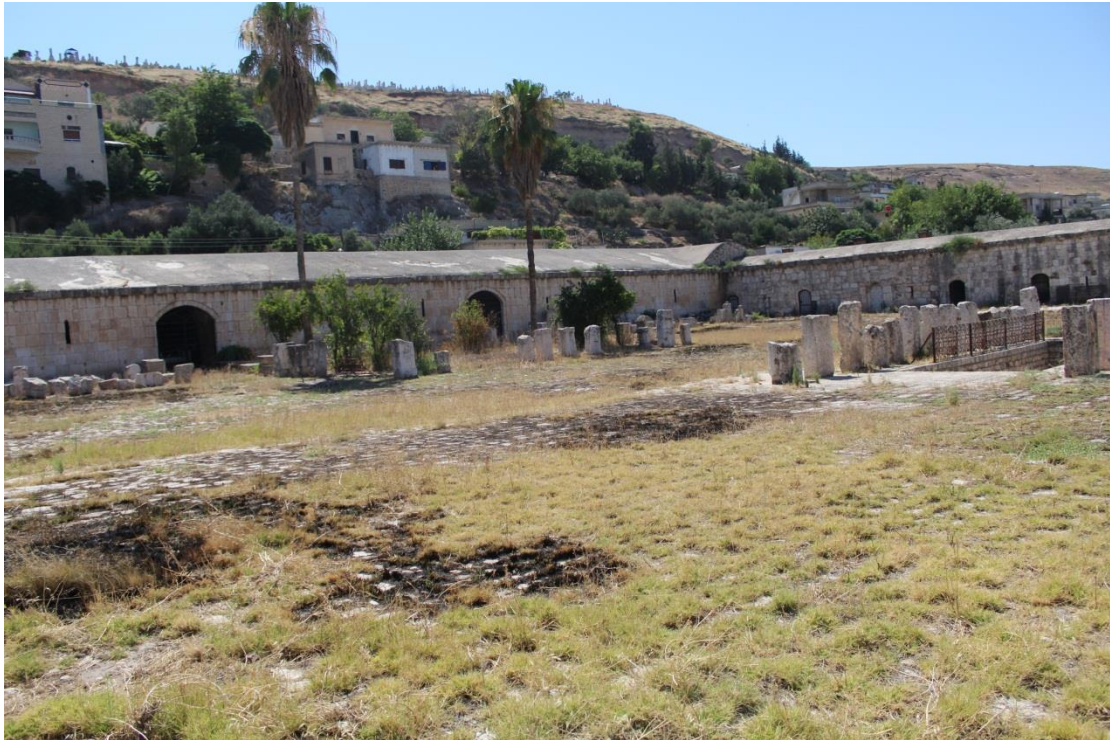
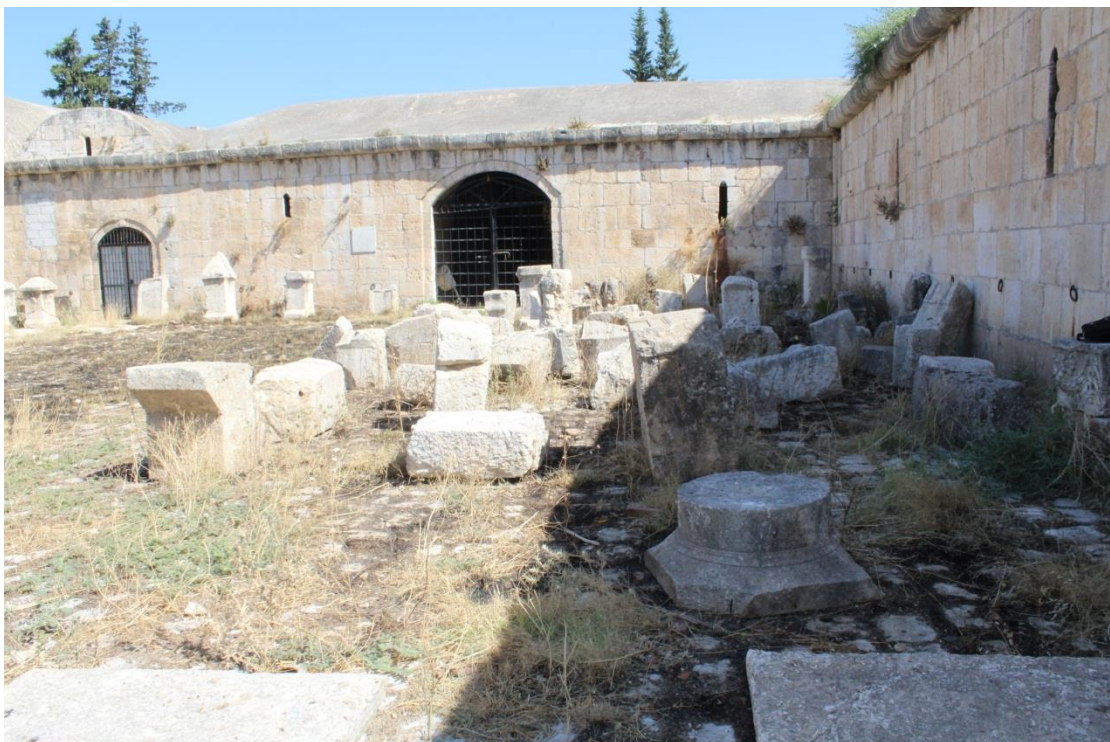
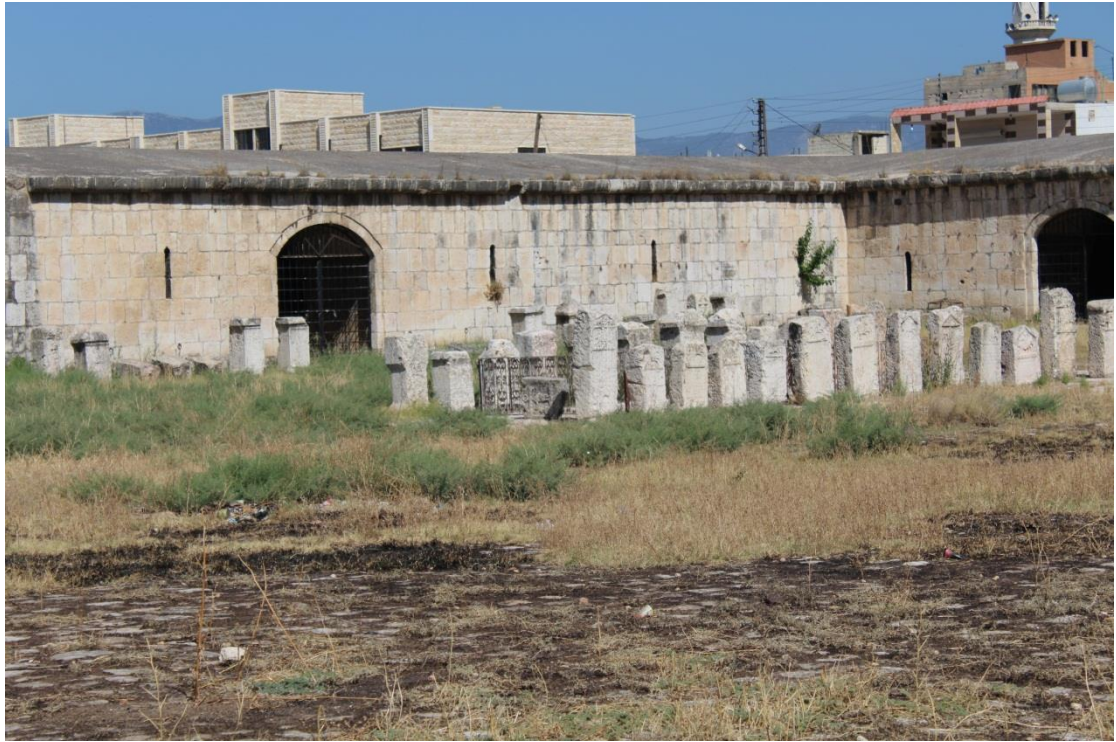
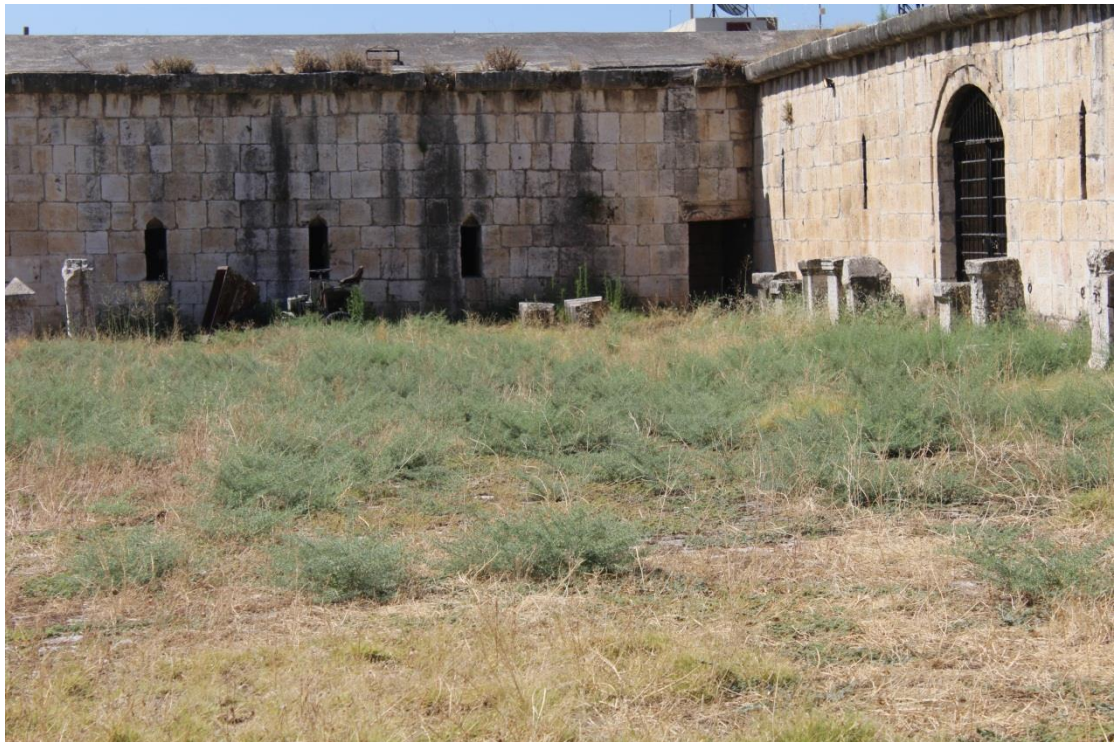
Photos of damage caused by vegetation overgrowth:

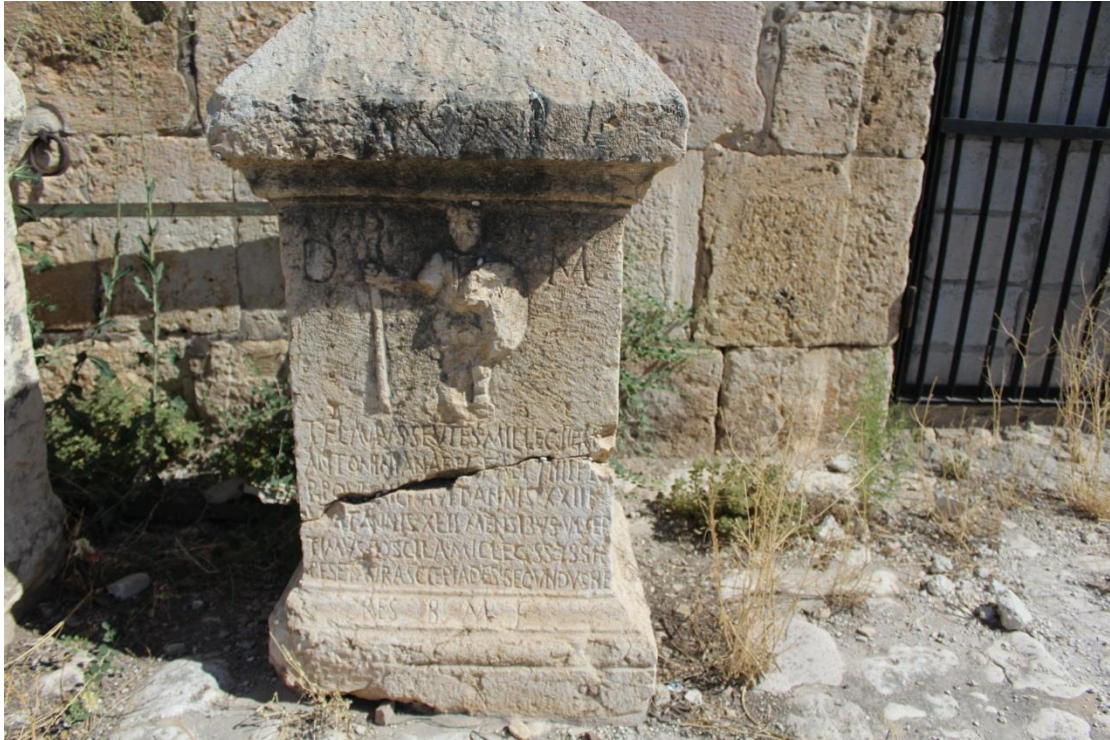
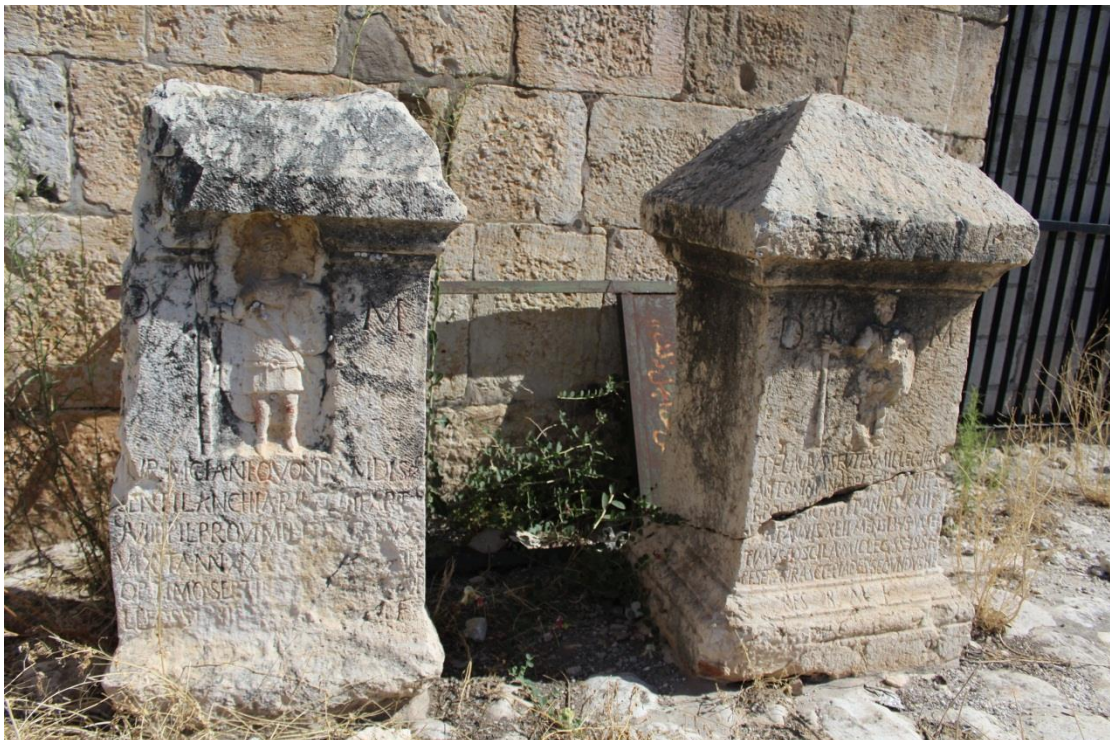
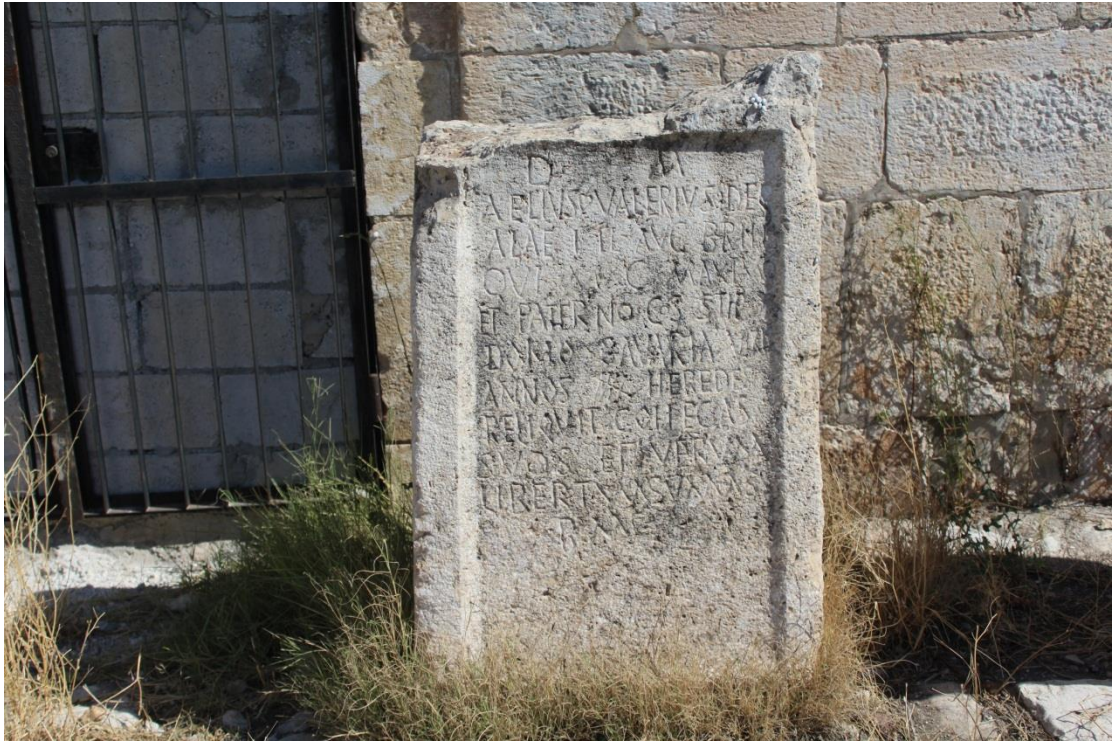
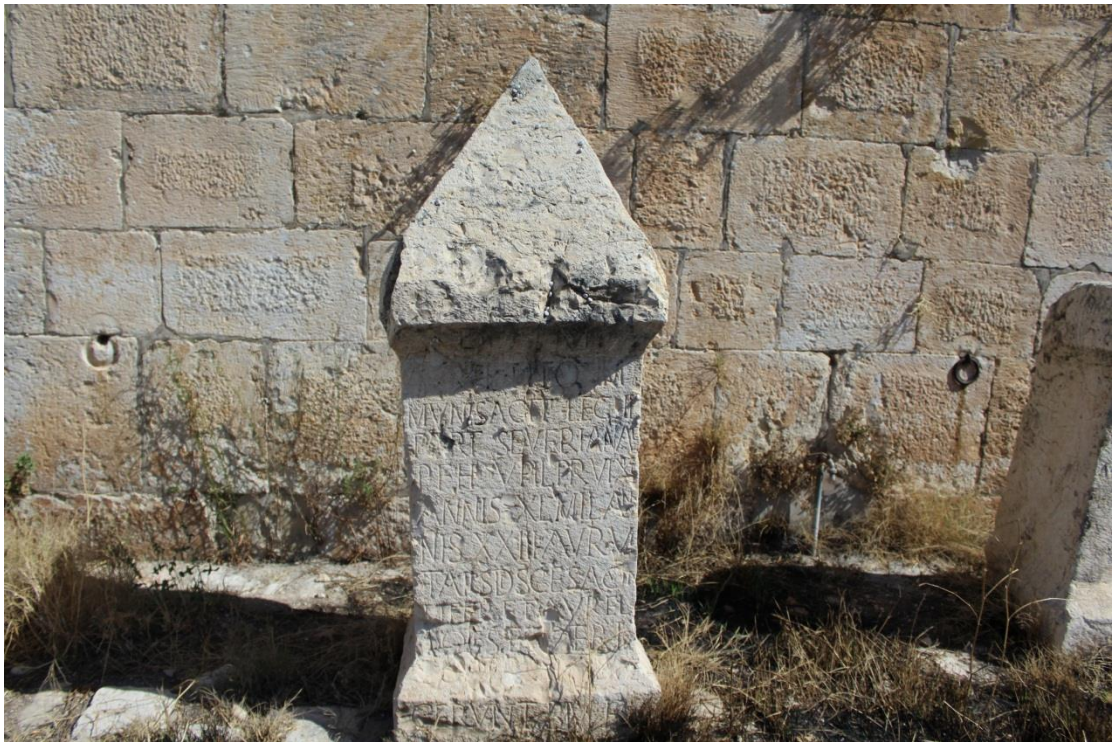
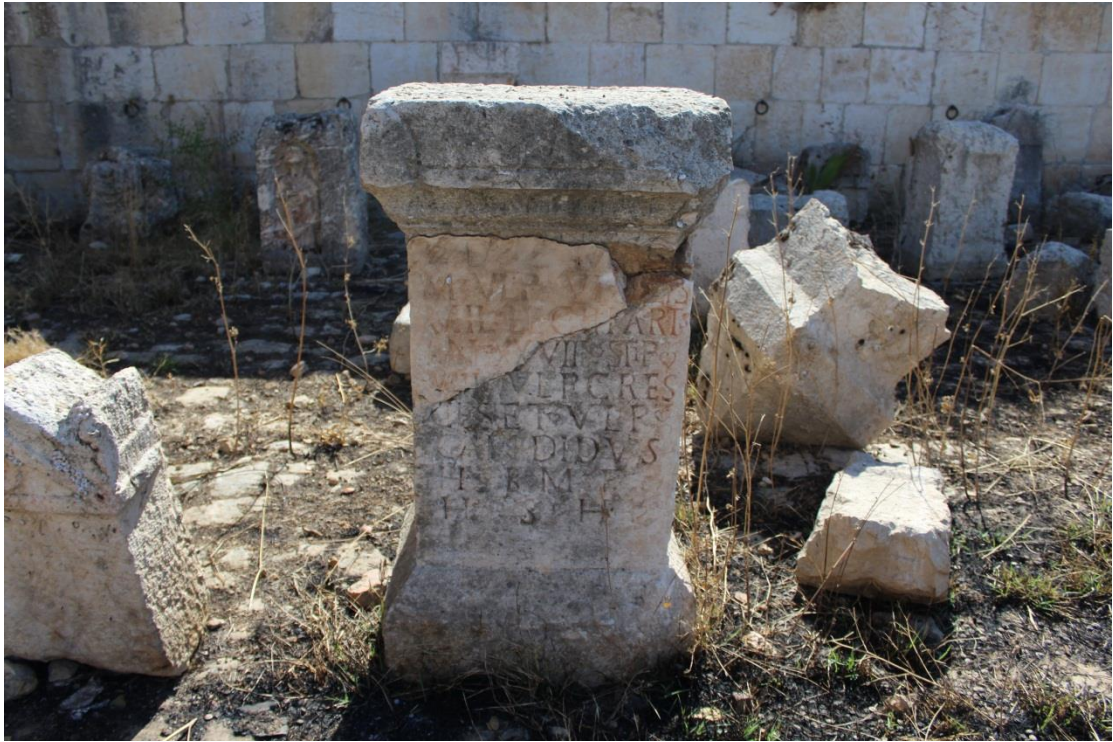
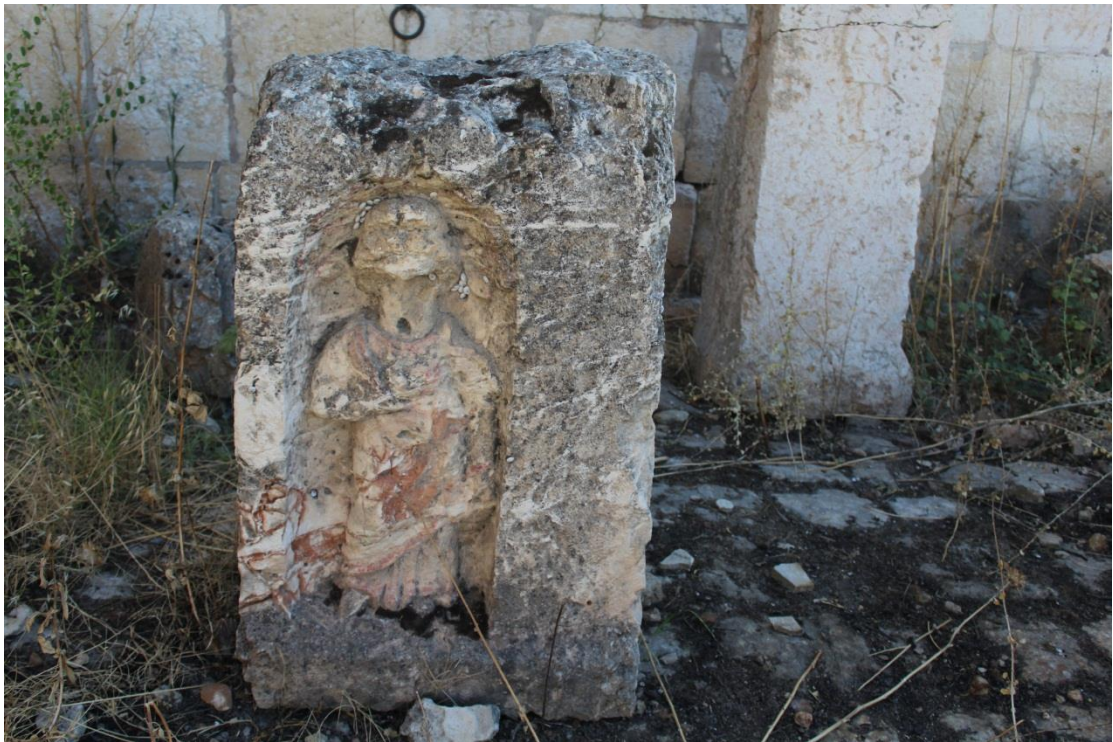
Photos of damage to objects in museum courtyard due to exposure to weathering:

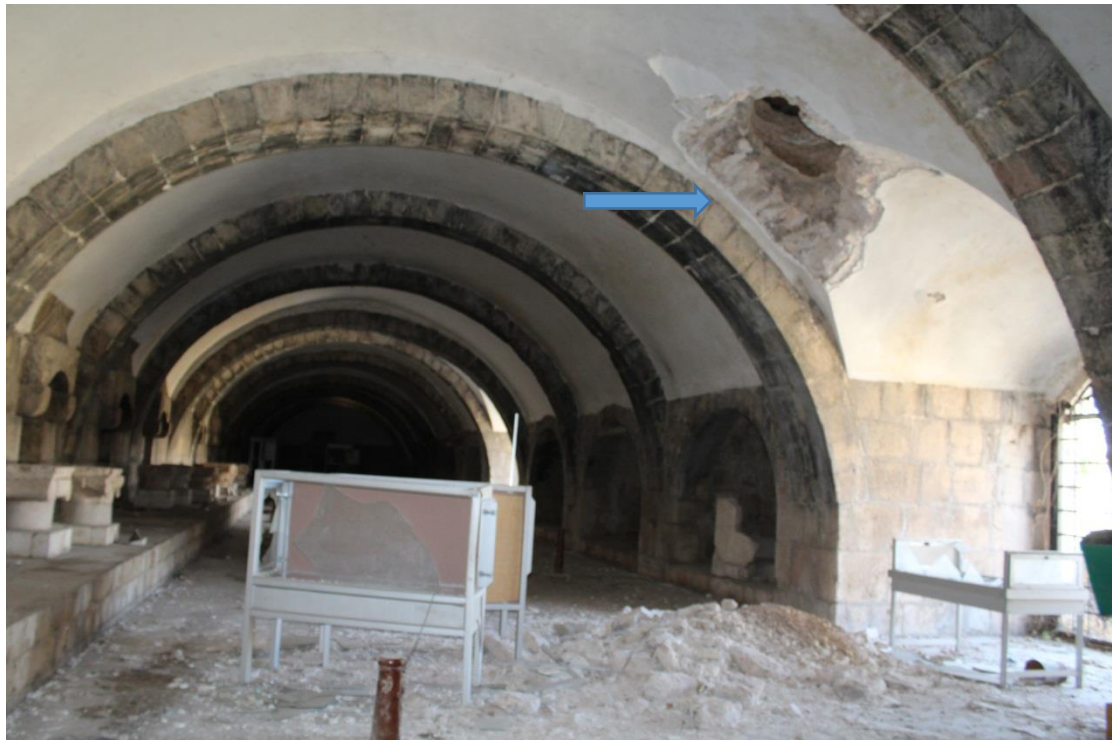
Photos of damage inside the museum wings:

Damage sustained by a naval mine

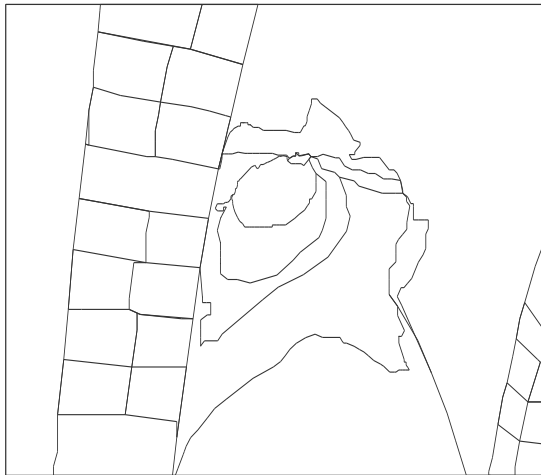
A topographic map of the damaged area

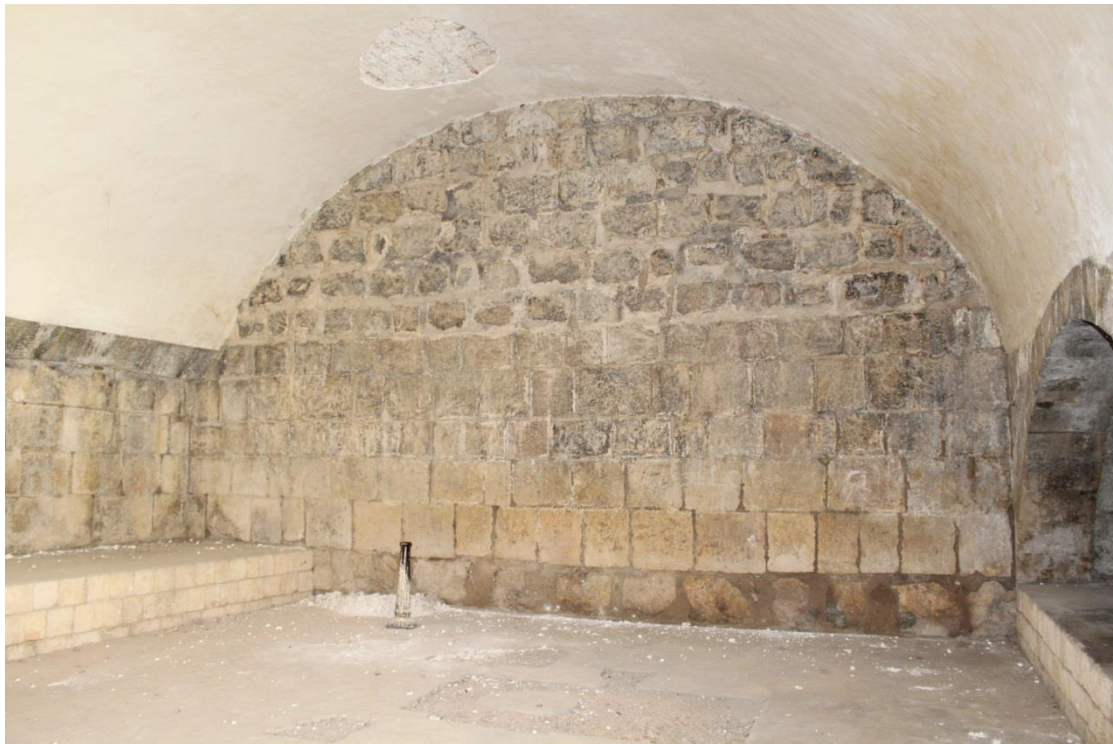
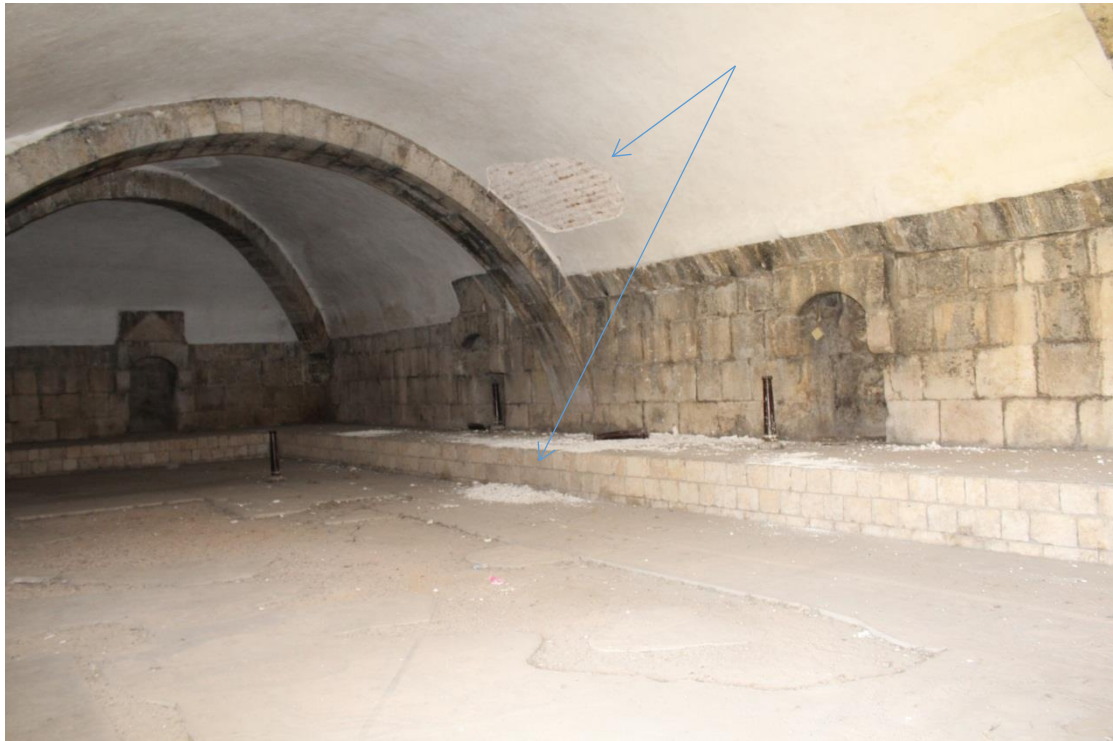
Photos of Damage inside the first wing:

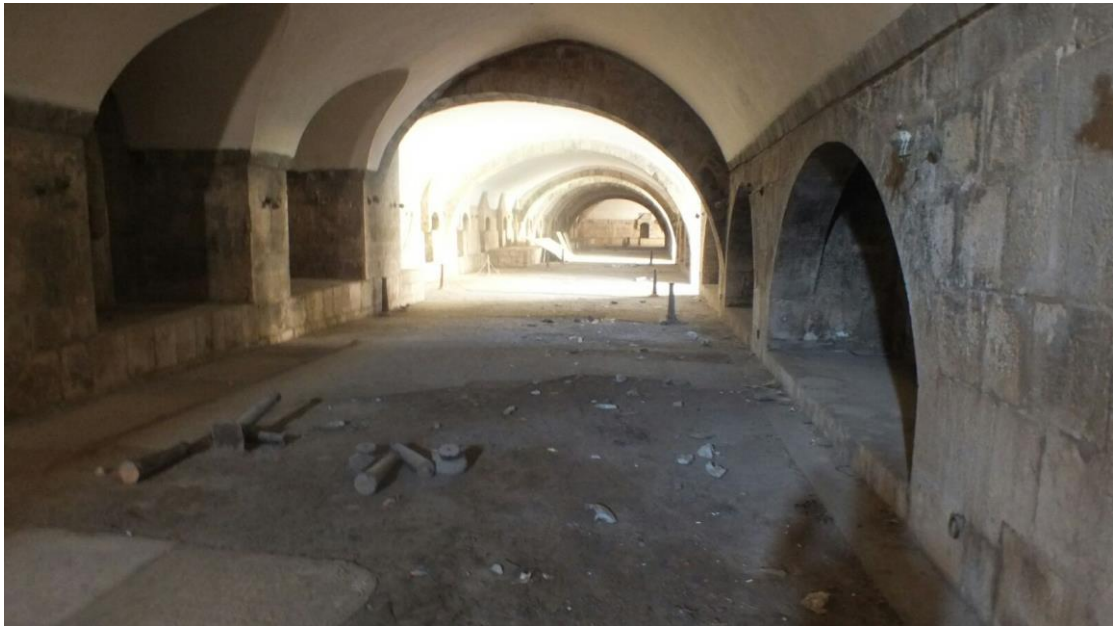
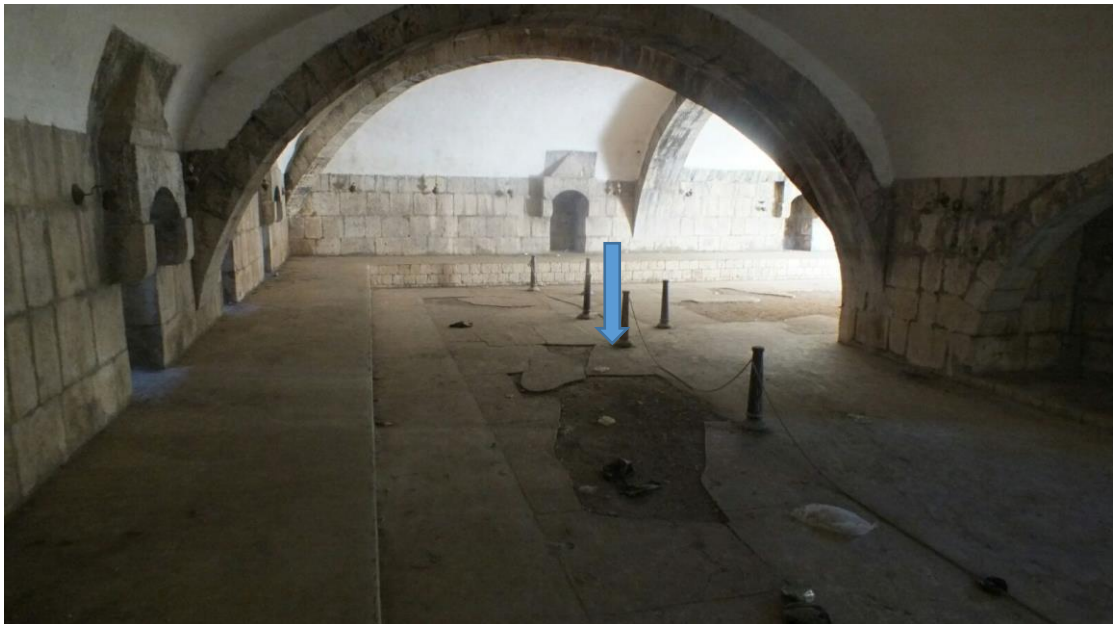
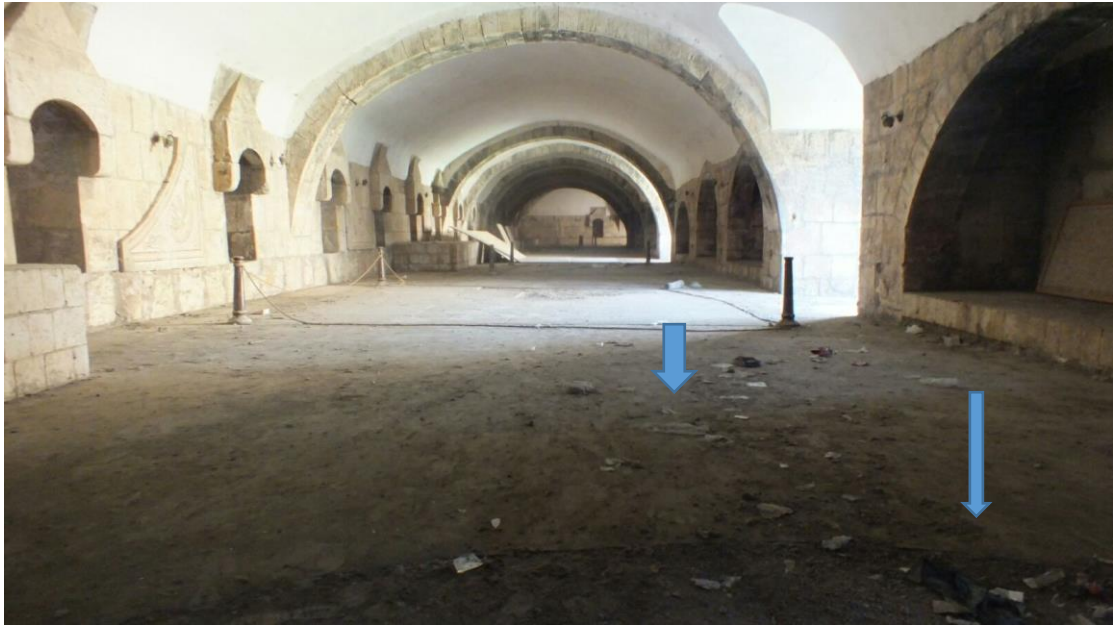
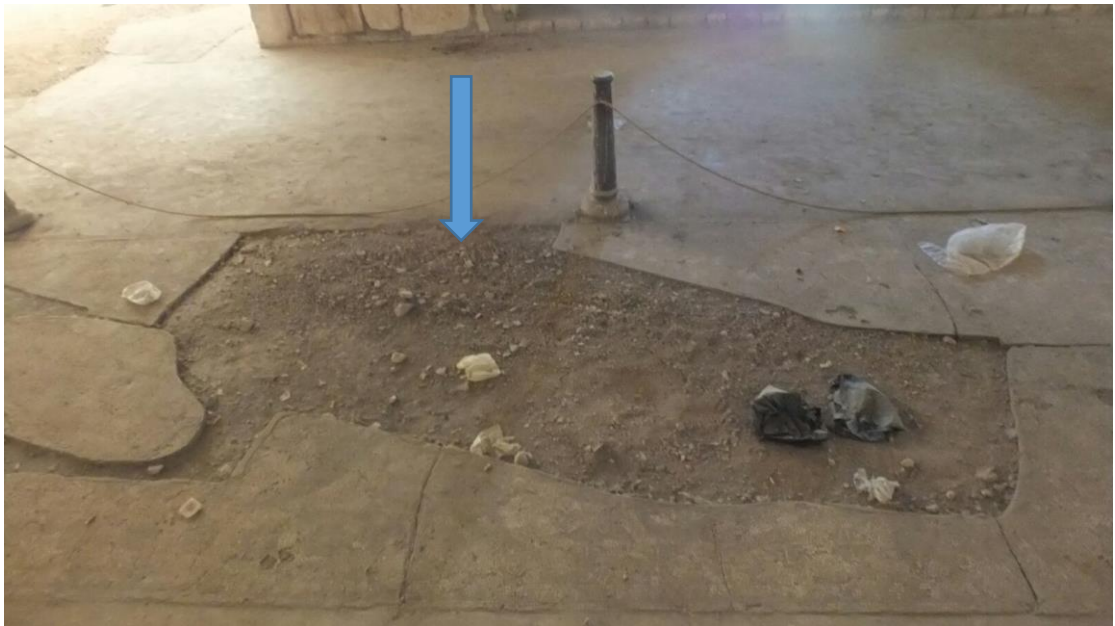
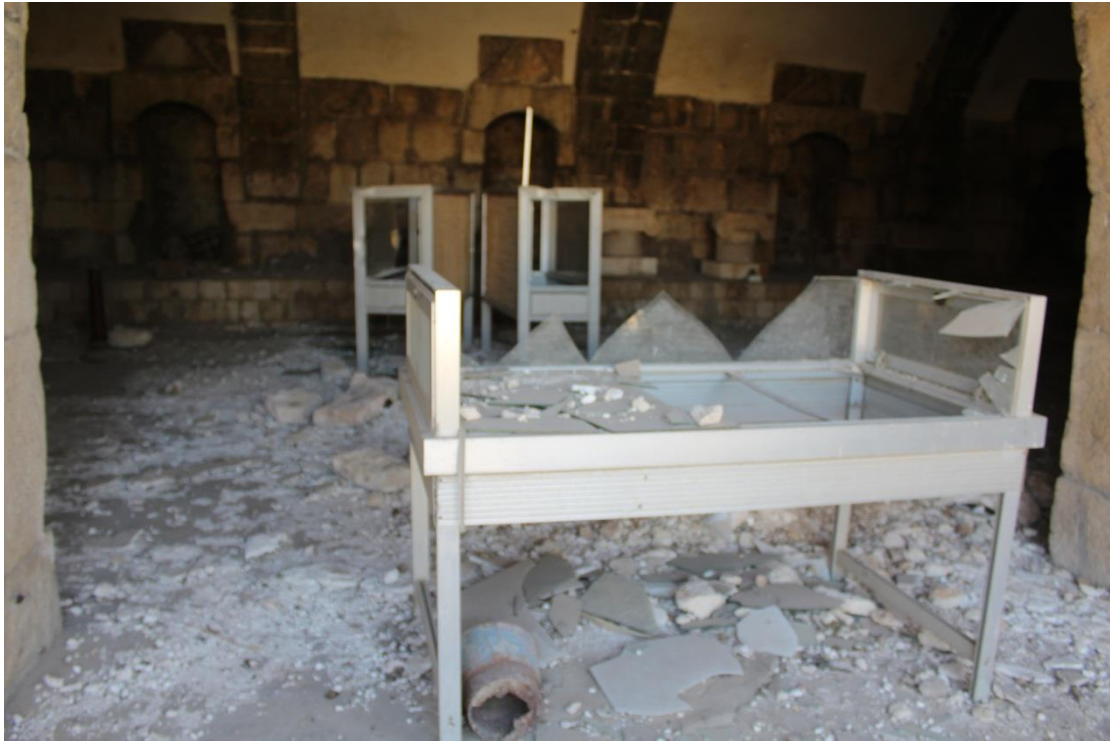
Photos of Damage to floors:

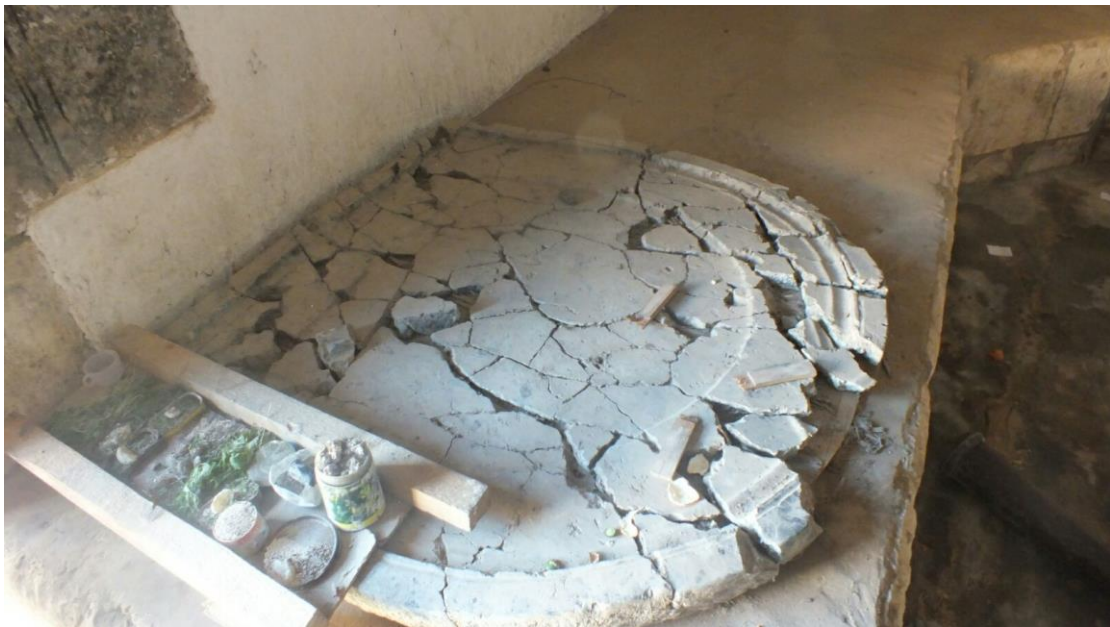
Photos of damage to display cabinets and objects:

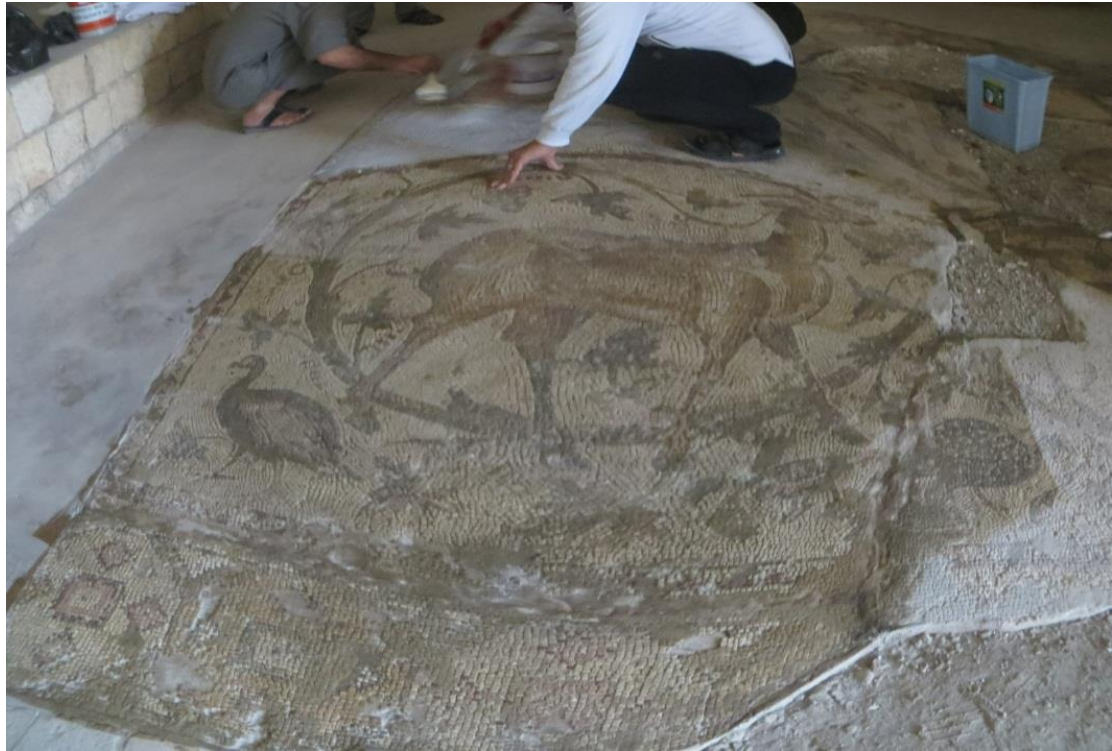
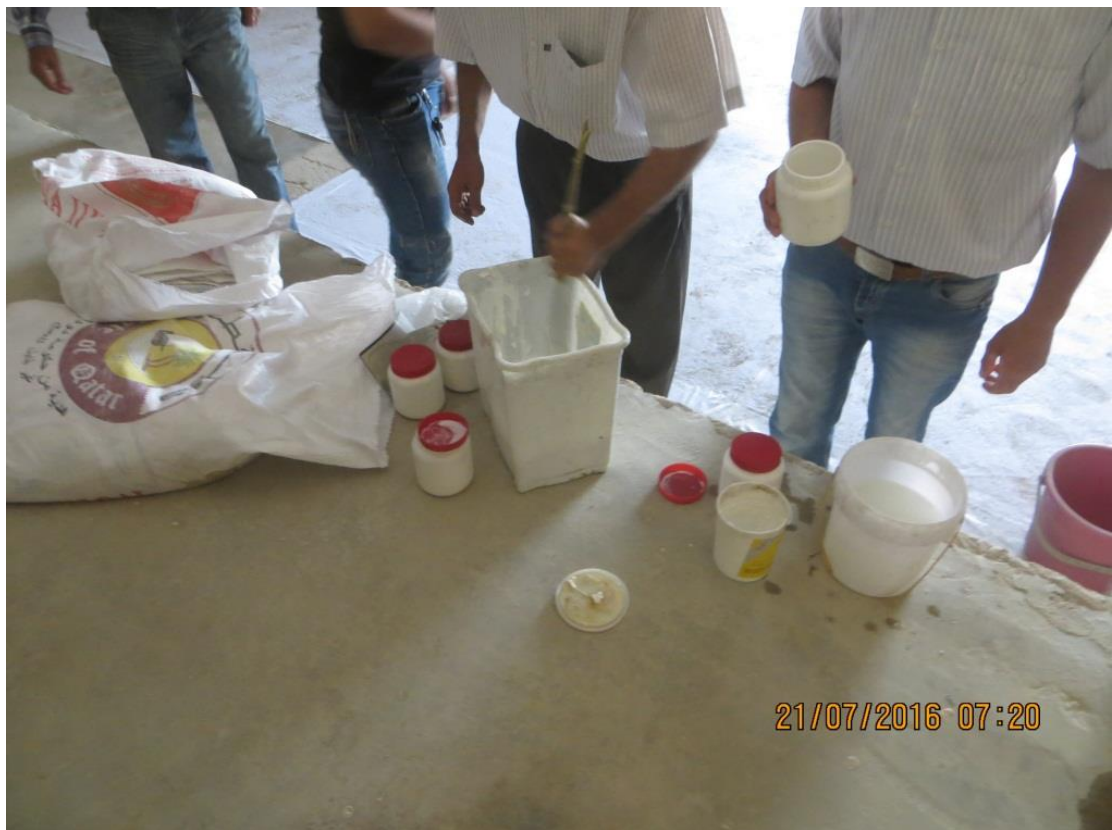
Covering Mosaic Floors with a Layer of Glue

Mixing the glue with water

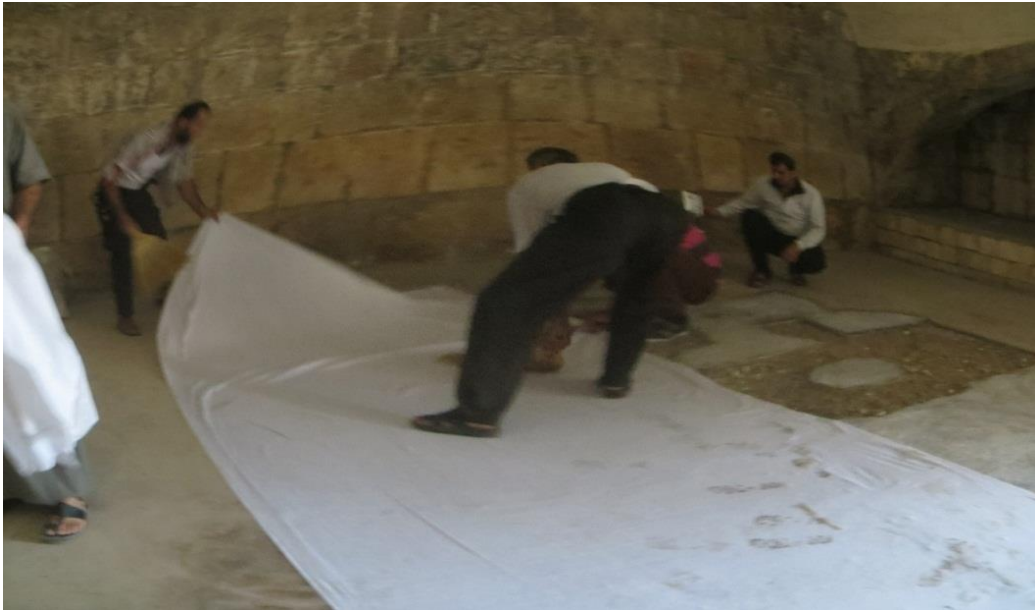
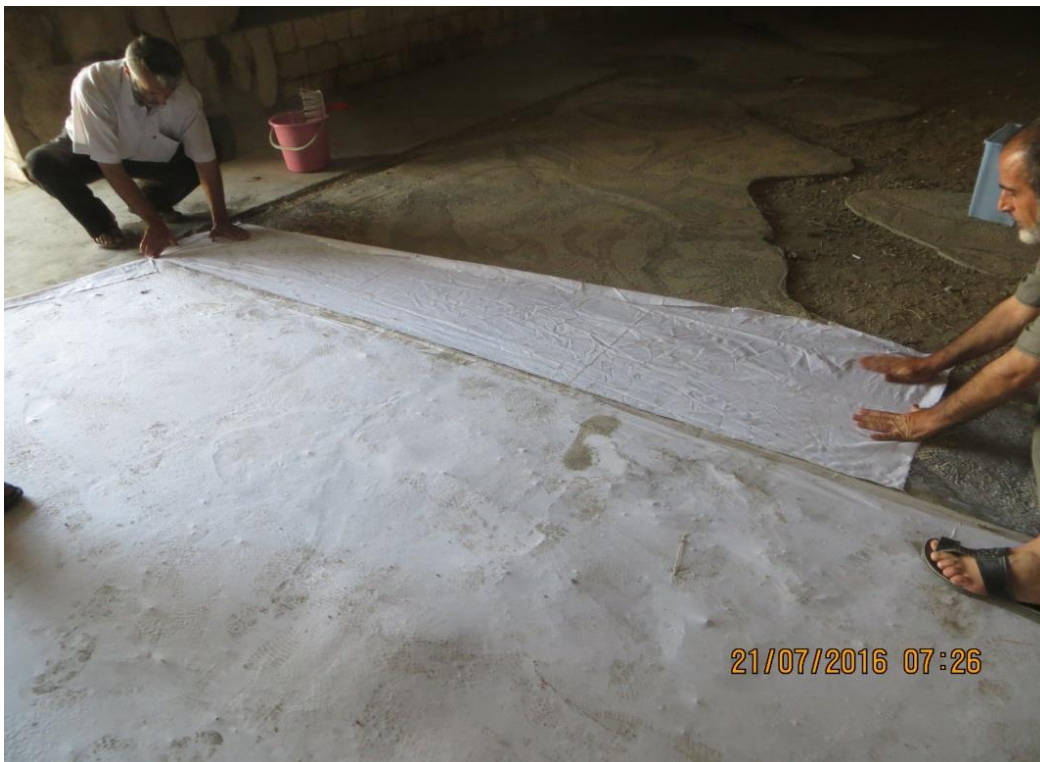
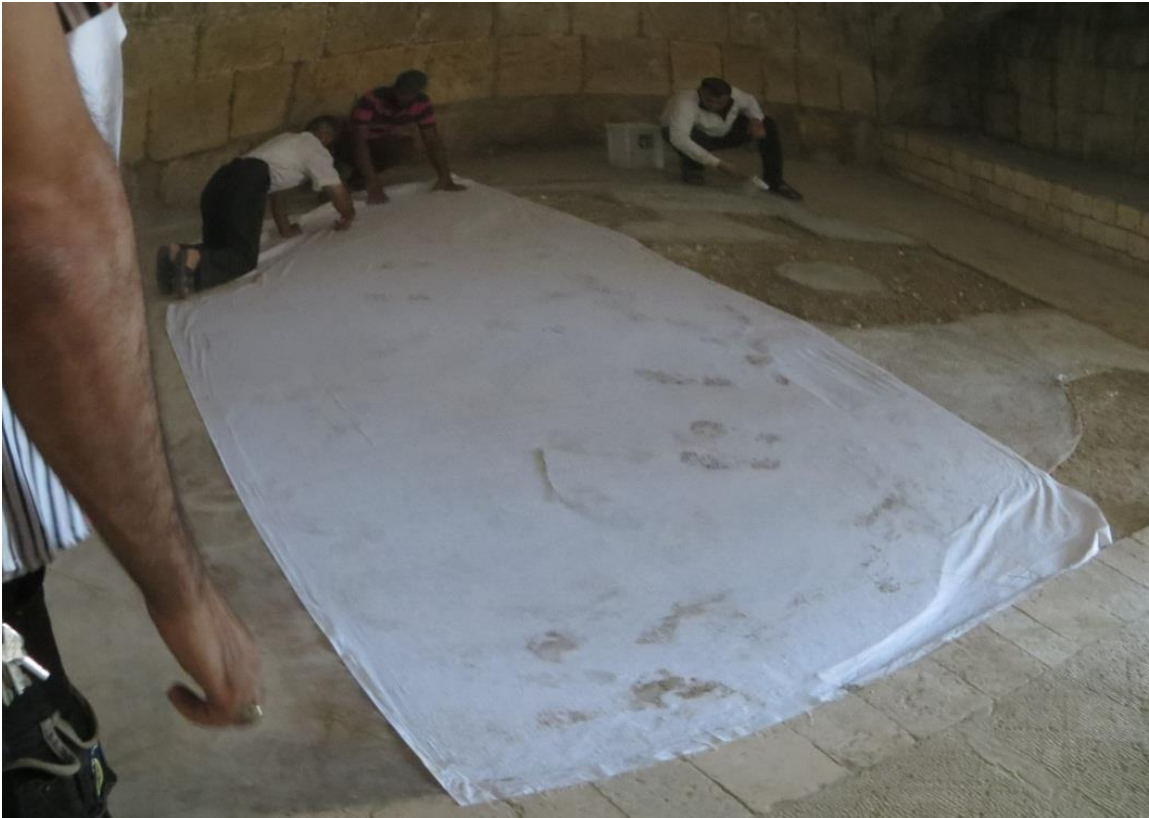
Covering Mosaic floors with cotton fabric to protect them from fragmentation due to pressure caused by explosions:

Gluing cotton sheets onto the mosaic floors

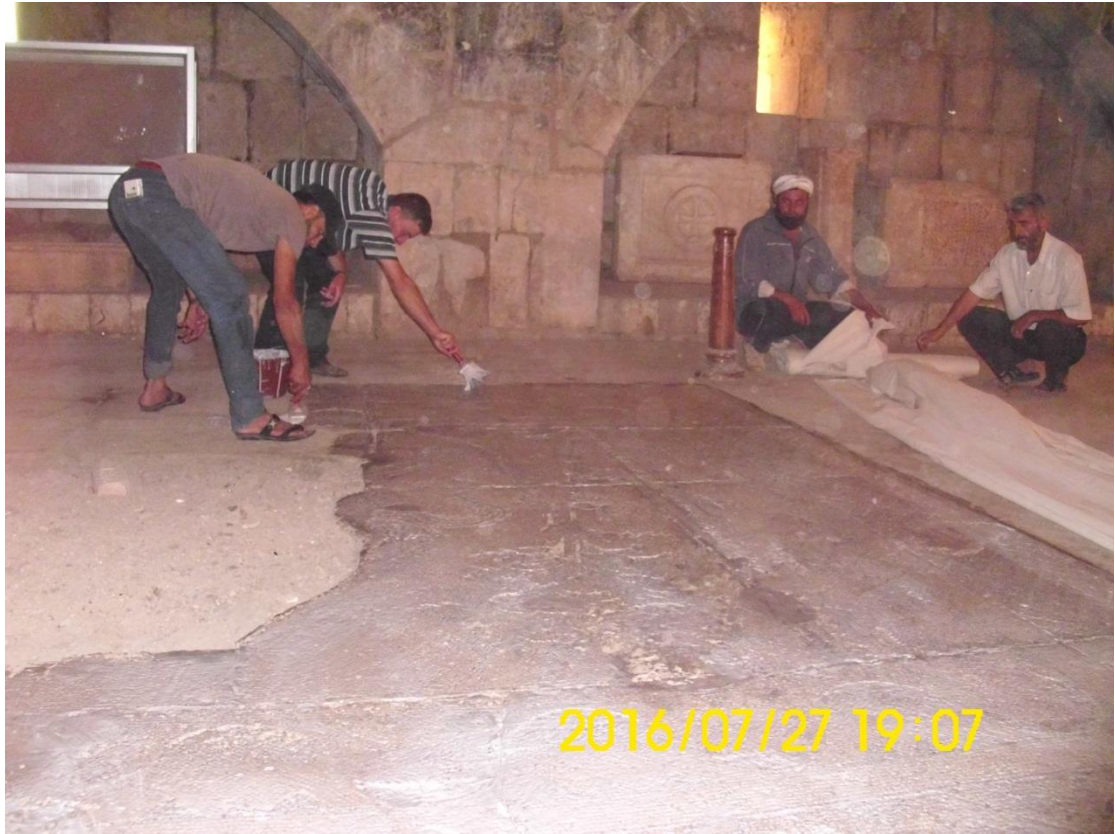
Mosaic panels covered with cloth prior to having sandbags placed over them
