The Day After Heritage Protection Initiative

Documenting Damage and Protecting the Contents of the Apamea Museum Phase: I

Project: Documenting Damage and Protecting the Contents of the Apamea Museum 2016

Location: Apamea Museum located in the city of the Citadel of Al-Madeeq, Hama Governorate.

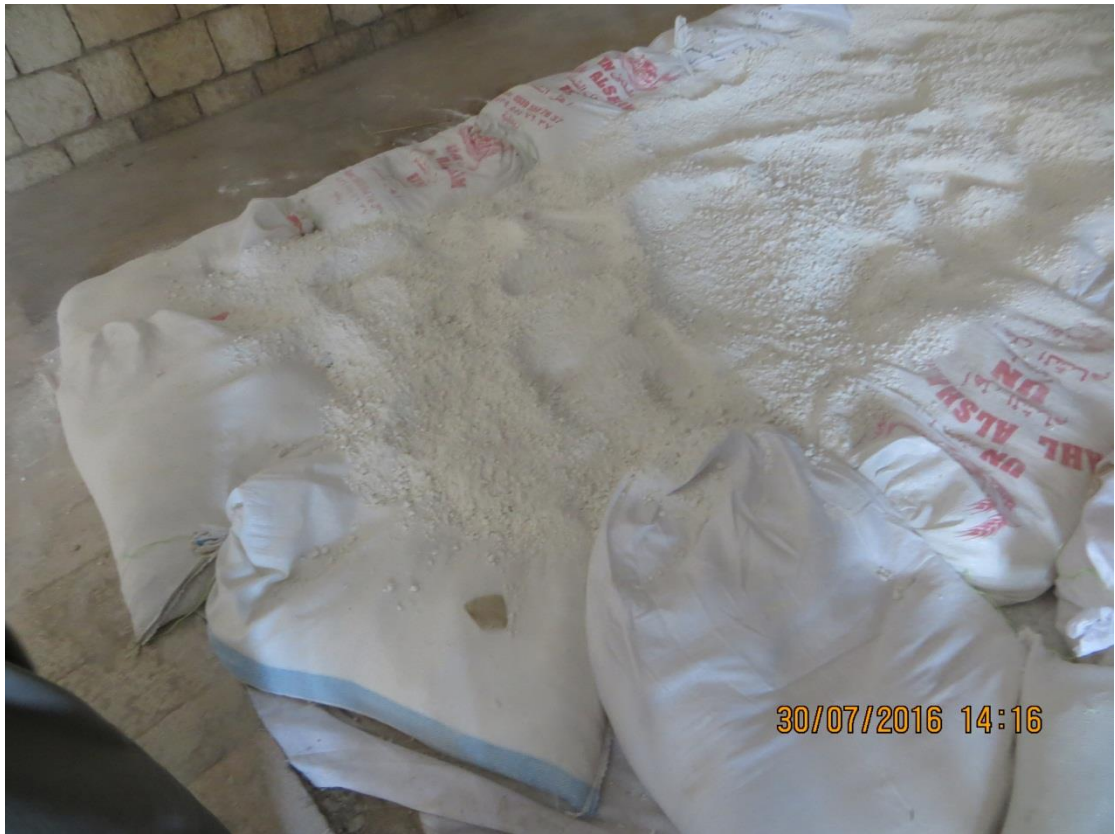
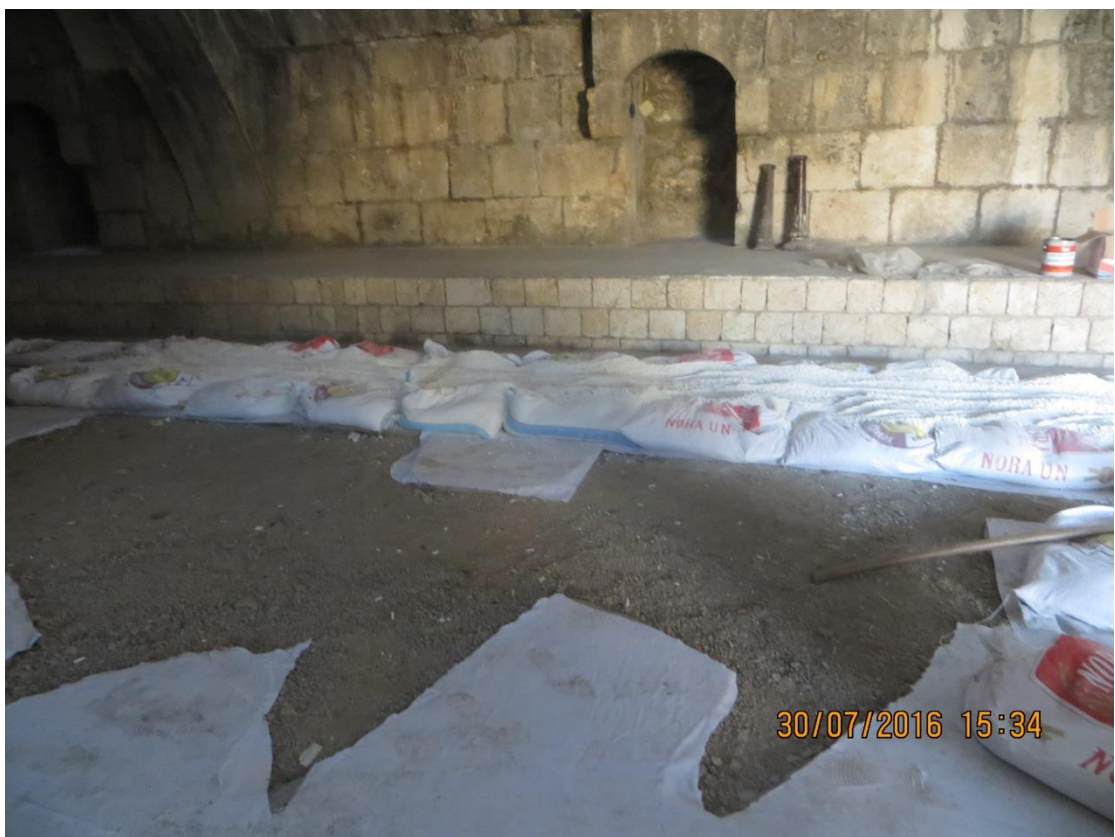
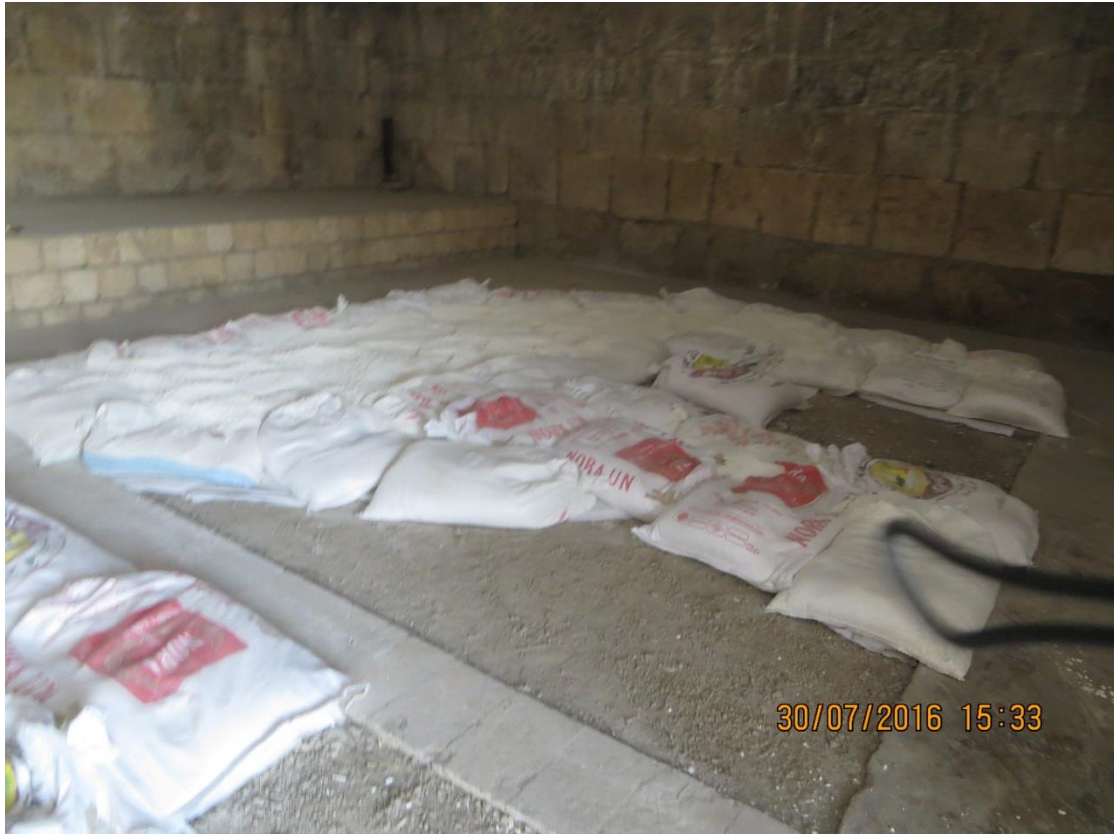
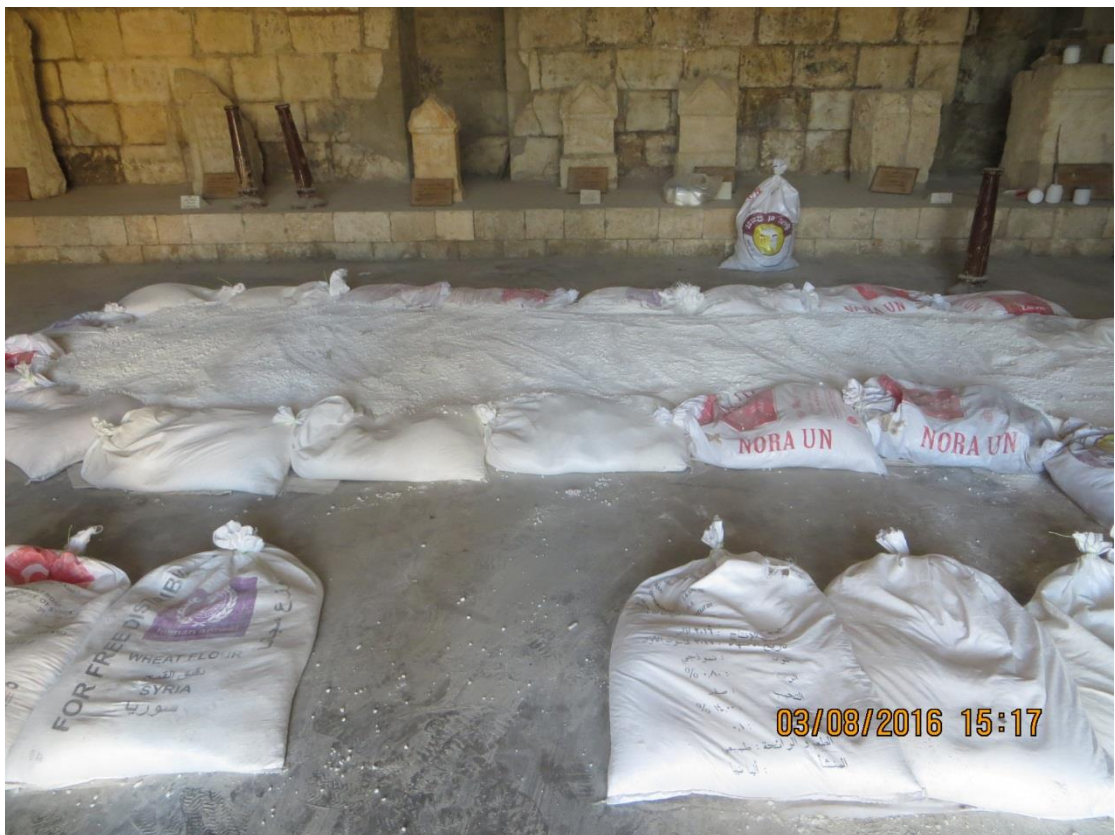
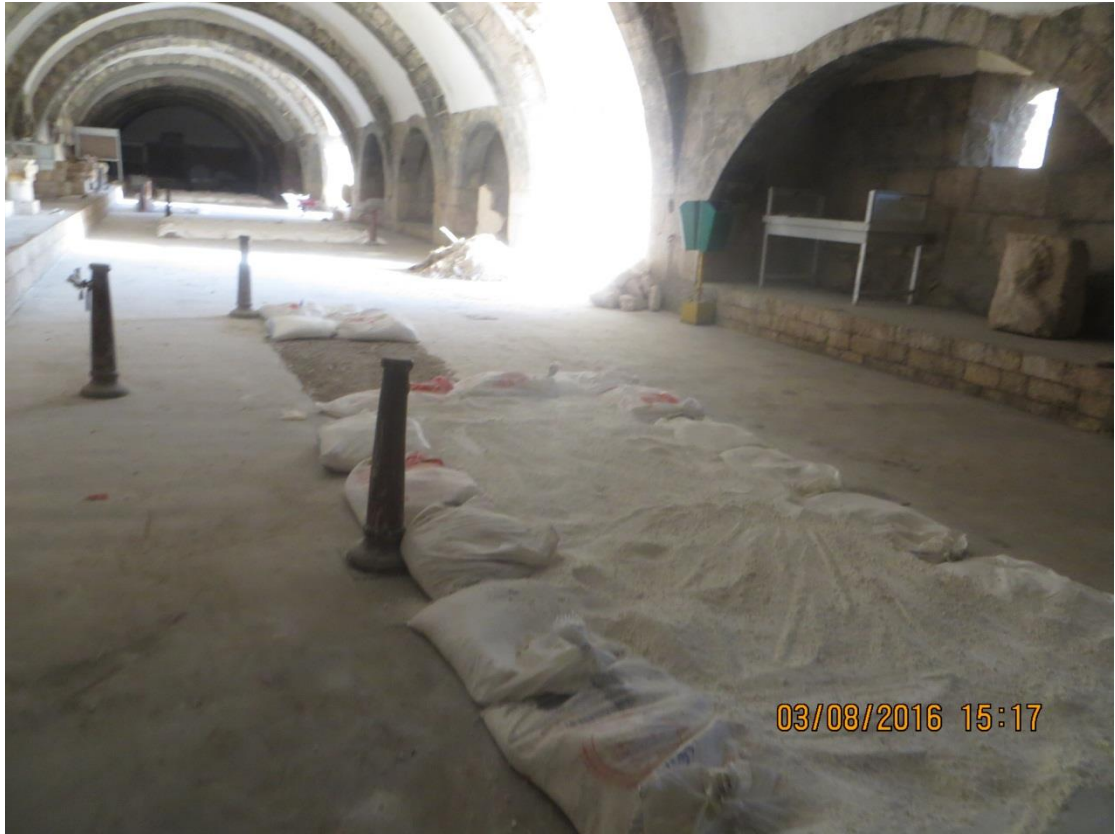
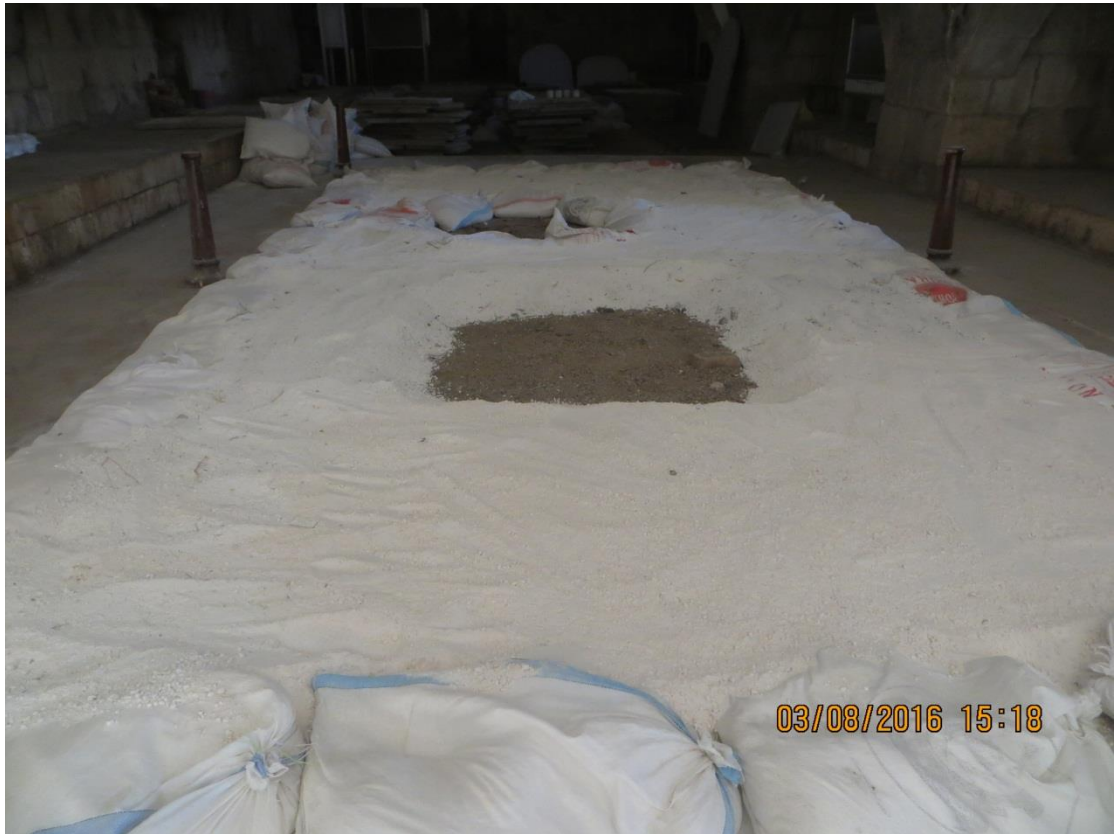
Stacking sandbags to protect mosaics
