## The Day After Heritage Protection Initiative

### Site Monitors Project

### Final Report: Protection of Mosaics

### Ma'arrat Al-Numan Museum

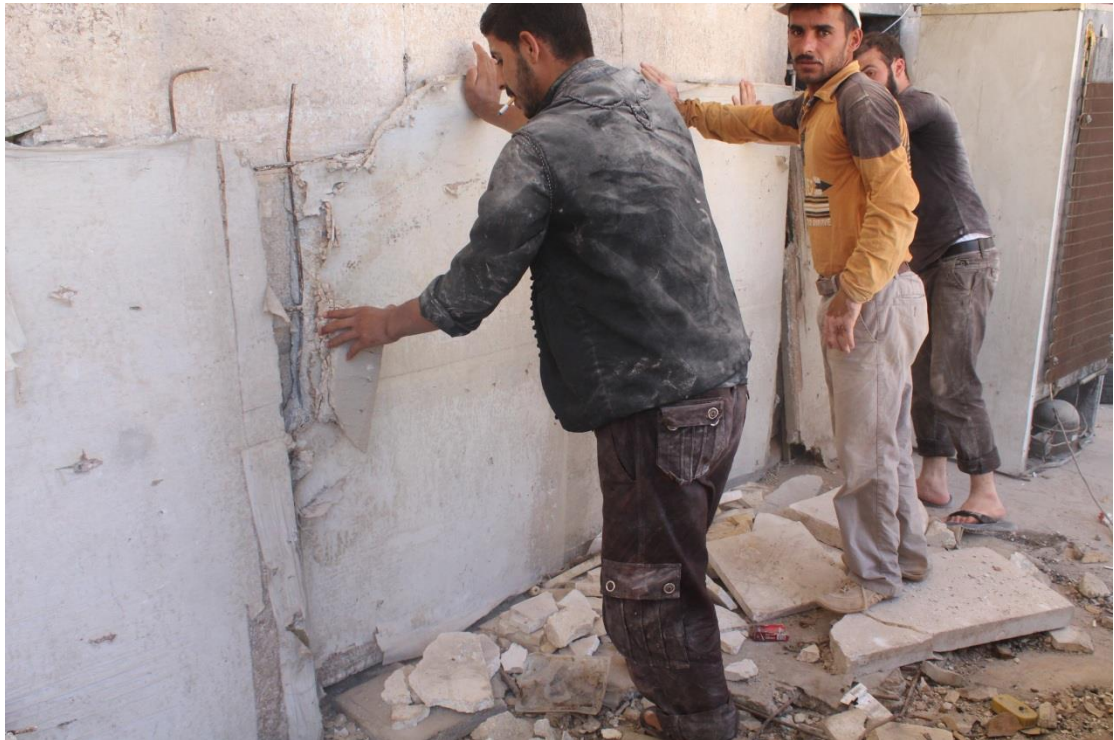
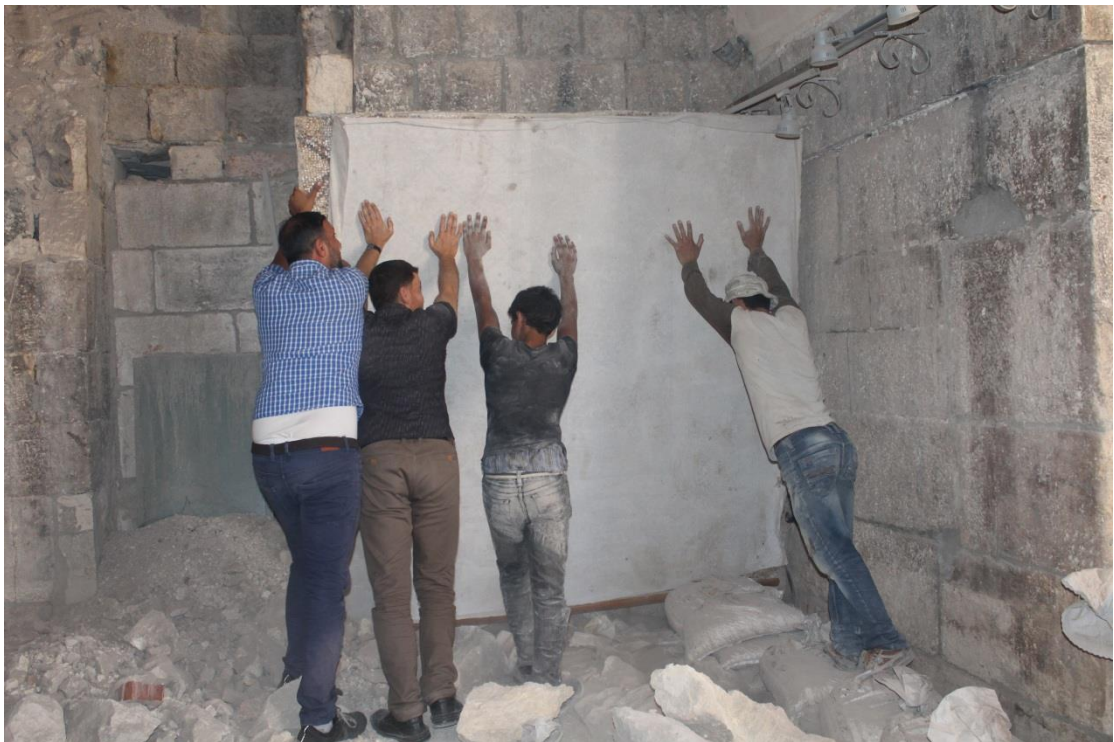
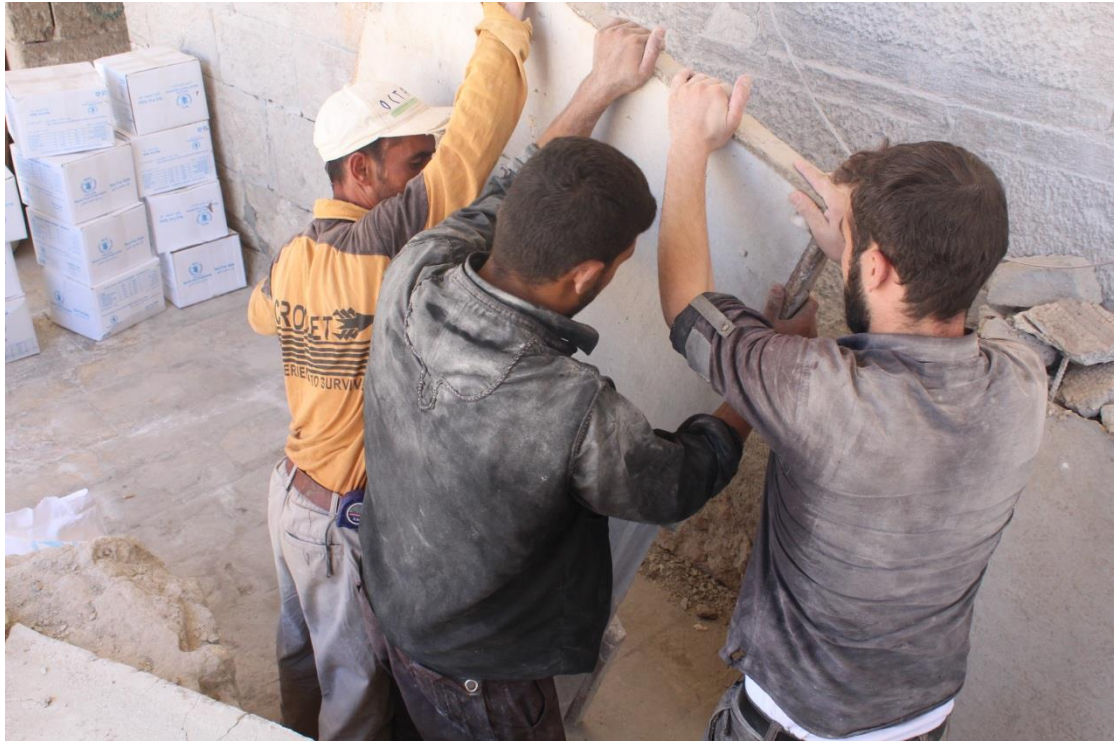
Moving the mosaics from the courtyard into the museum building

Move exposed mosaics from the courtyard into the museum building for protection.

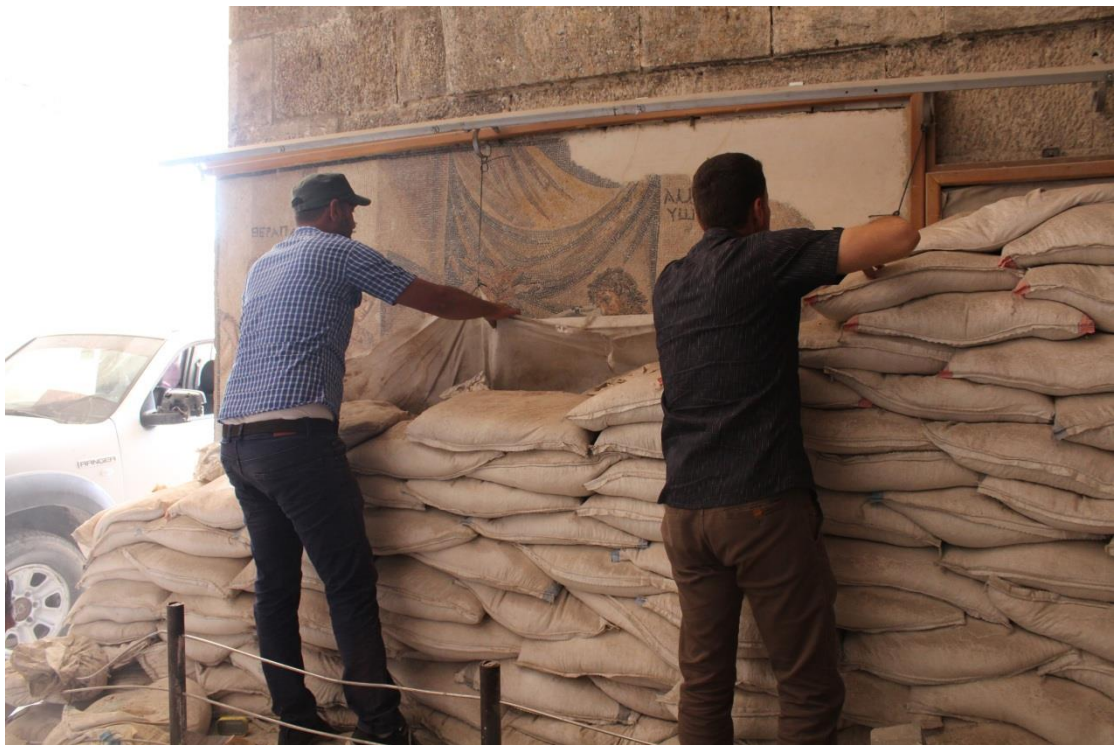
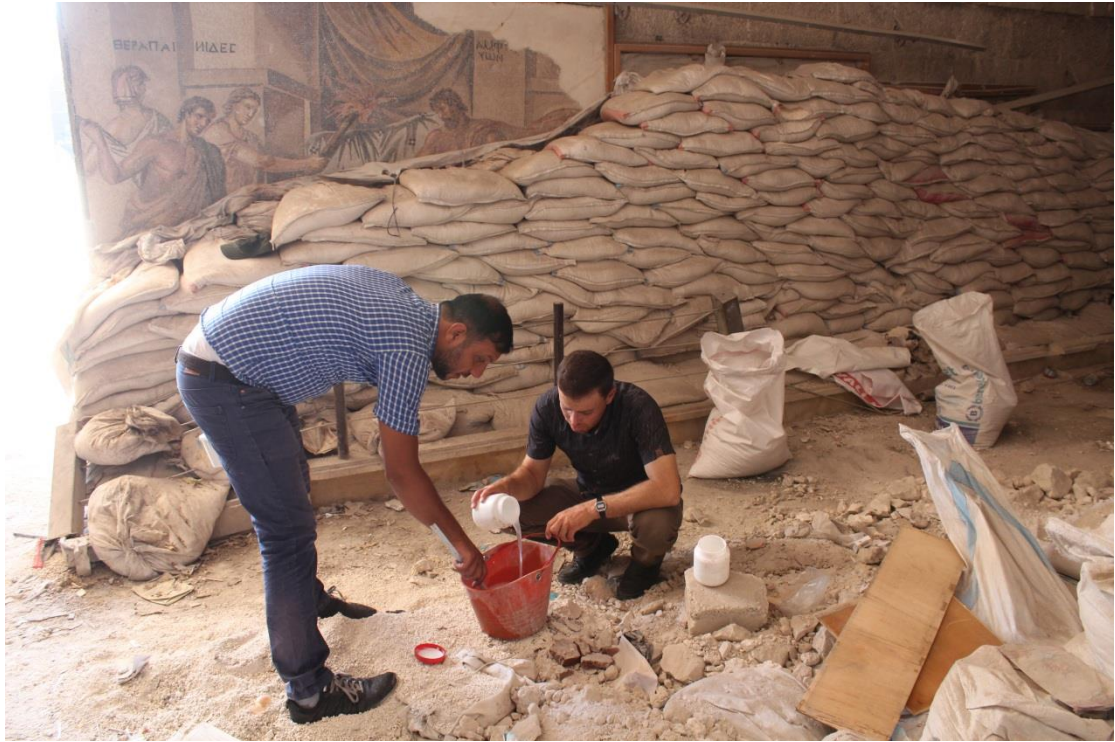
Preparing exposed mosaic for protection

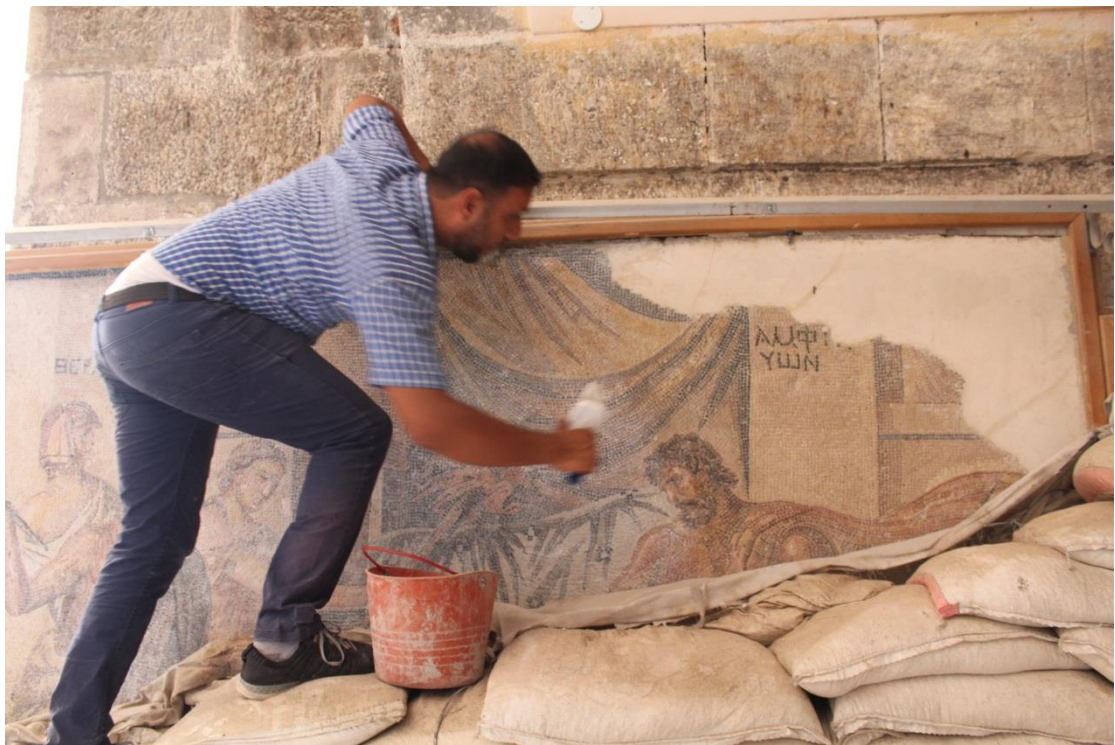
Covering mosaic with water soluble glue

Lay a protective cover on the mosaics by applying a layer of glue (water soluble) and placing a layer of TYVEK (or similar material) over them.

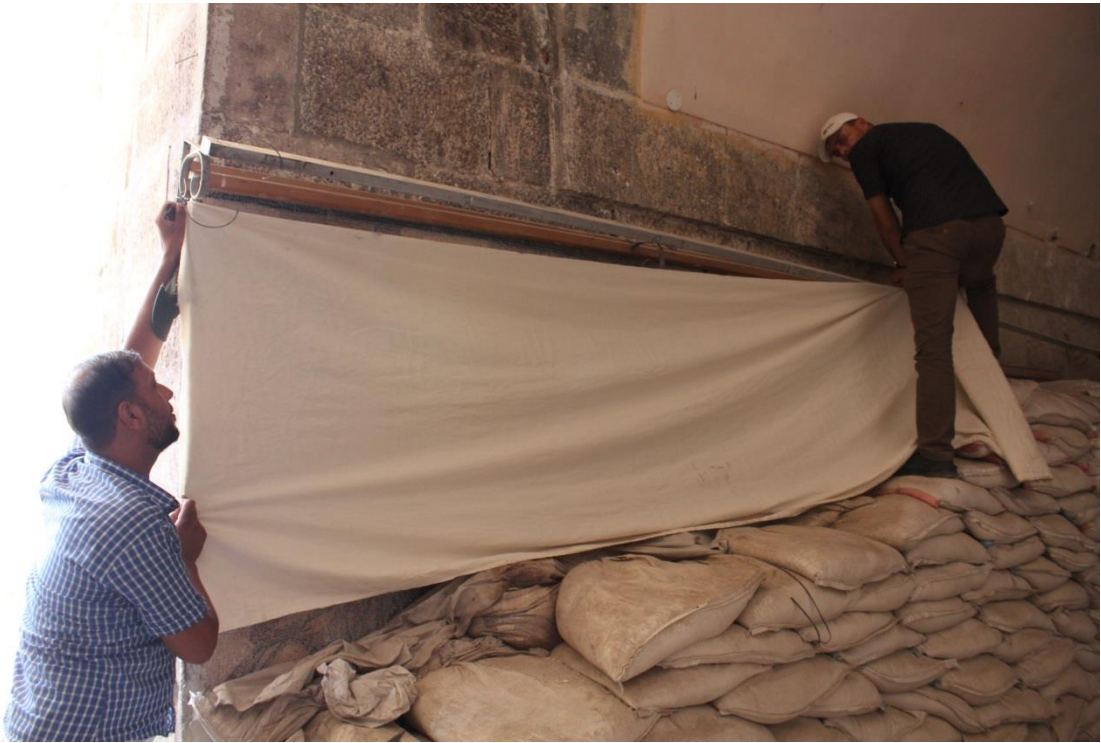
Covering mosaic with cloth over the glue

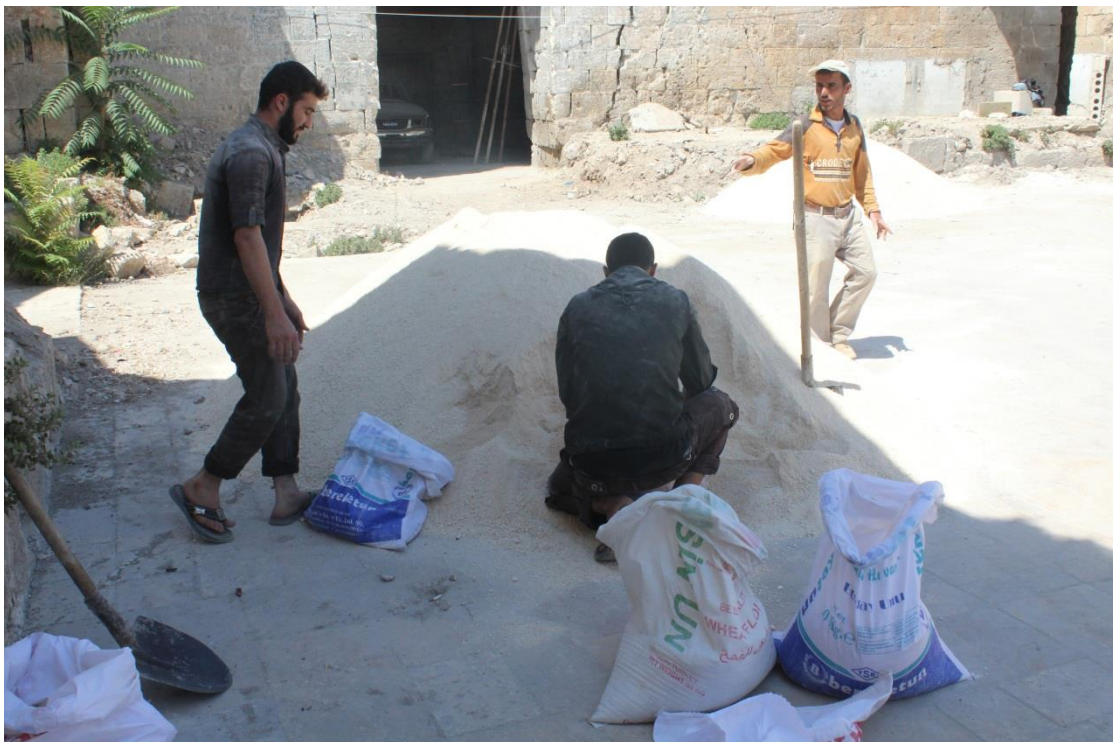
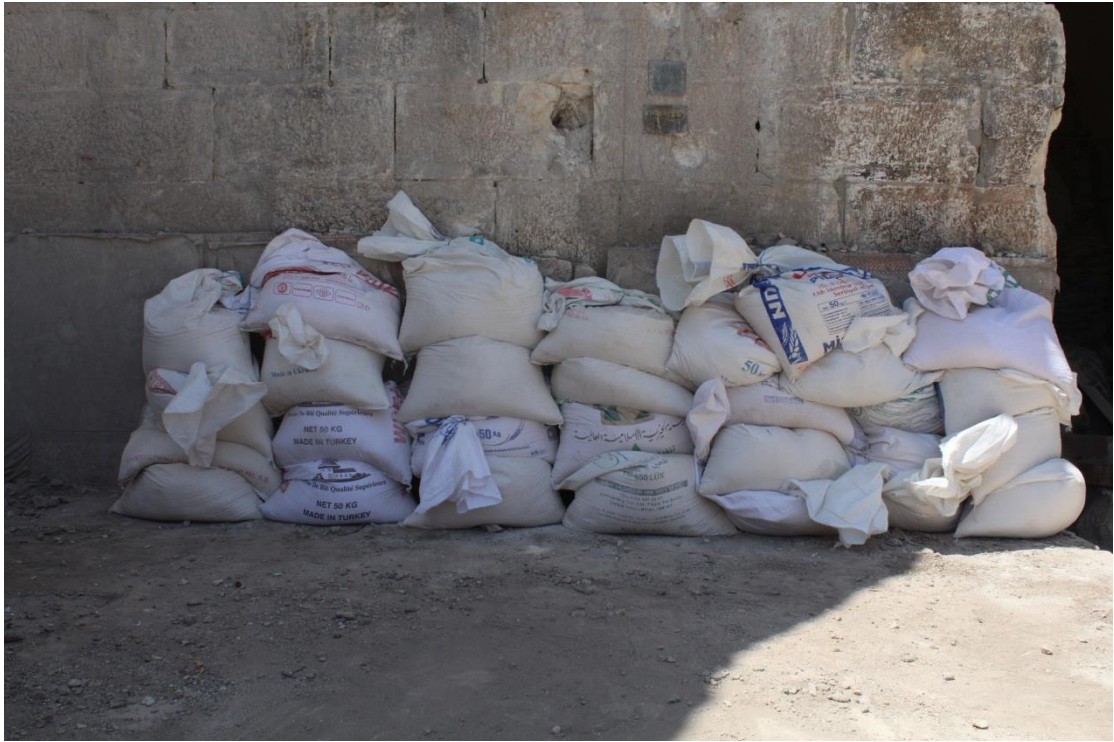
Filling up sandbags for protecting mosaics

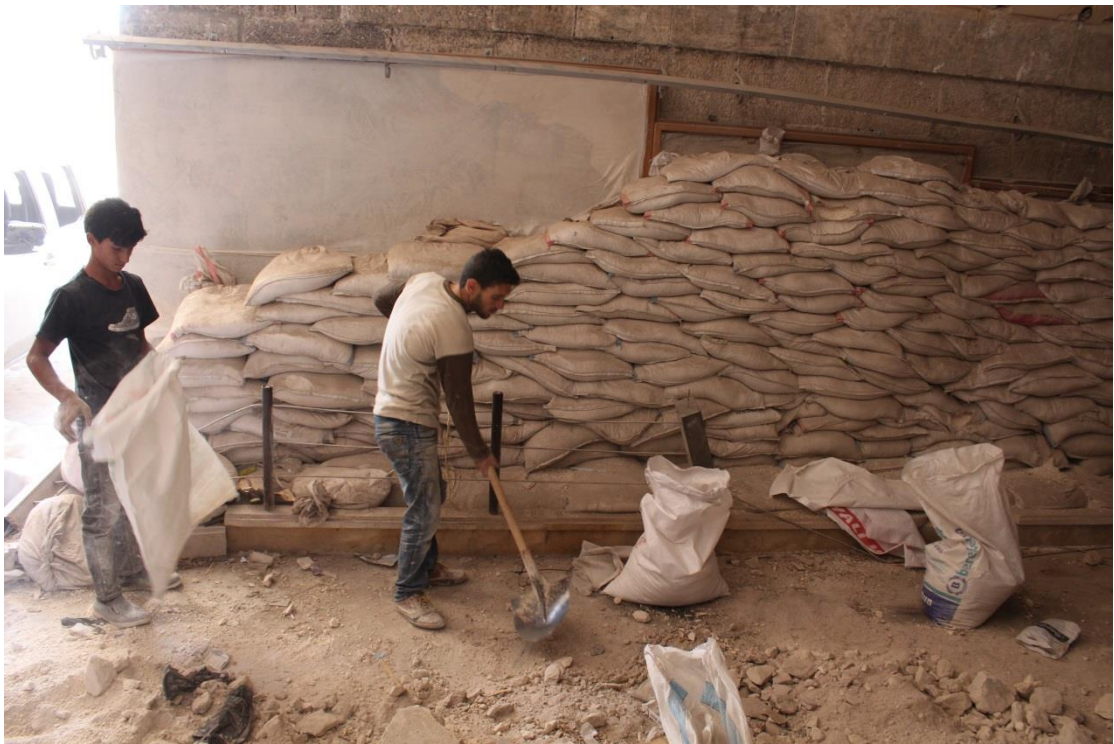
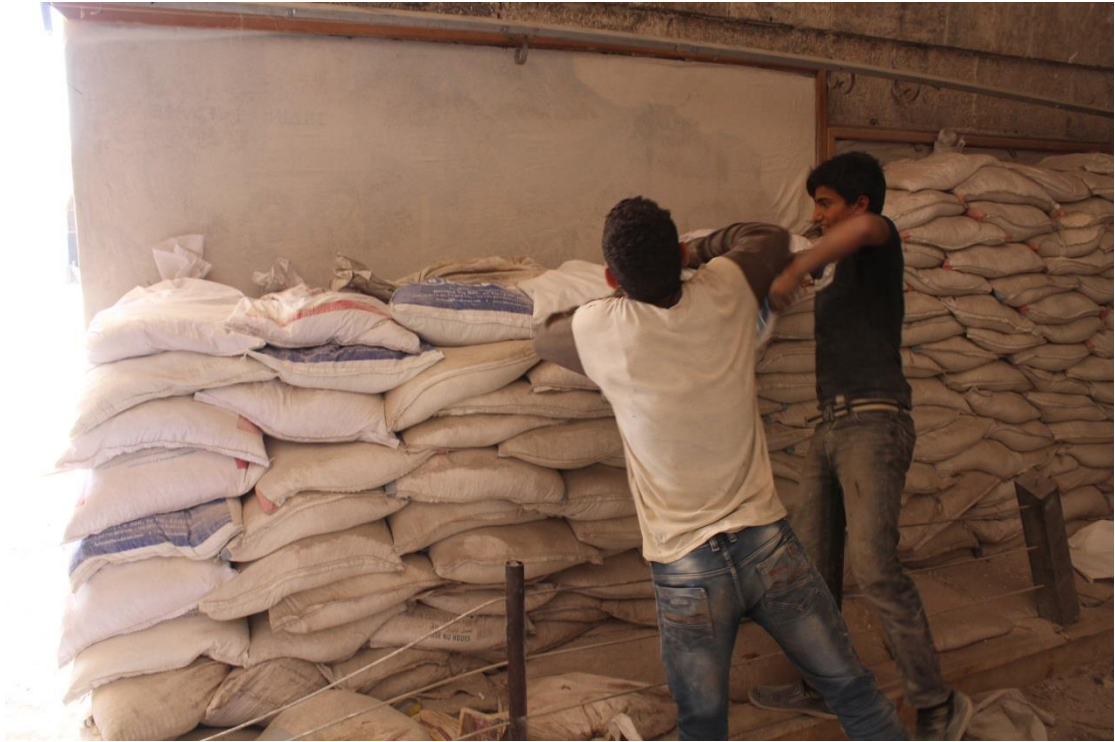
Preparing Sandbags

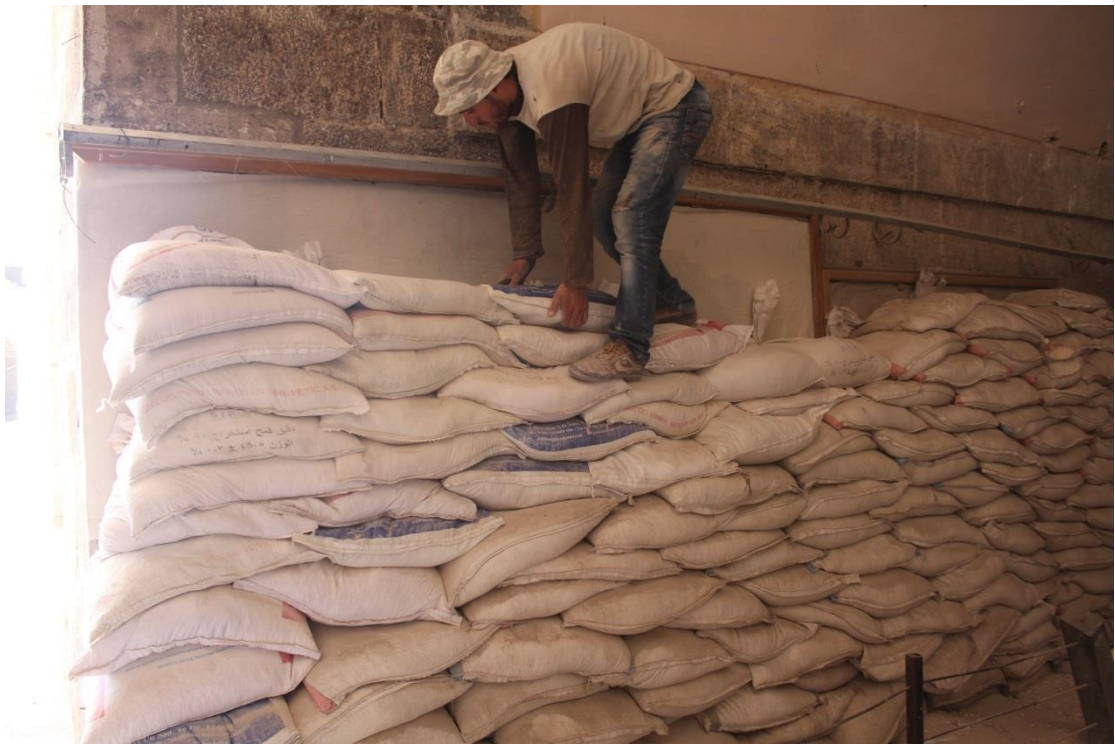
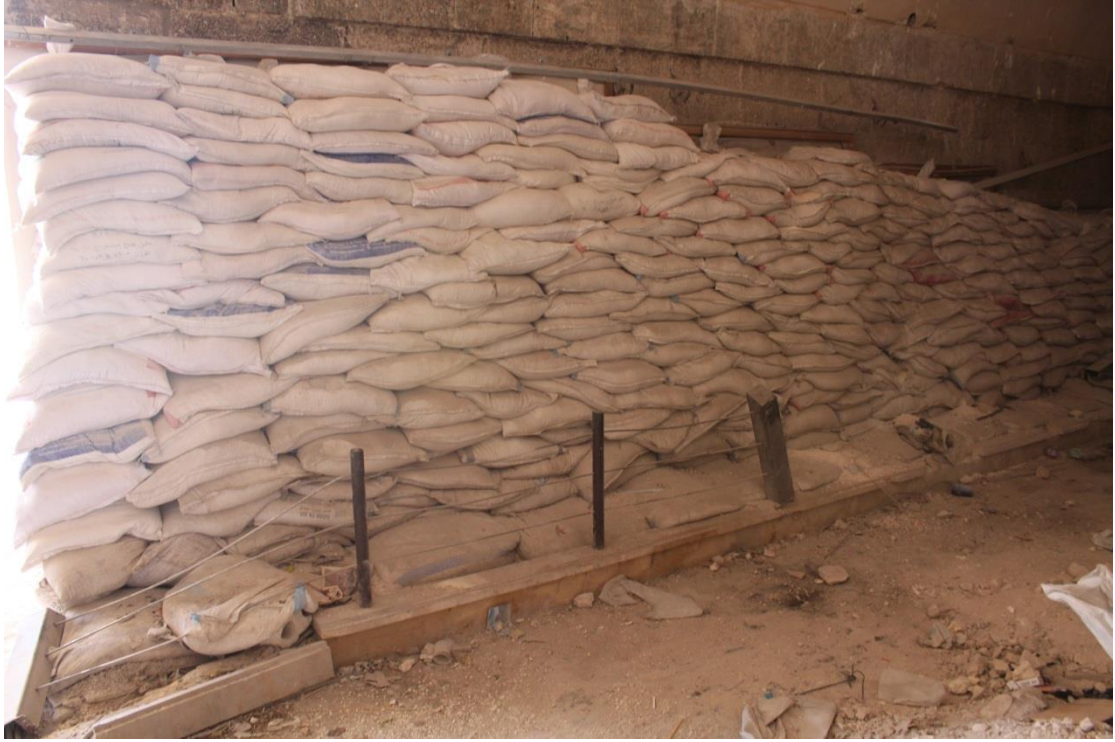
Sandbagging the cloth covered mosaic

Protect the mosaics by placing sandbags over and around them. This method of protection has been successfully implemented at the museum of Ma'arra previously and is recommended by the Smithsonian Museum.

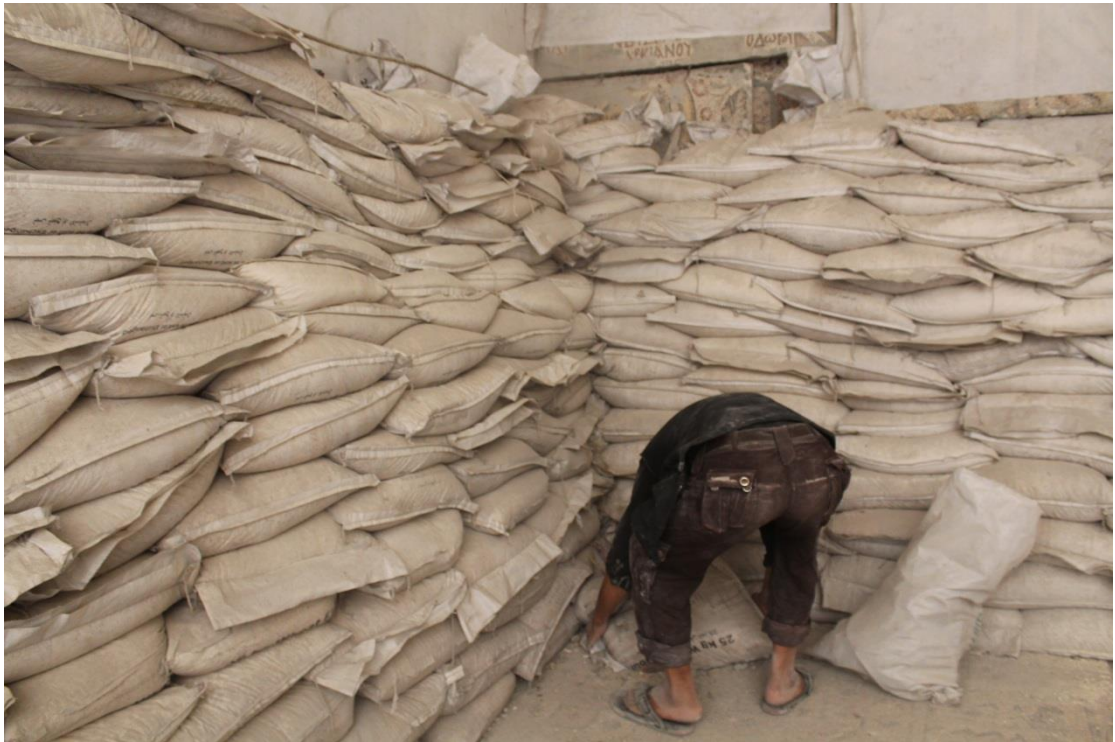
Sandbagging mosaics

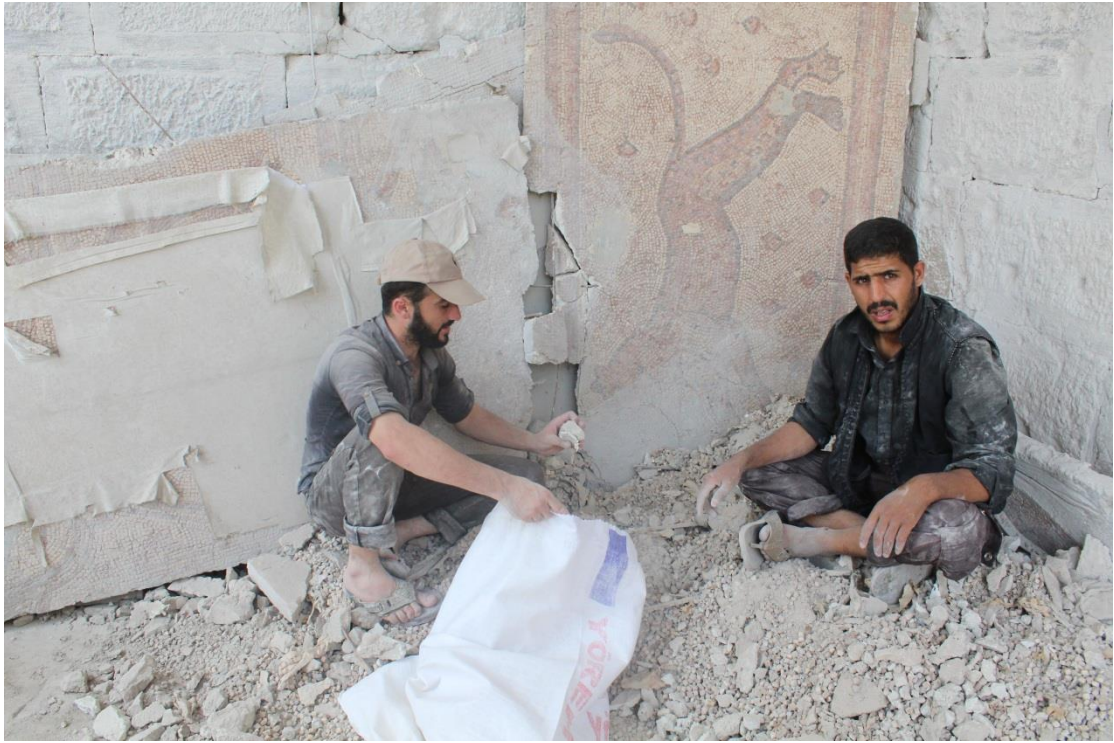
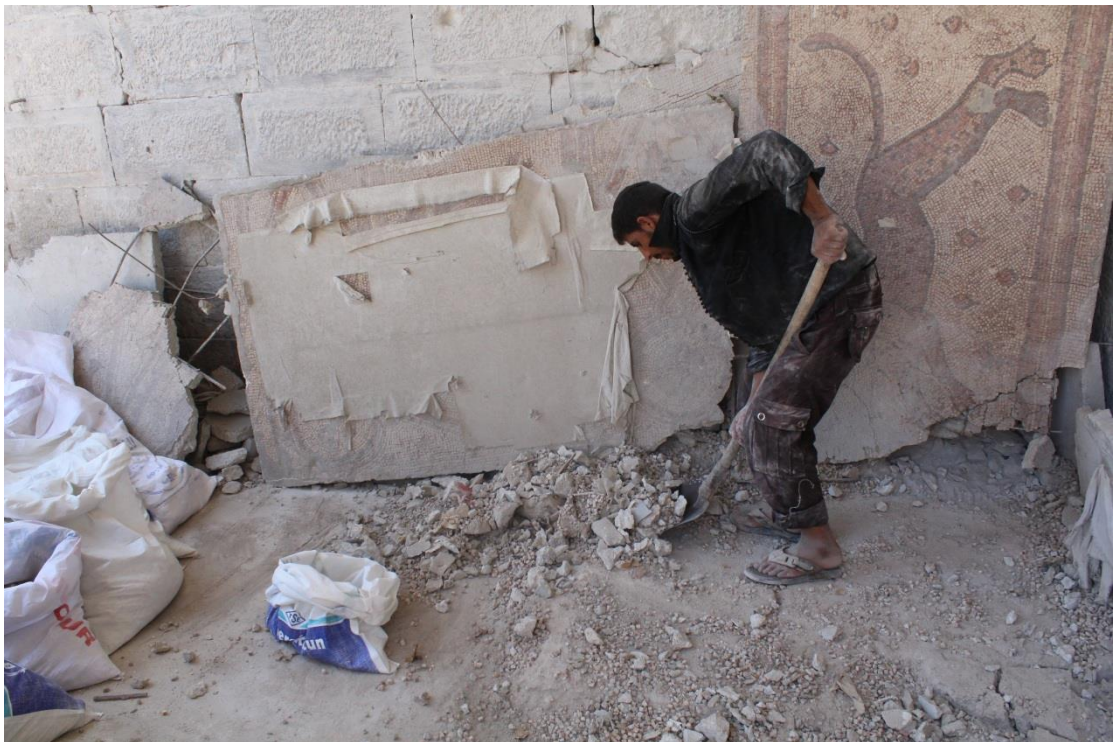
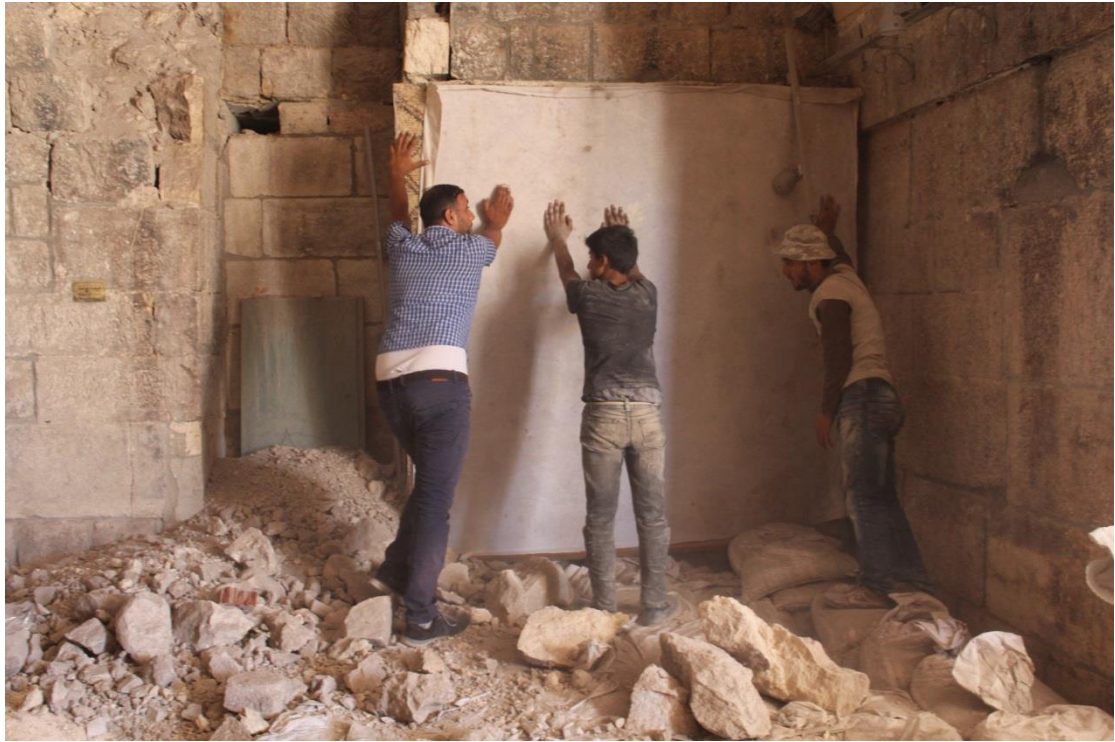
Cleaning the museum wings and securing the mosaics

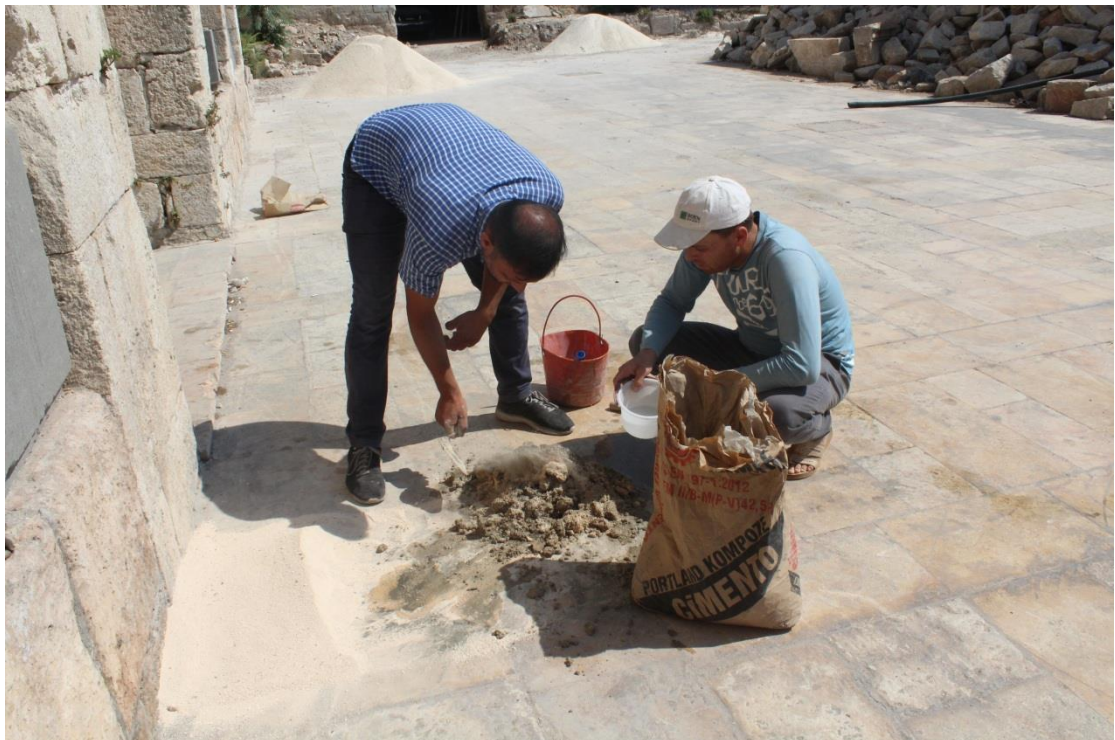
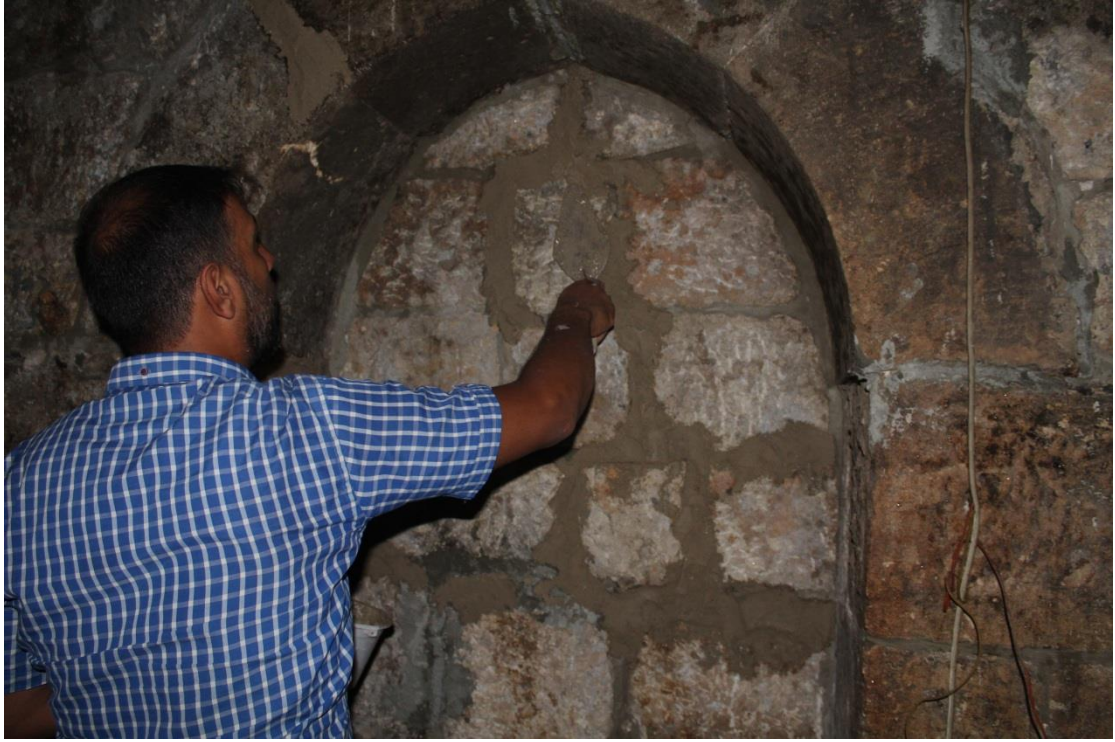
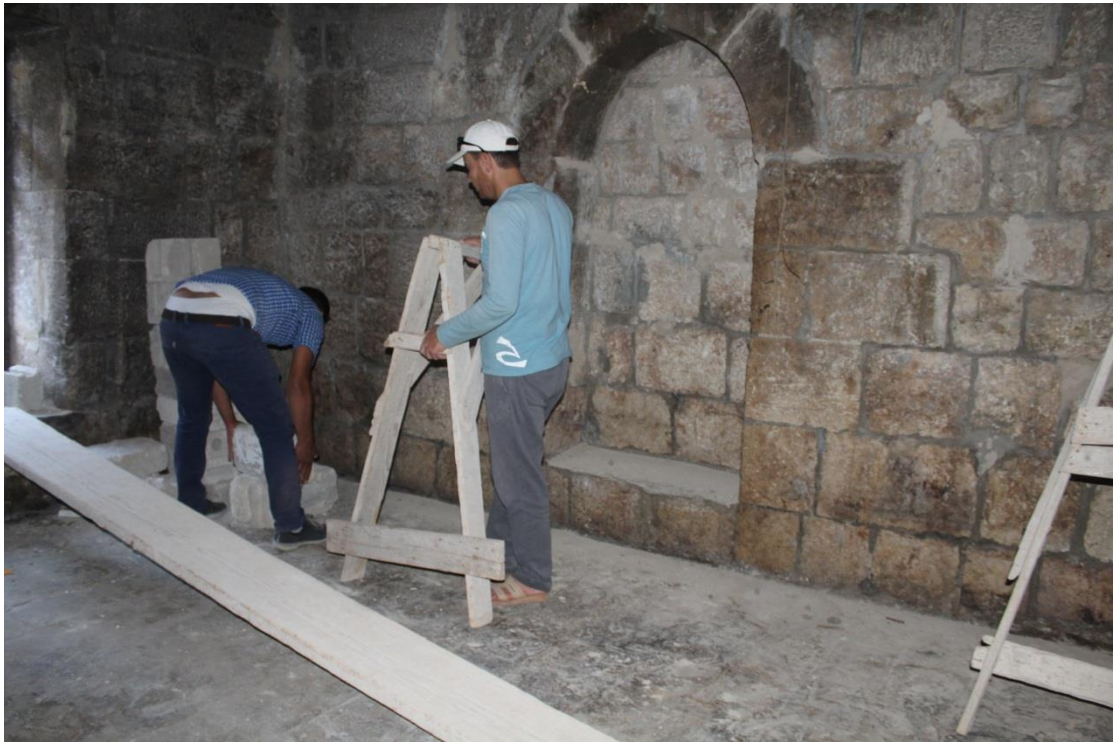
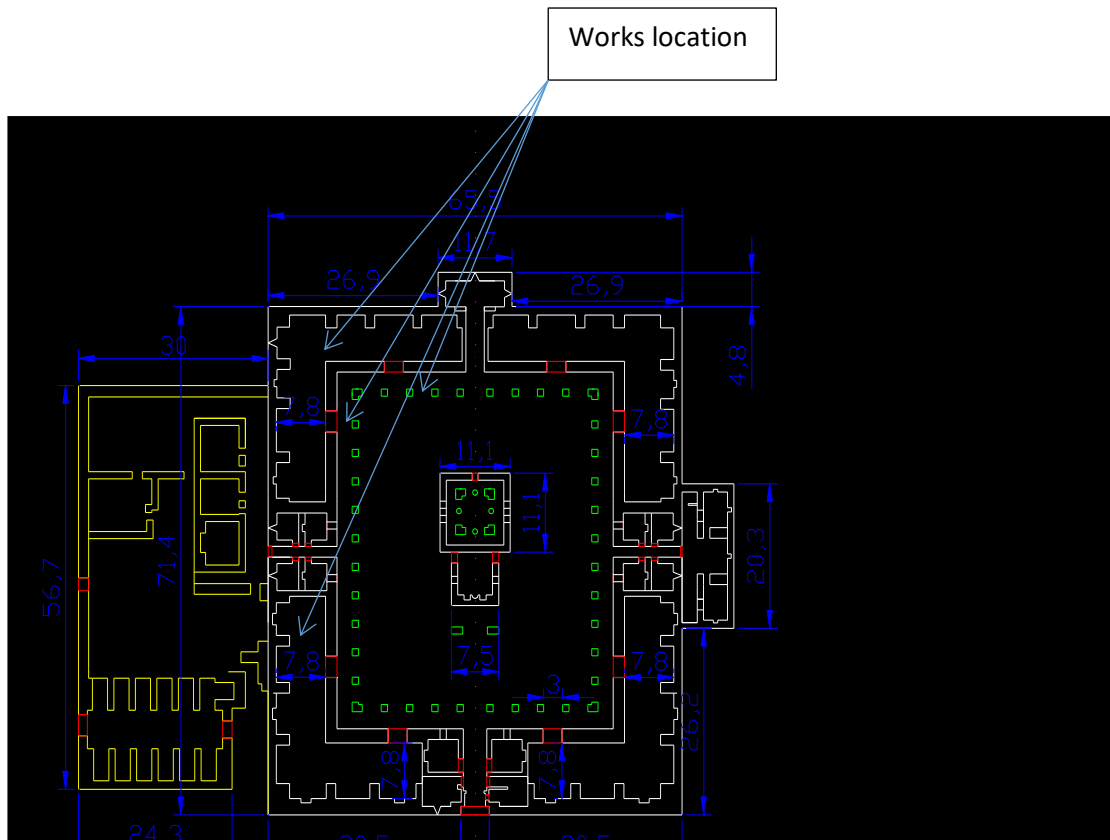
Restoring damaged stone burial tombs
