## The Day After Heritage Protection Initiative

### Site Monitors Project

#### Damage Report Ma'arra Museum Regime Airstrike

June 15, 2015.

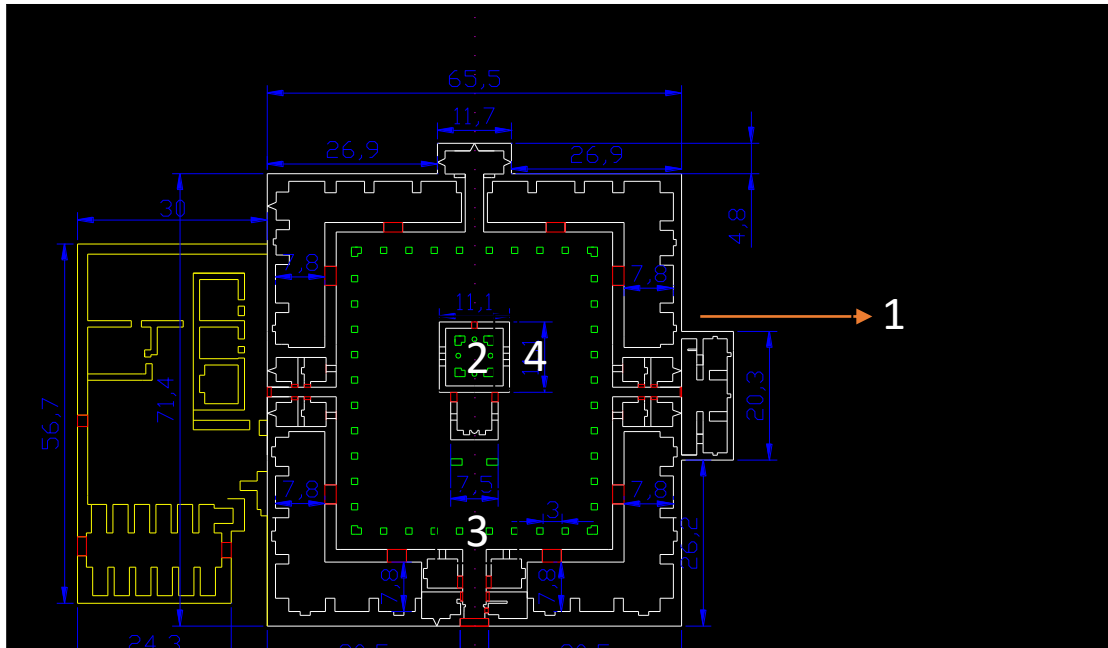
A horizontal projection of the Ma'arra Museum (Khan Murad Basha).

[1] The east wing. [2] The mosque and impact point of the barrel bomb. [3] The main entrance. [4] The east wall of the mosque.

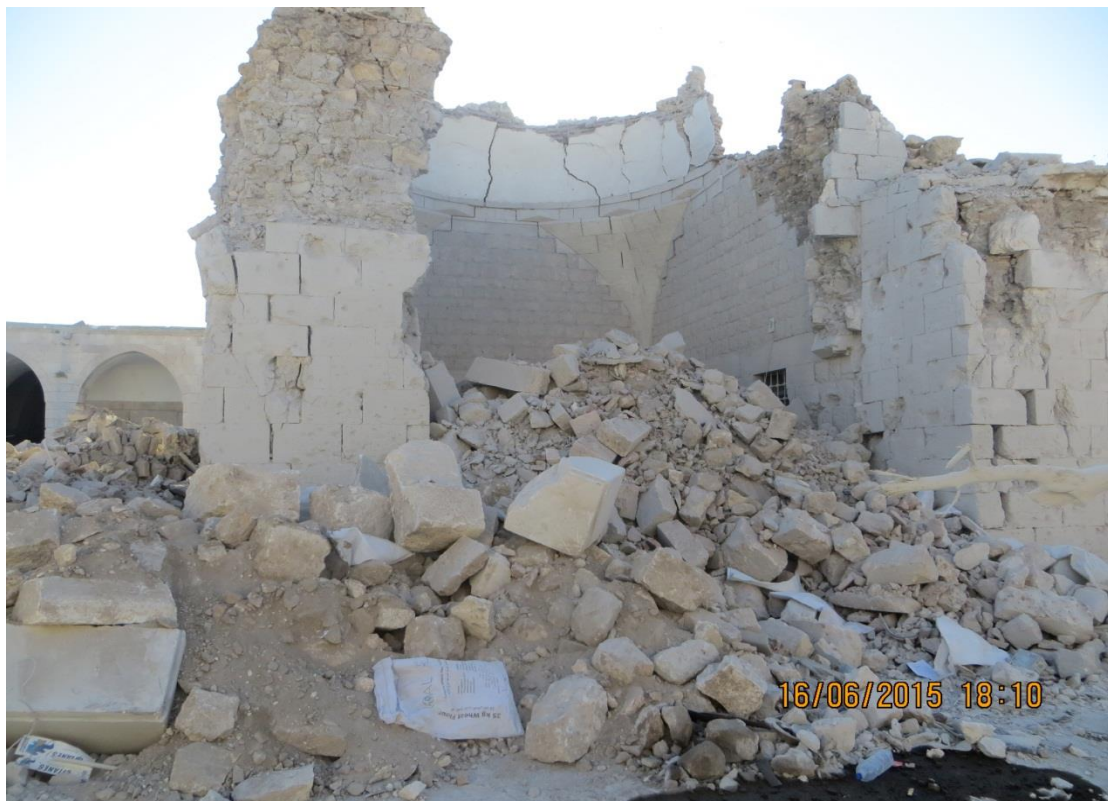
Severe damage to the mosque. The ceiling and the eastern side were completely destroyed and the southern front was partially damaged.

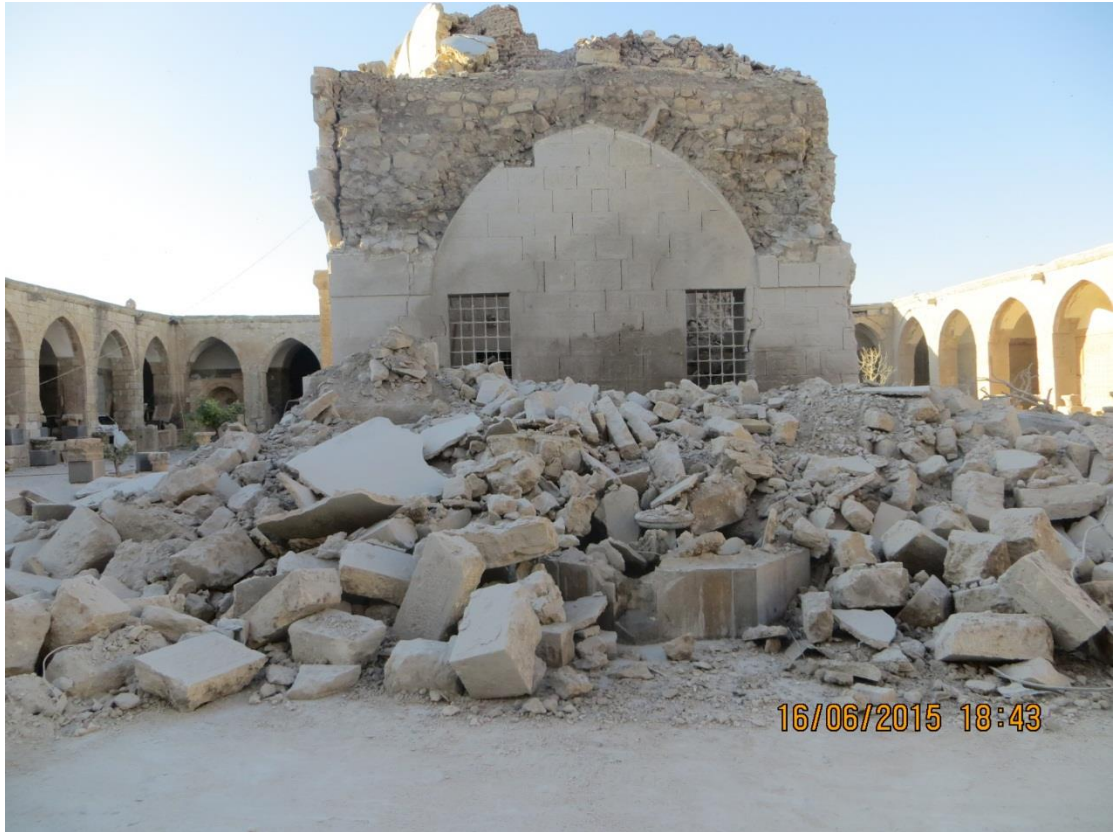
The south side of the mosque.

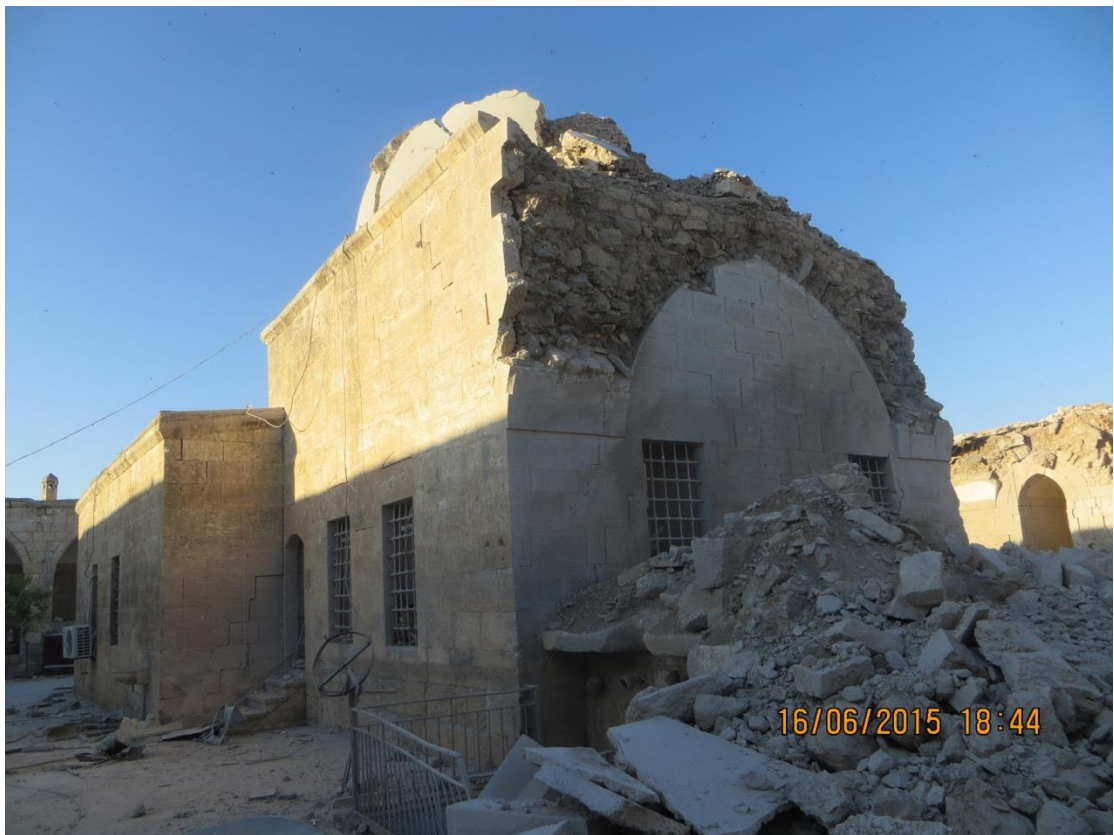
The southwest corner of the mosque

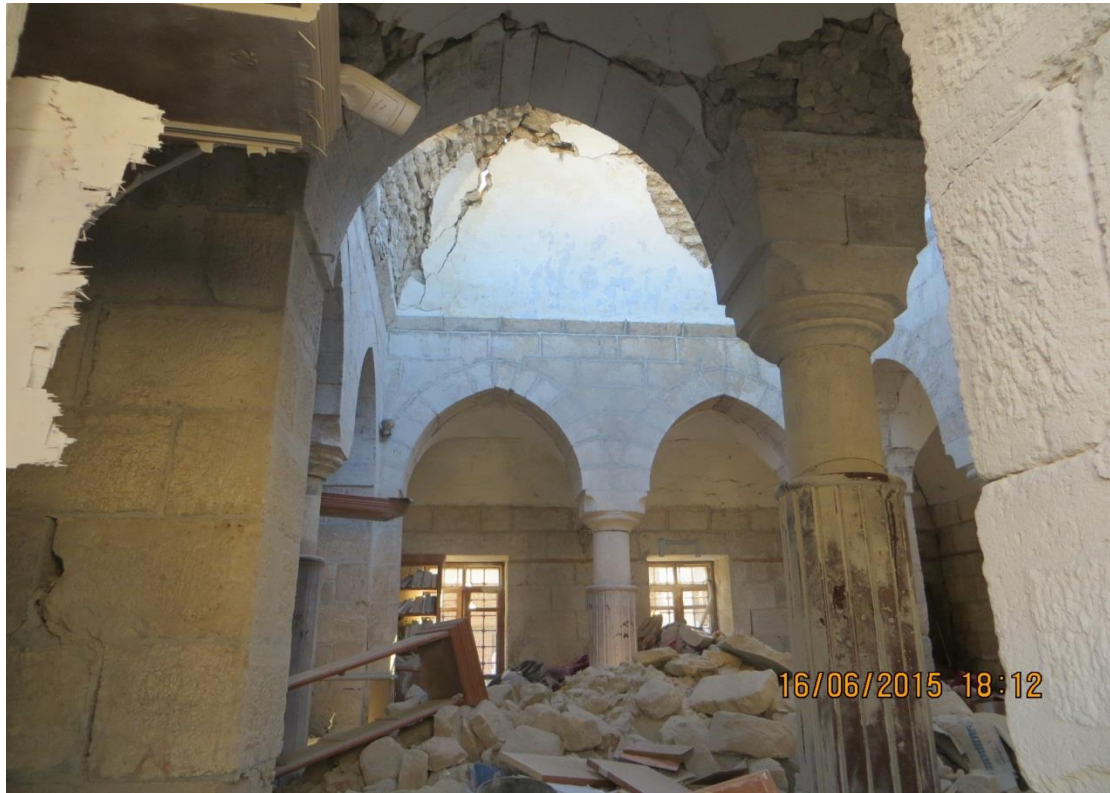
Damage to the *Tekkiye*. Total collapse of the ceiling and extensive damage of the walls. The *Tekkiye* contains Al-l'layah Library.

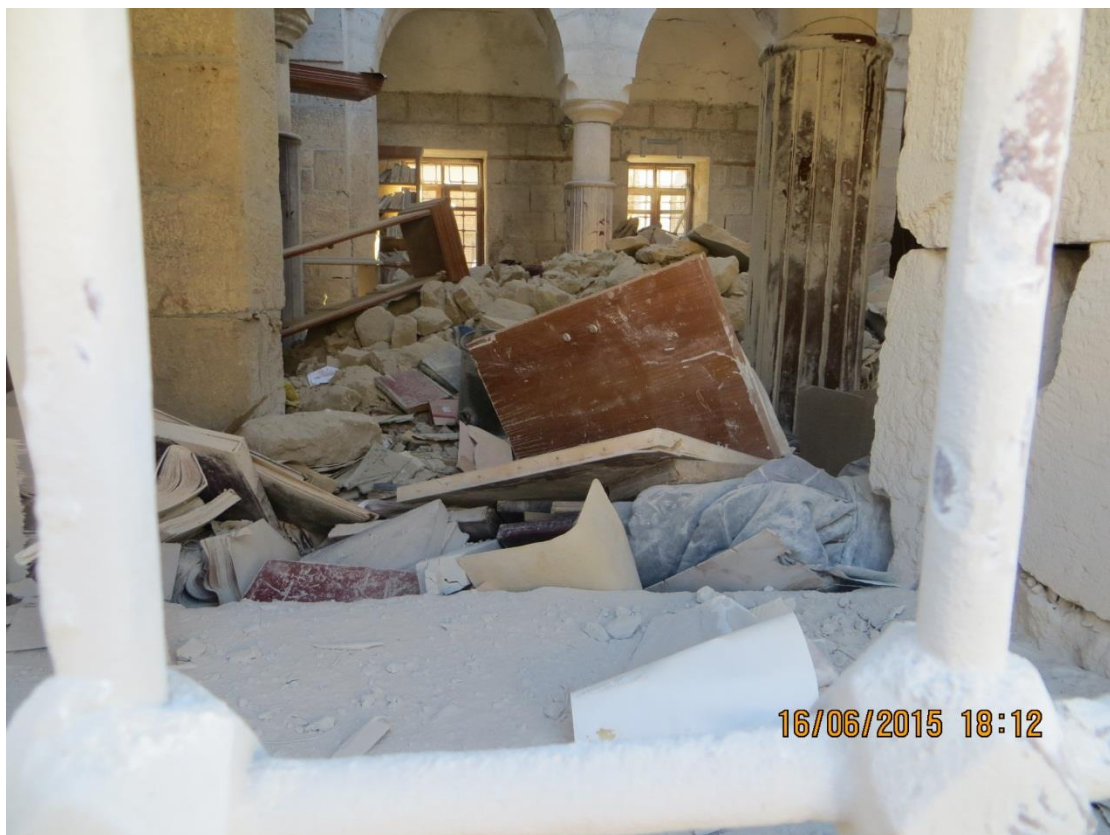
Books and manuscripts inside *Tekkiye*

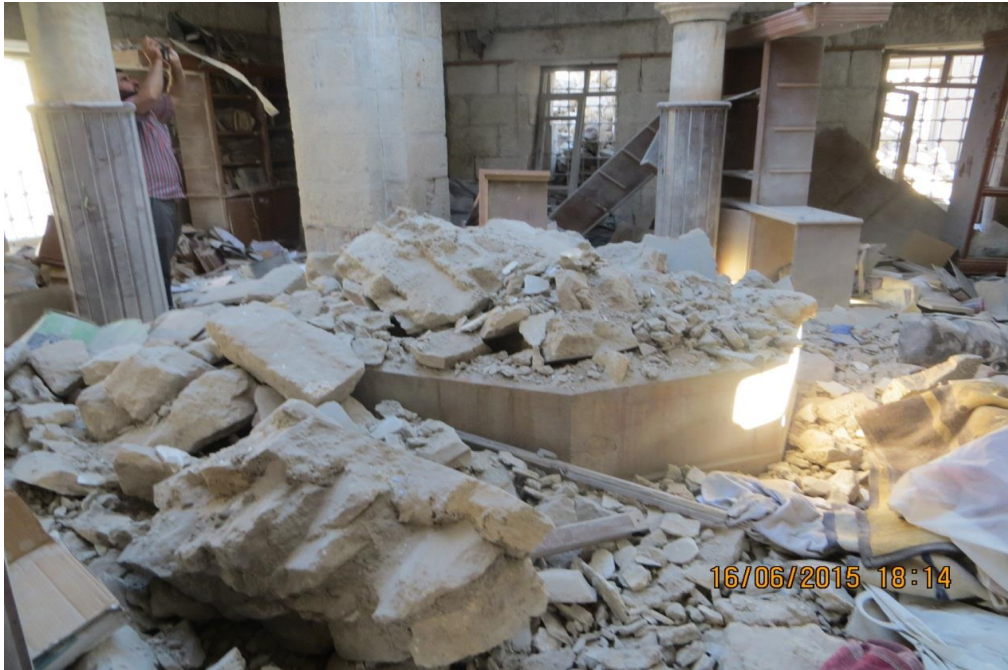
The damaged areas will deteriorate rapidly if no measures are taken to repair and stabilize the affected areas. A room used as an office for the employees is in danger of collapsing. The ceiling of the first wing is also in danger of collapse. Since arches hold up the structure, any collapse of the stones will compromise the structural integrity of the entire wing. It is therefore urgent that any deterioration of the arches be prevented through immediate action.

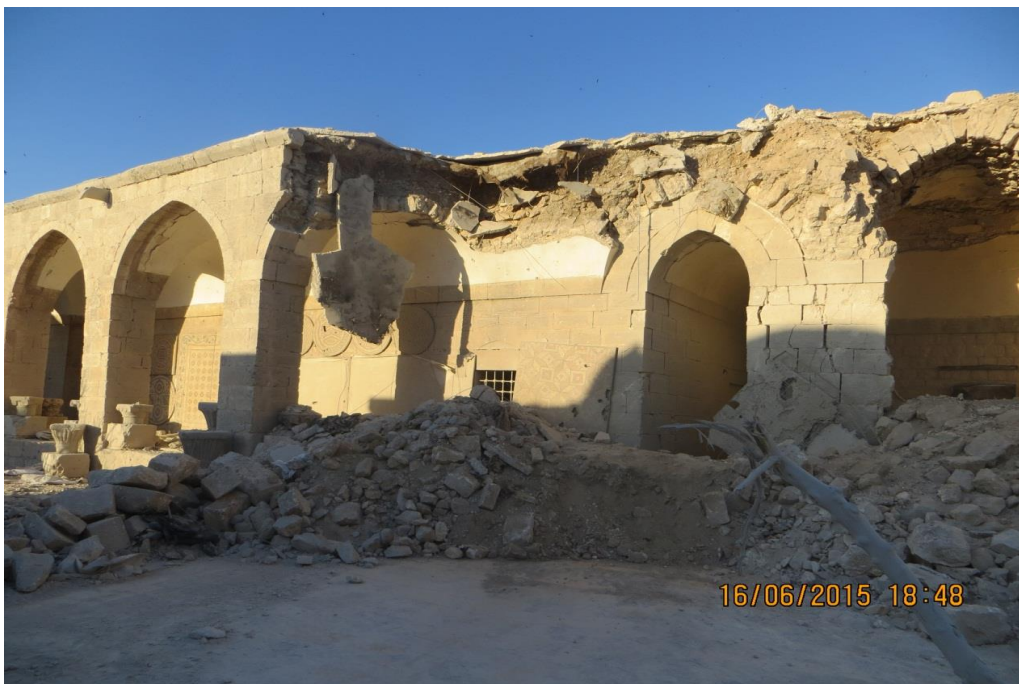
Severe damage to the covered gallery and parts of the east wing

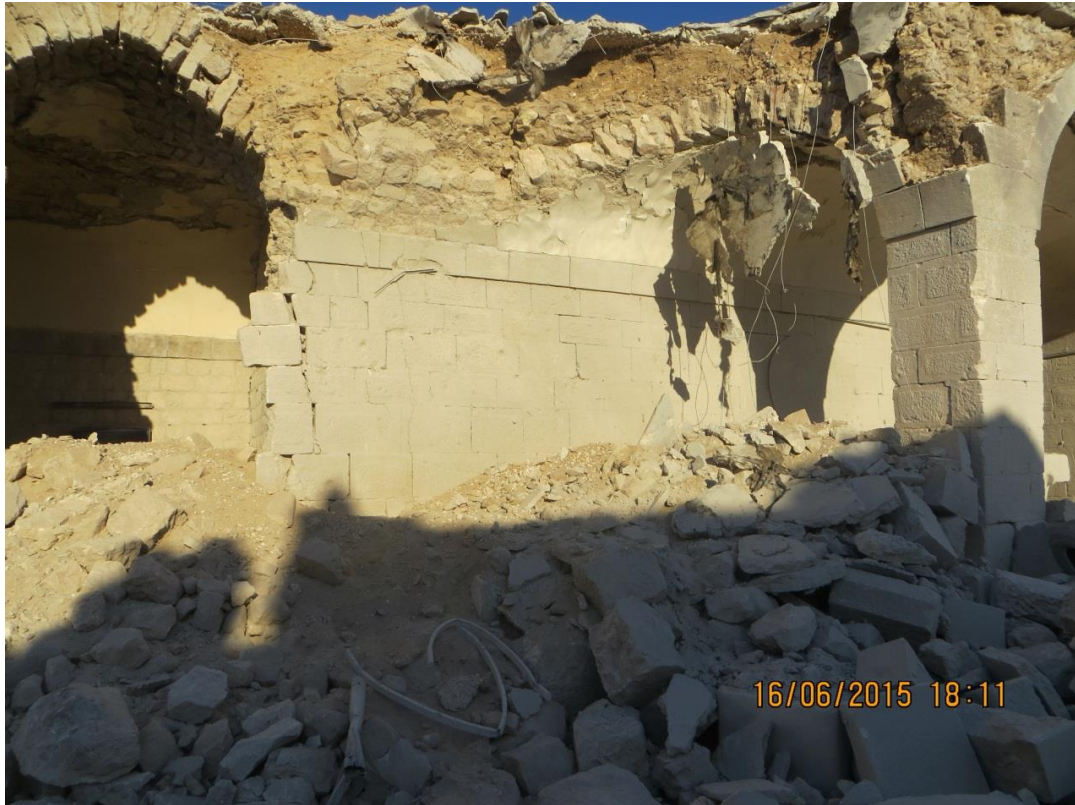
Close up of the severe damage to the covered gallery and parts of the east wing

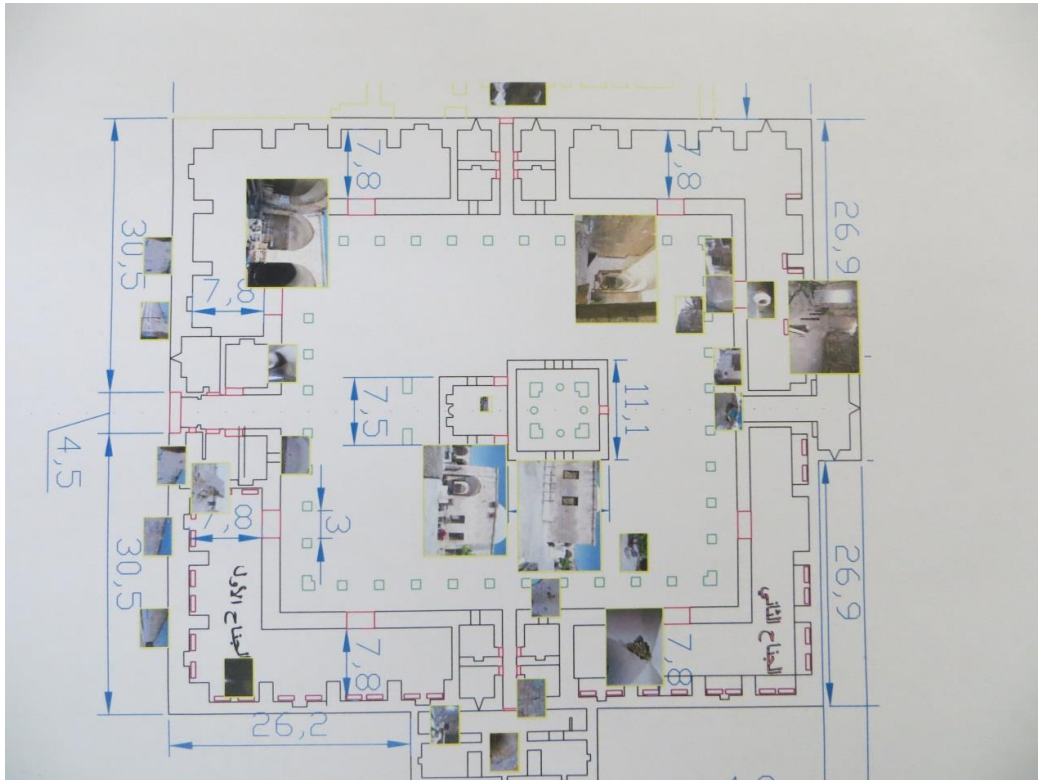
A schematic drawing of the museum

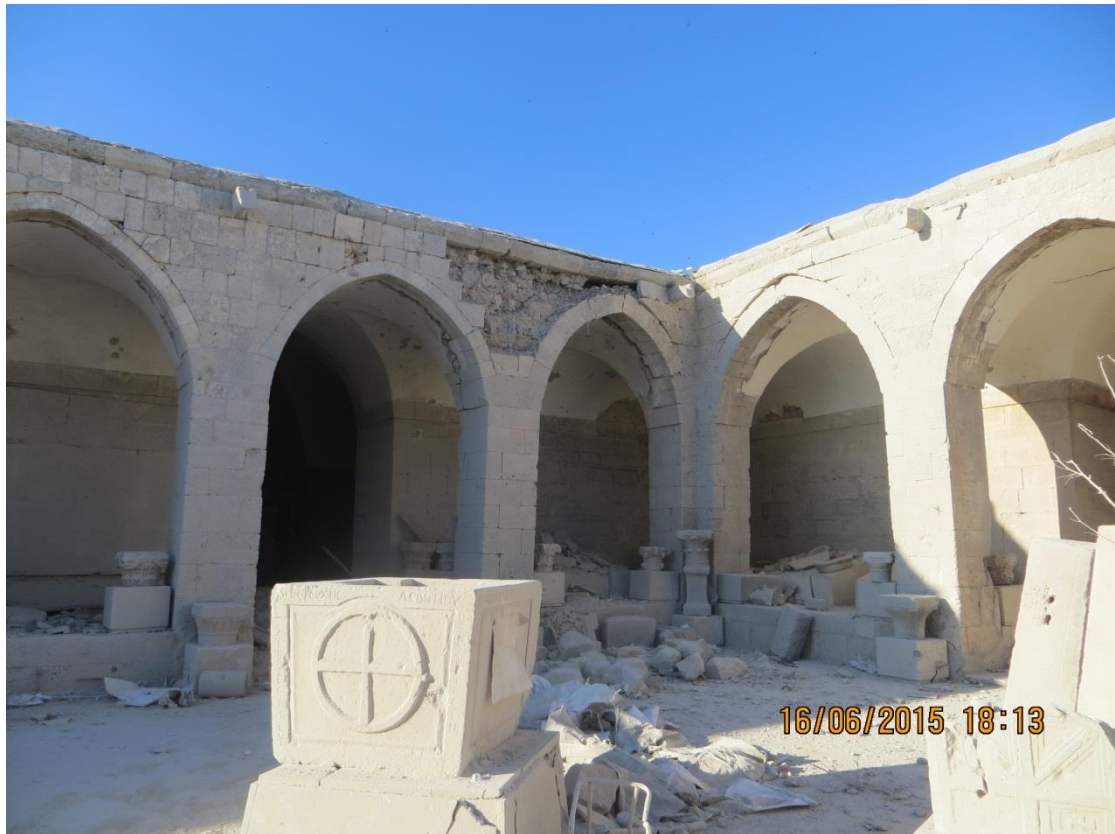
The northeast corner of the museum.

Extensive damage due to the force of the explosion causing major cracks to appear in the walls.

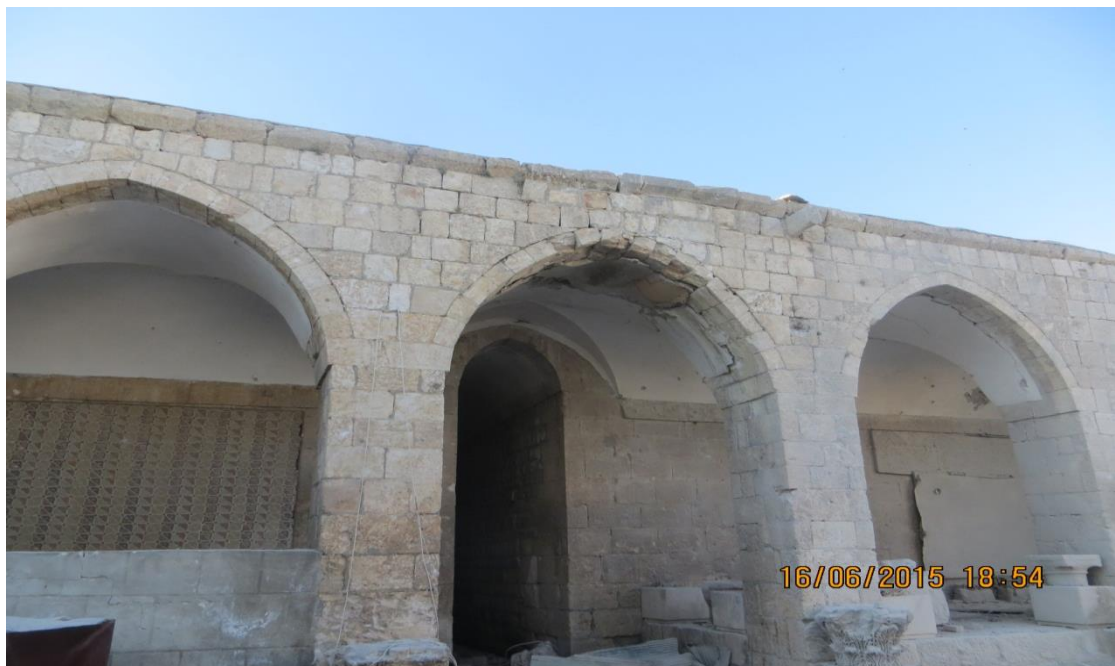
The east wing showing earlier repair done to the arch in the summer of 2014.

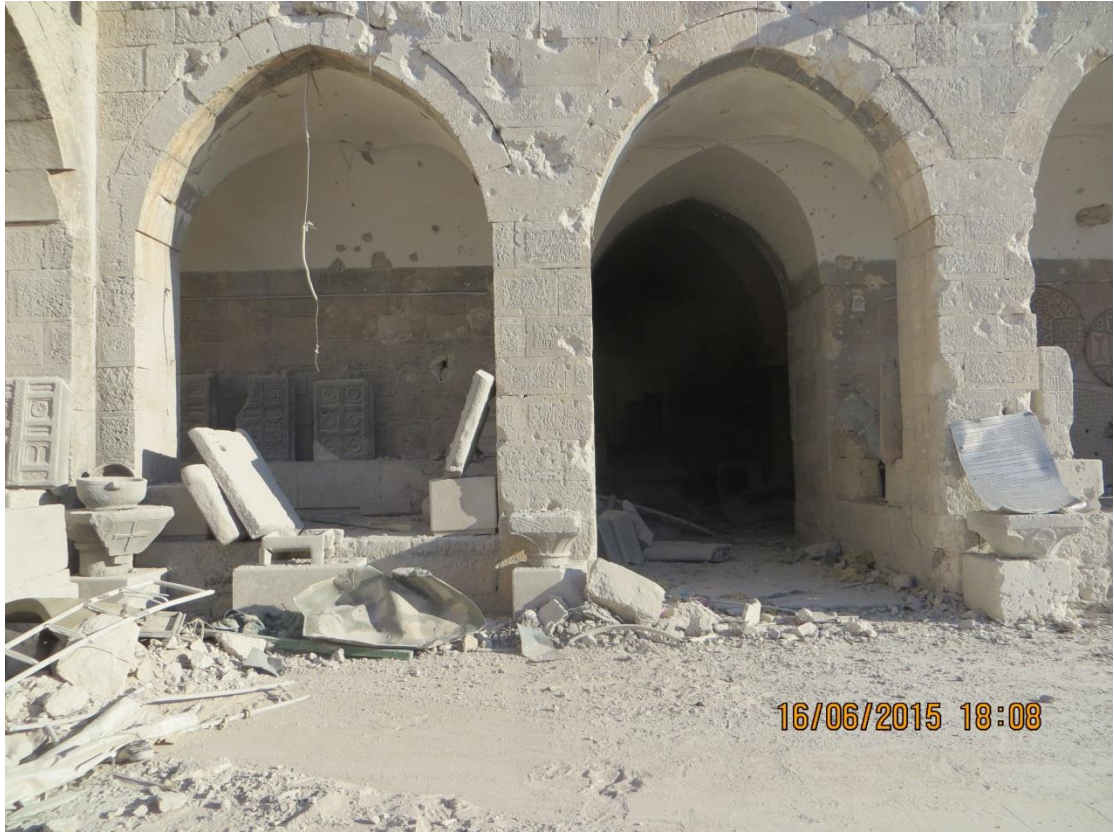
The main entrance to the museum (photo facing south).

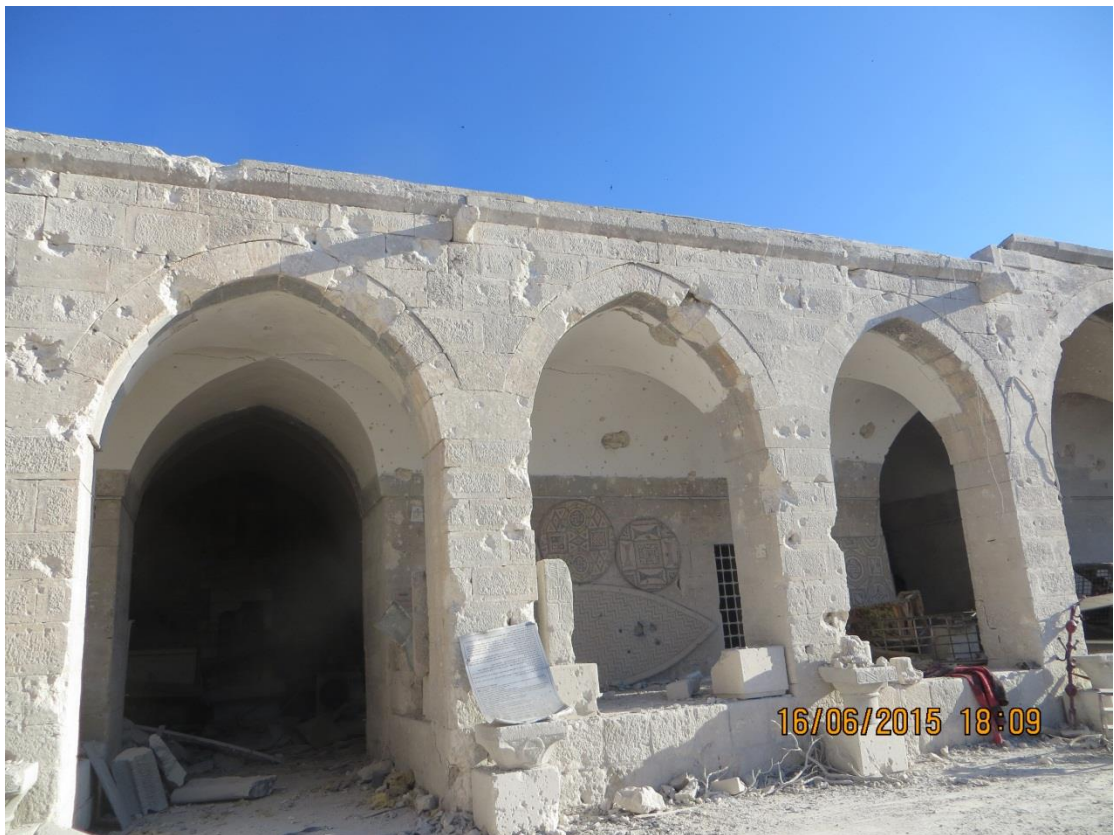
The main entrance to the museum (photo facing south).

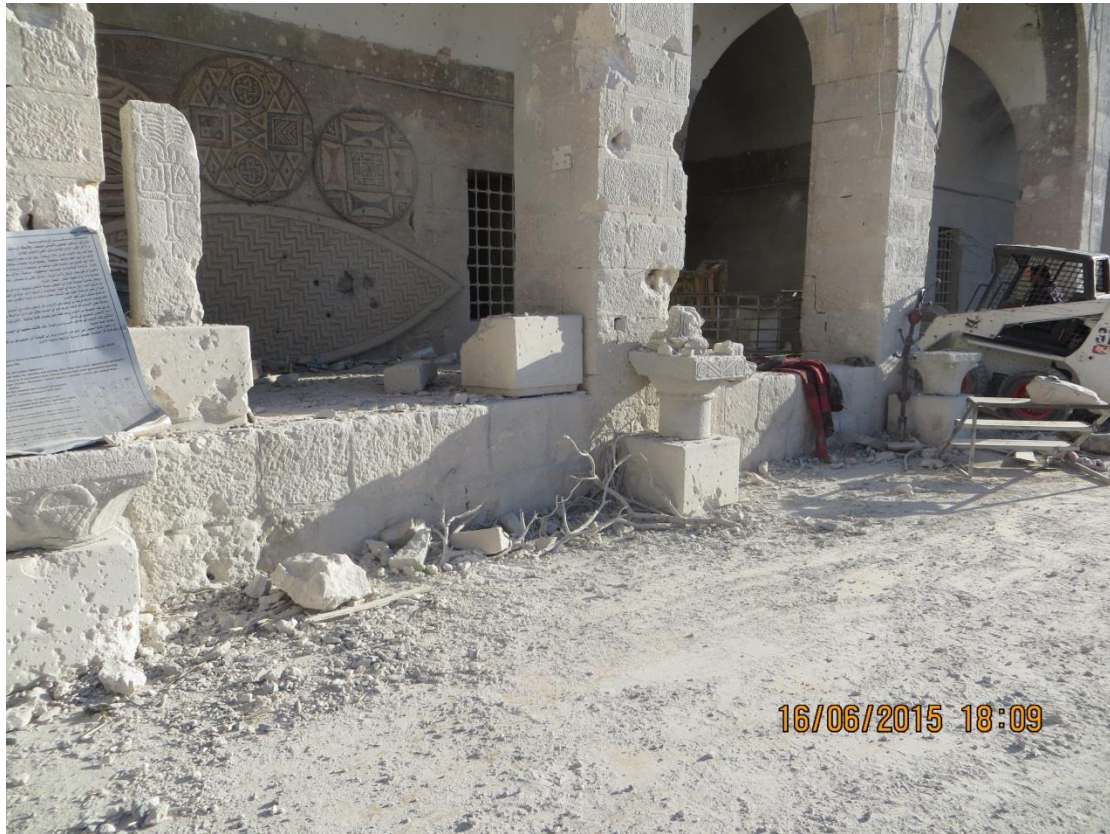
Stone objects and mosaic panels damaged by the blast.

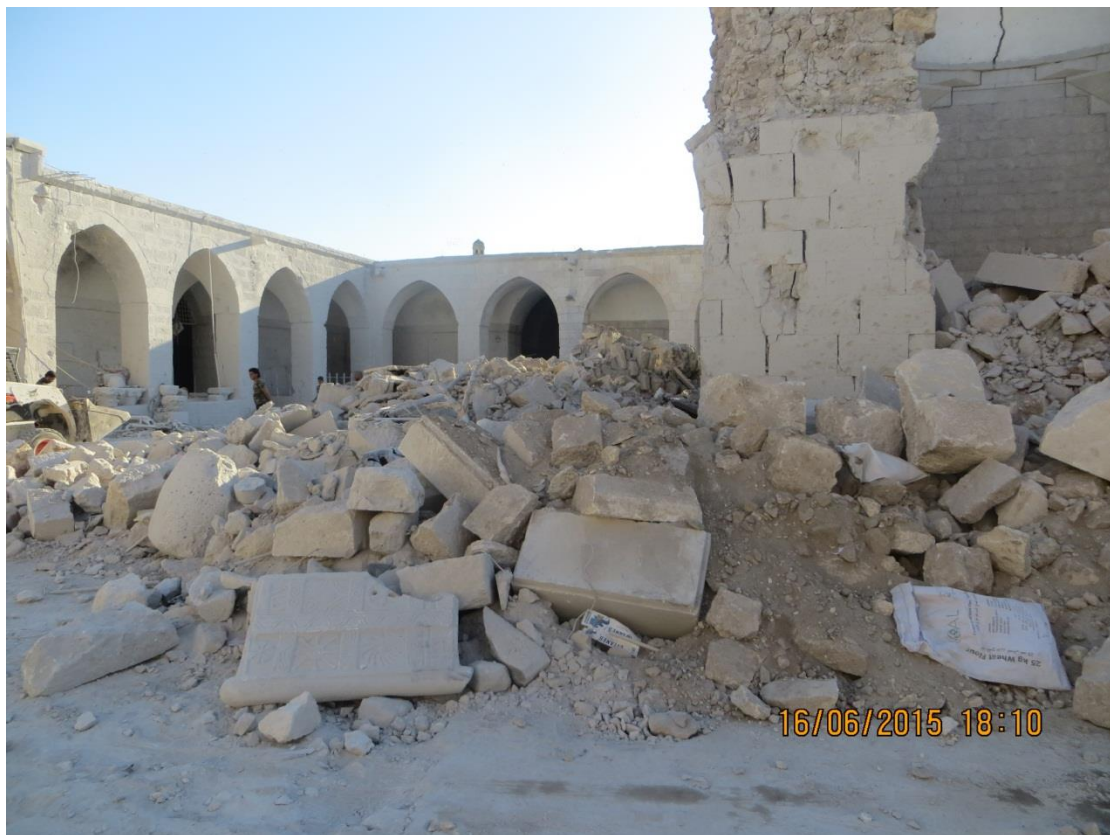
Museum objects buried in the rubble in the rubble.

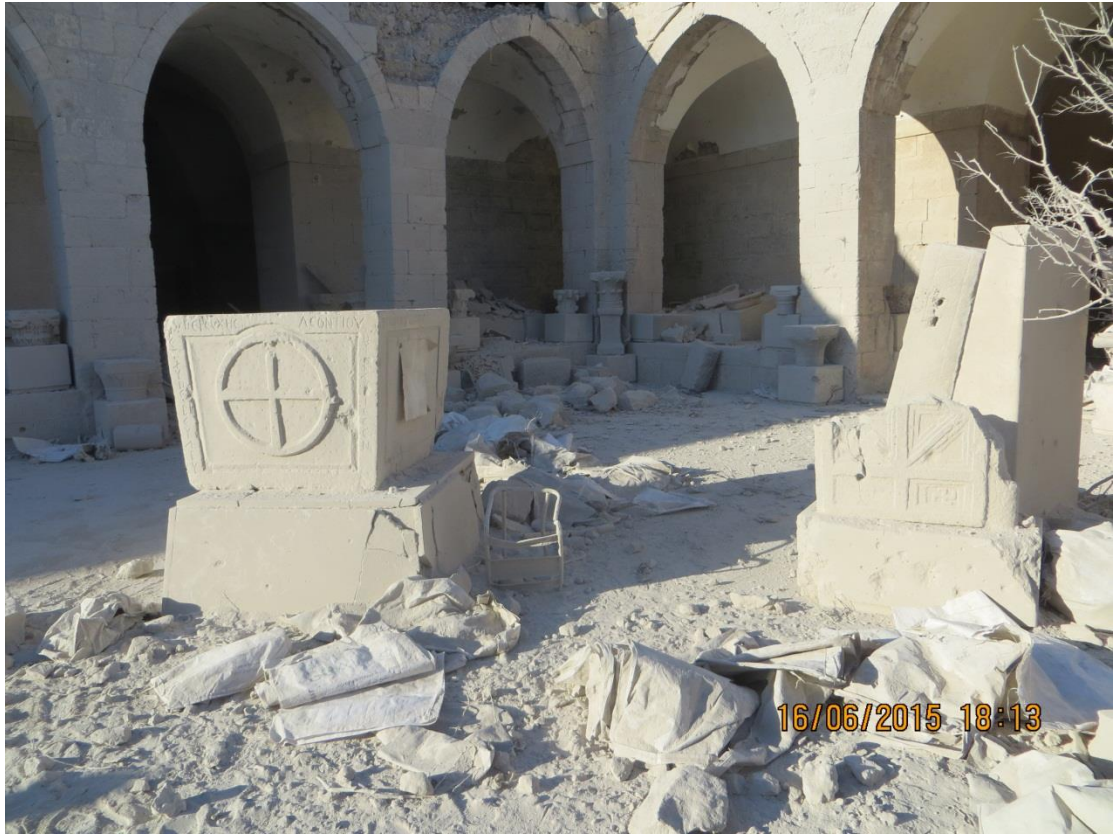
Sarcophagus and other stone objects damaged by the blast.

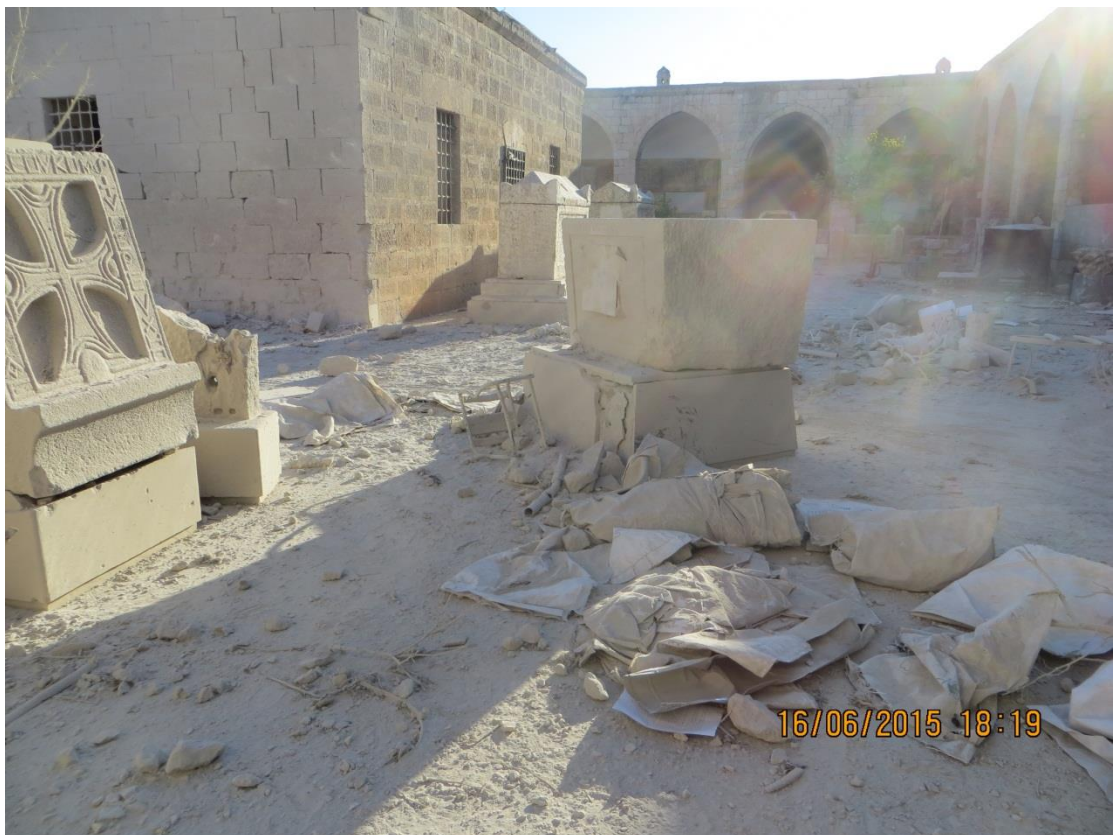
Sand bags scattered due to the explosion.

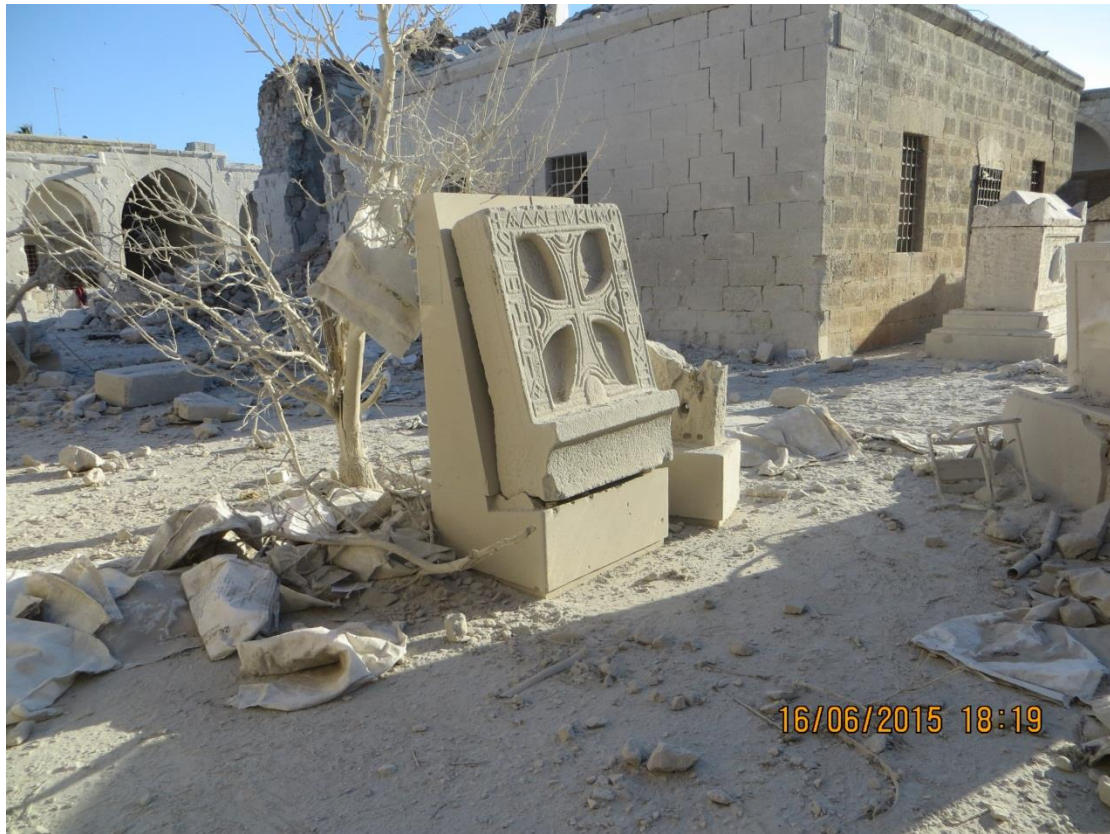
Sand bags used to shield objects on display in the museum courtyard scattered by the blast.

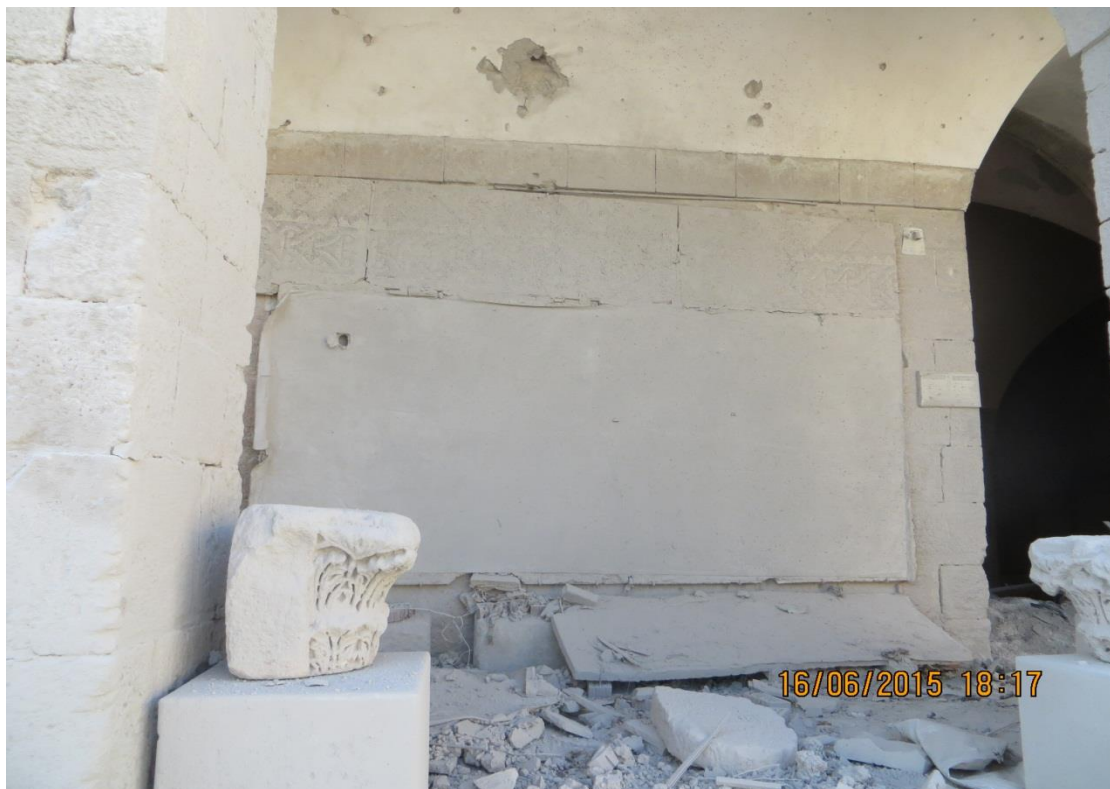
Mosaic panel covered with a layer of glue and cloth exposed after the fall of the sand bags due to the blast.

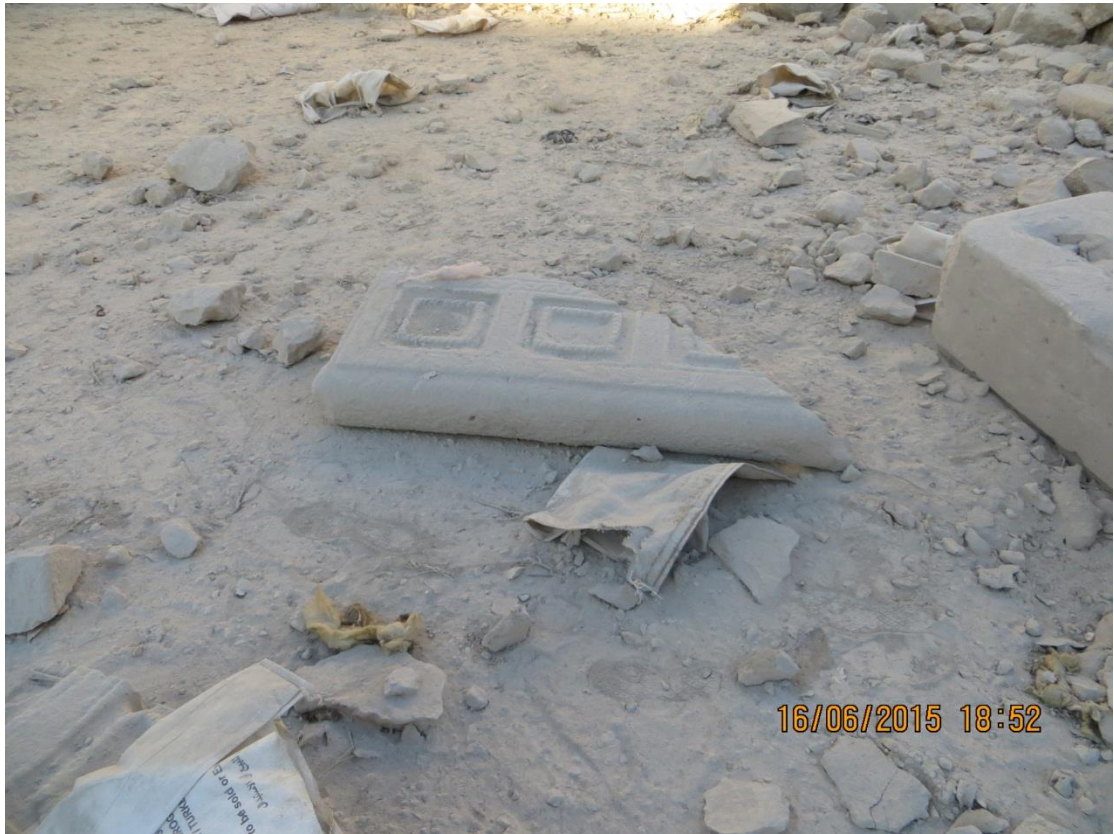
A basalt door, smashed by the explosion.
