The Day After Heritage Protection Initiative

Site Monitors Project

Progress Report on Damage Assessment, Stabilization and Preservation Work in Ma'arra Museum Following the Third Airstrike January 2018.

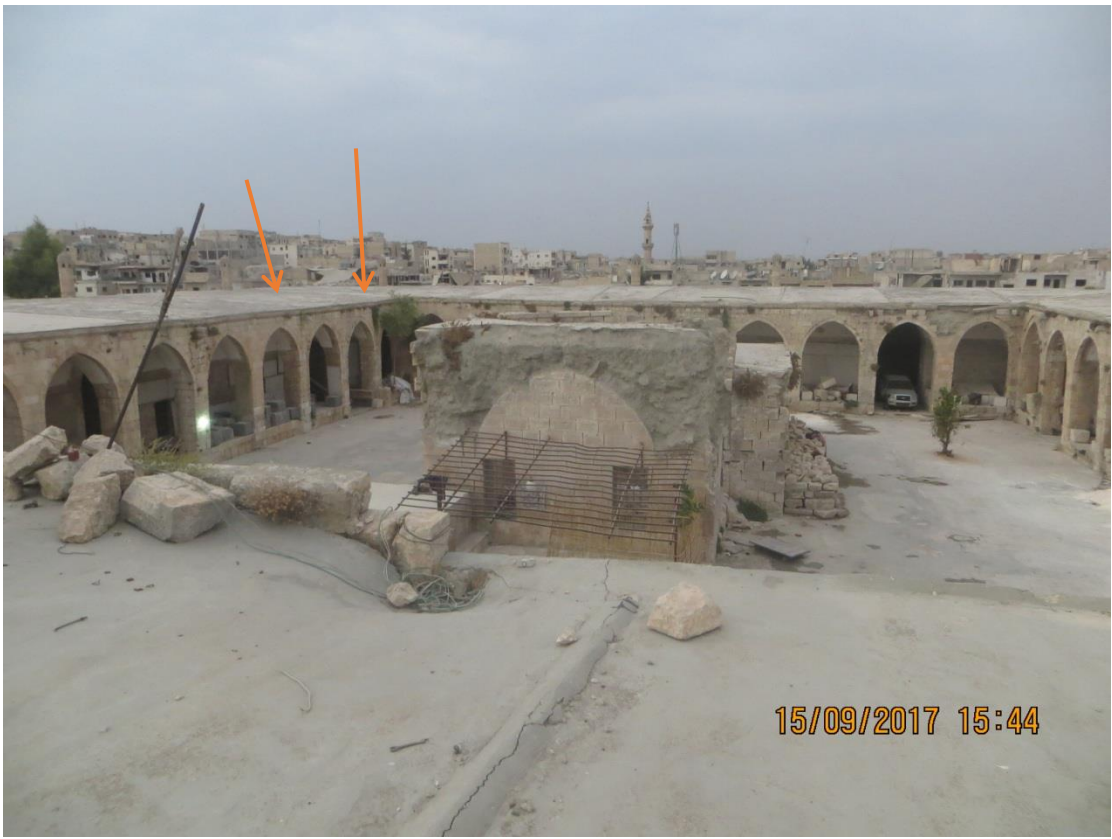
Pre-strike image showing where the museum was struck by the missiles (indicated by orange arrows)

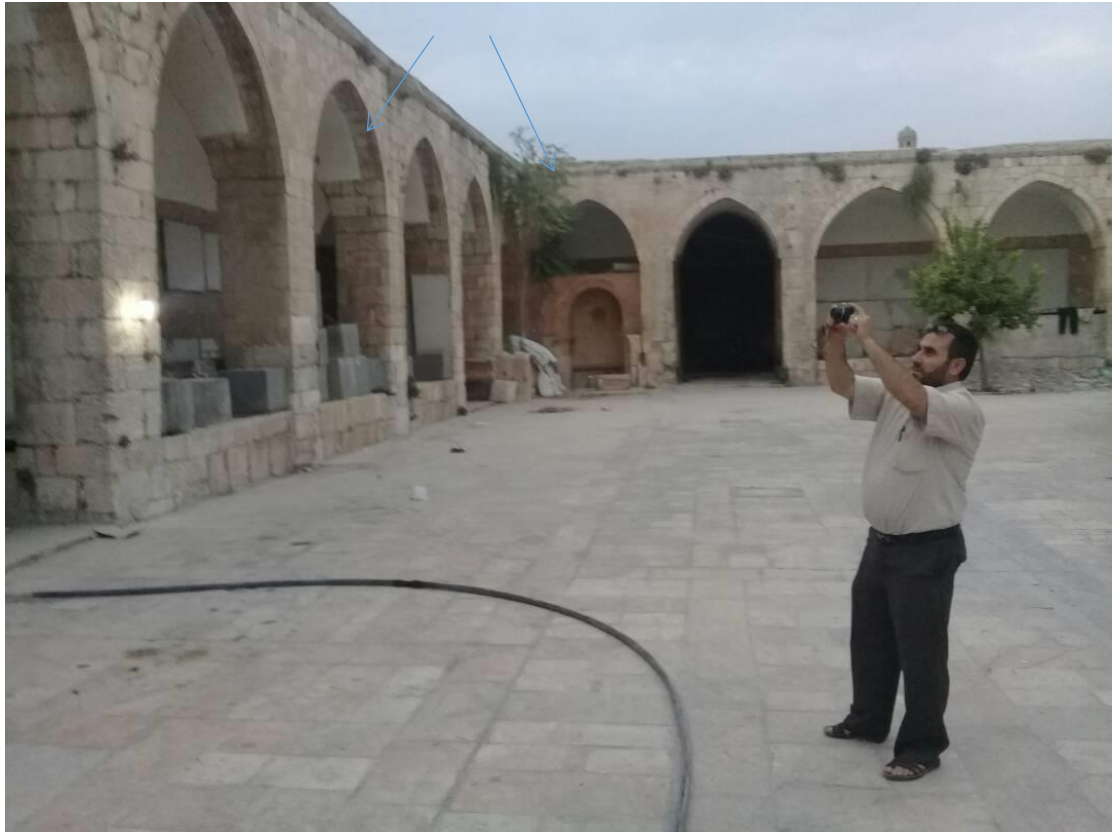
Pre-strike image showing where the museum was struck by the missiles (indicated by blue arrows)

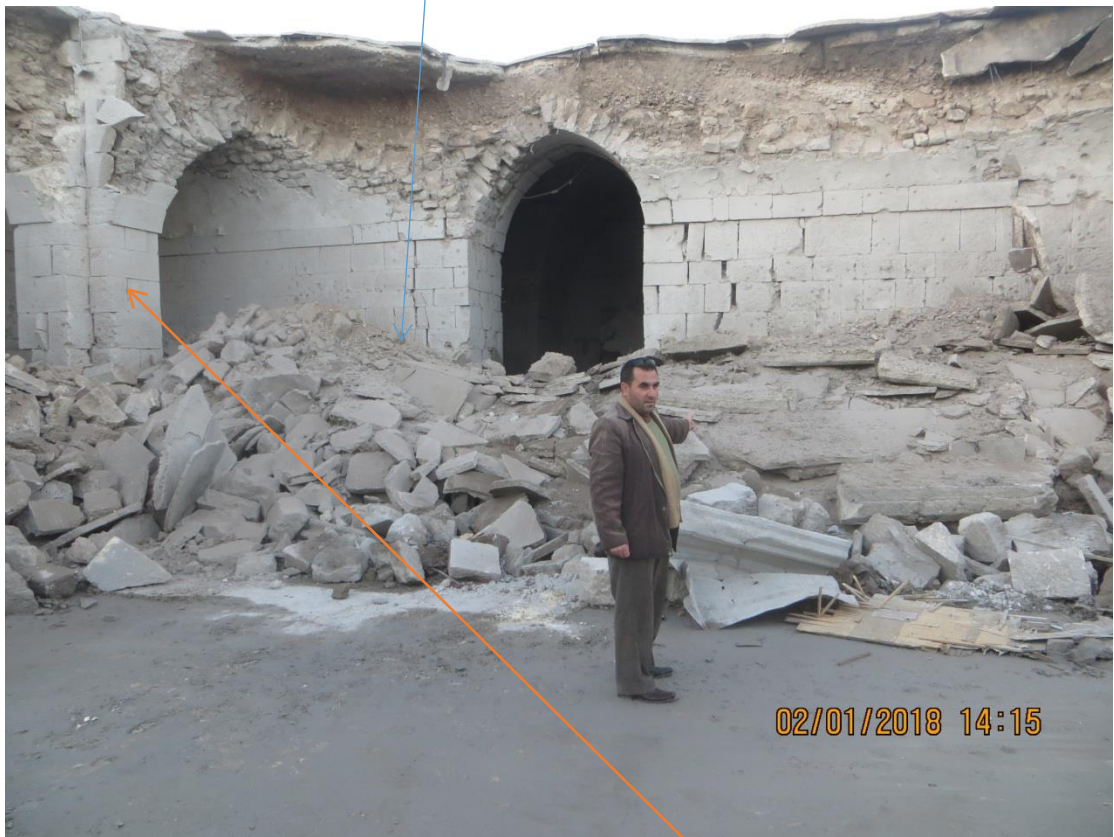
Damage to the northwest corner of the museum

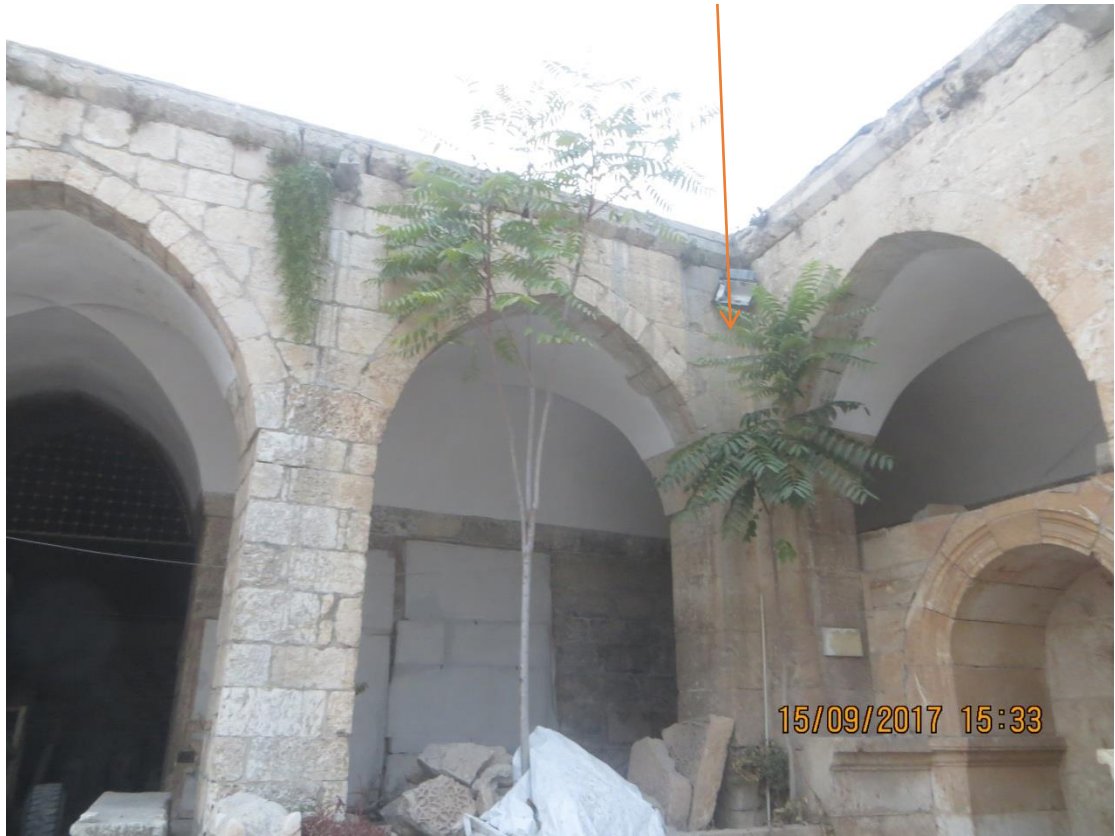
Prestrike image showing corner undamaged

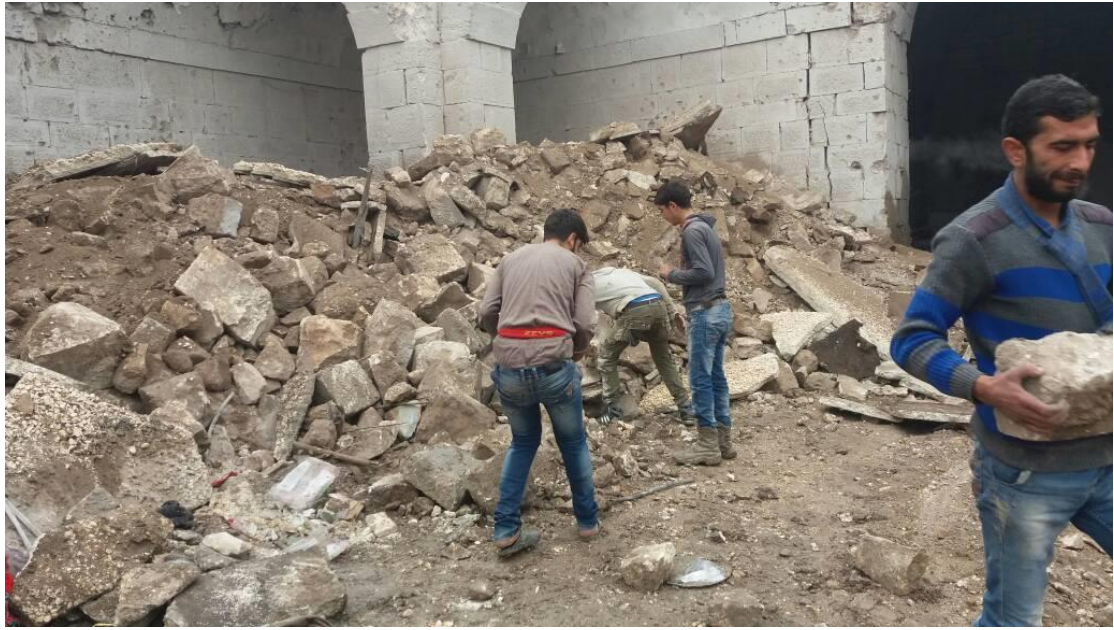
Digging out the rubble and collecting fallen masonry

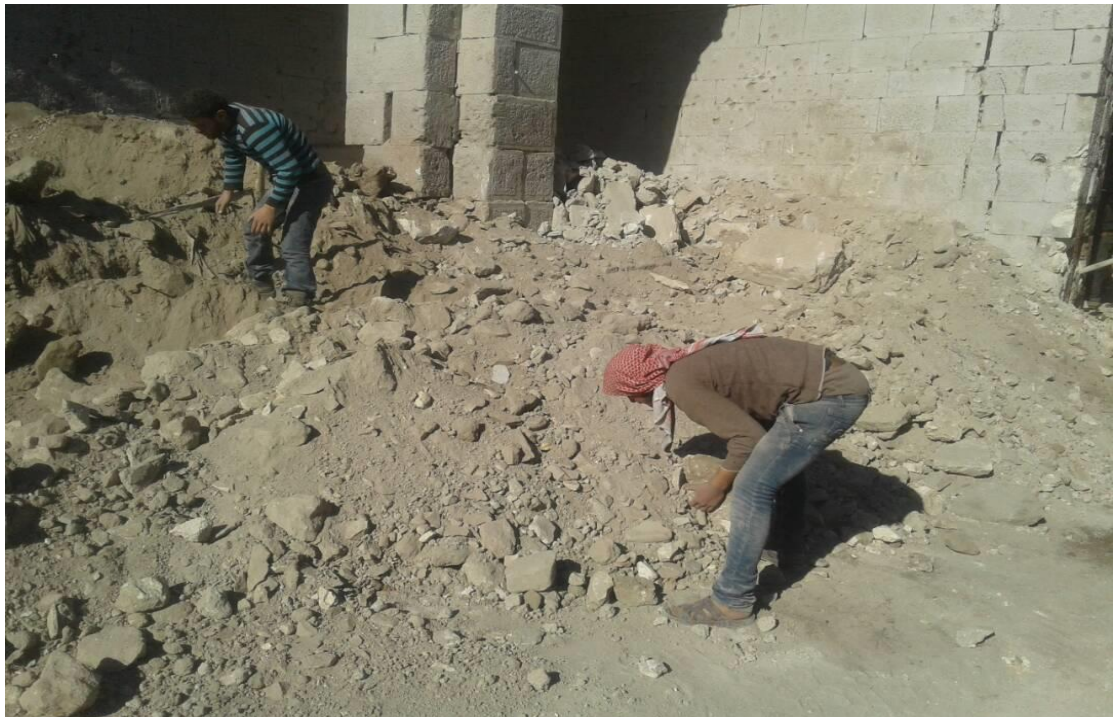
Digging out the rubble and collecting fallen masonry

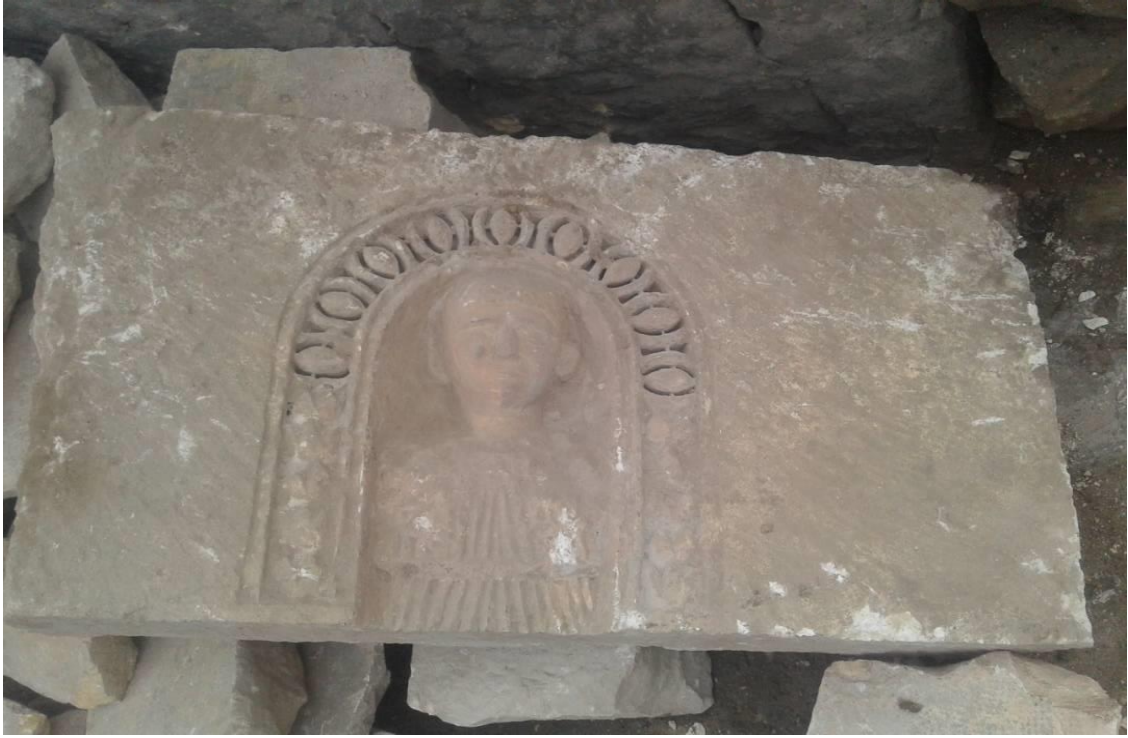
The facade of a tomb preserved in the first wing

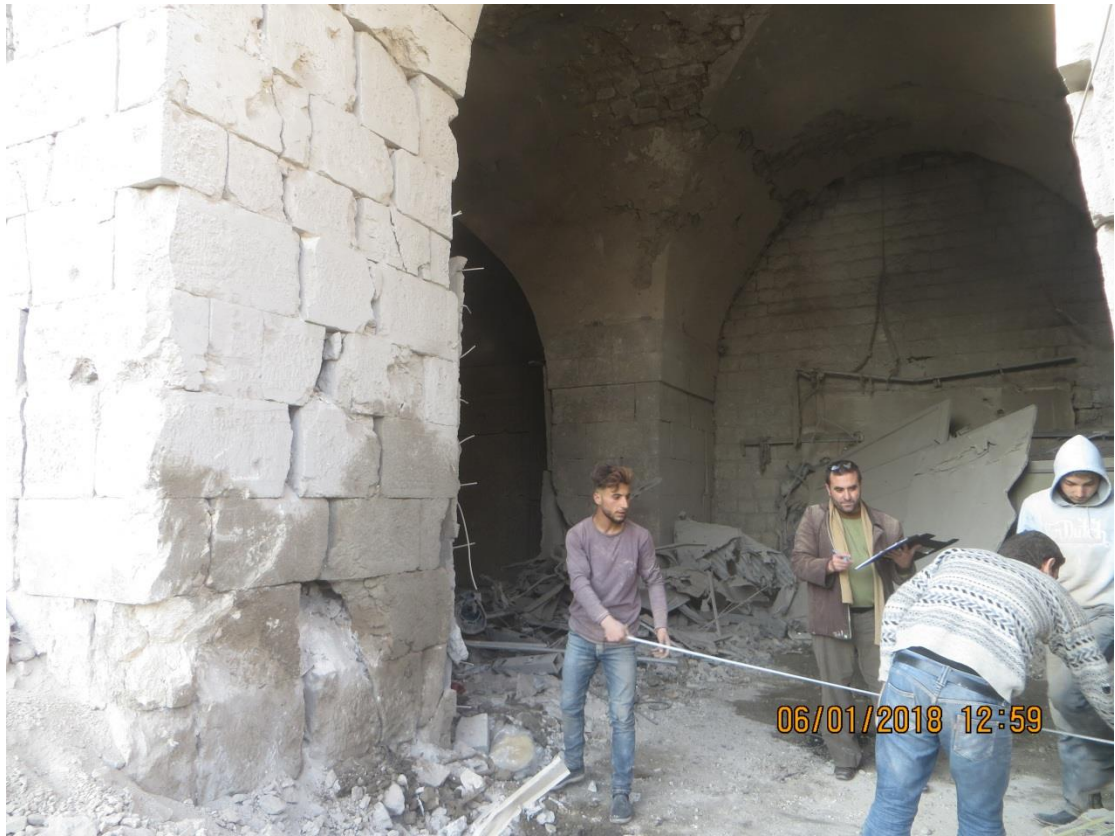
Digging out the rubble and collecting fallen masonry

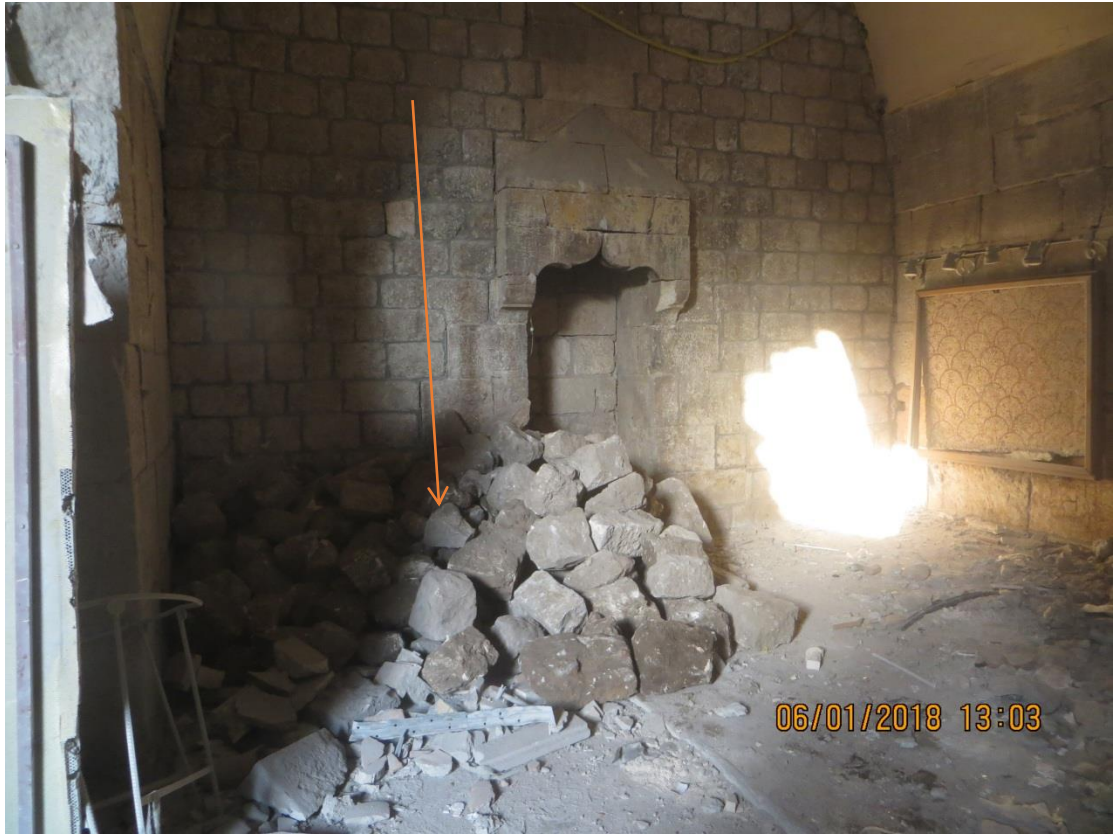
Gathering collapsed masonry

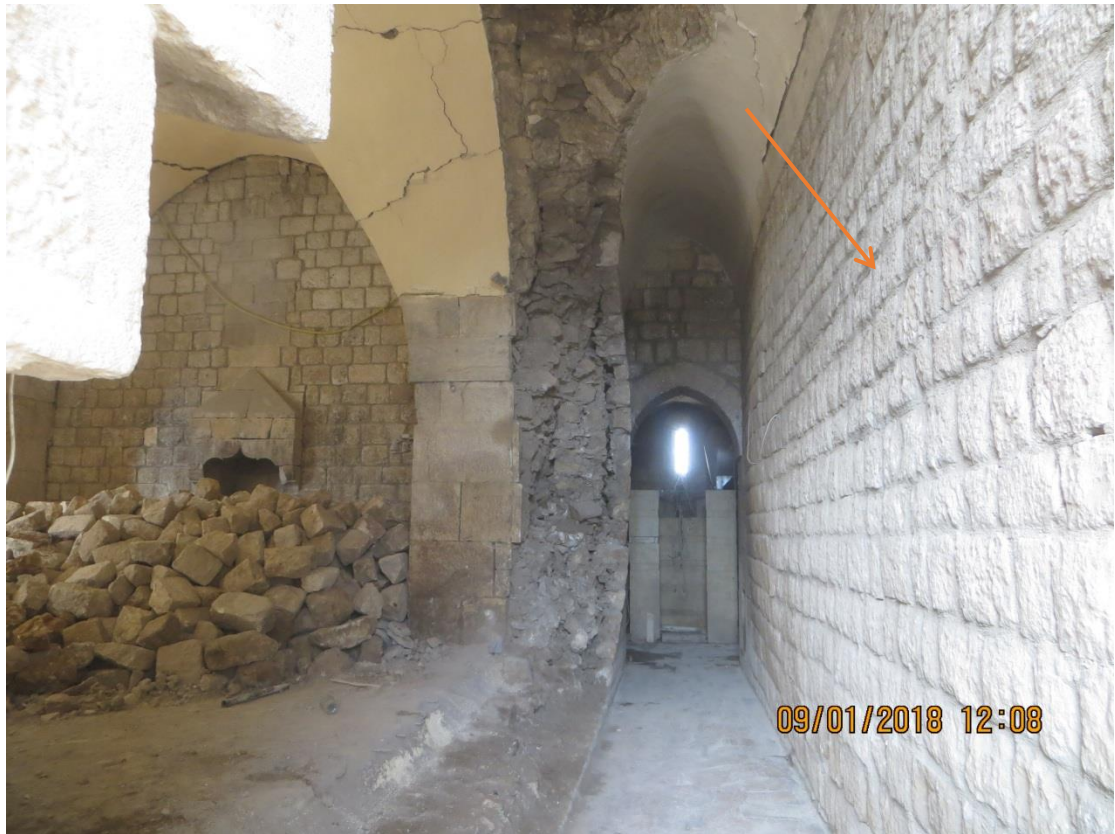
The previously dismantled wall and rebuilding was not affected by missile targeting

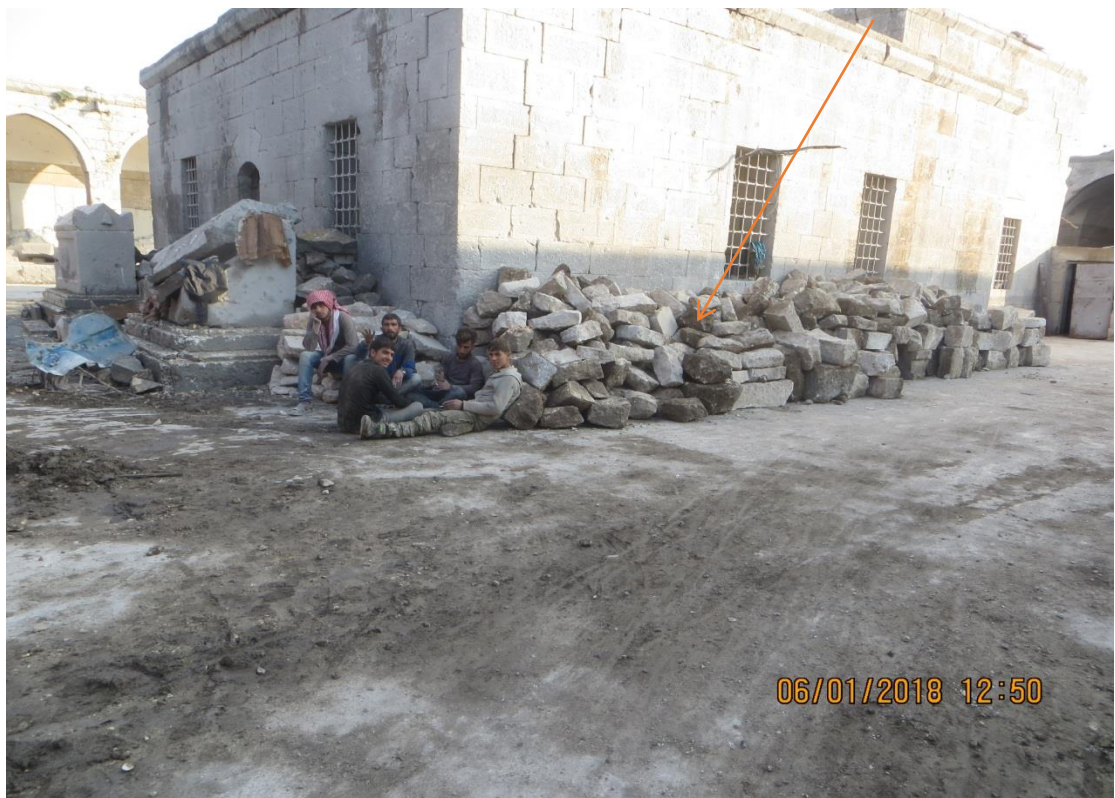
Gathering and sorting collapsed masonry

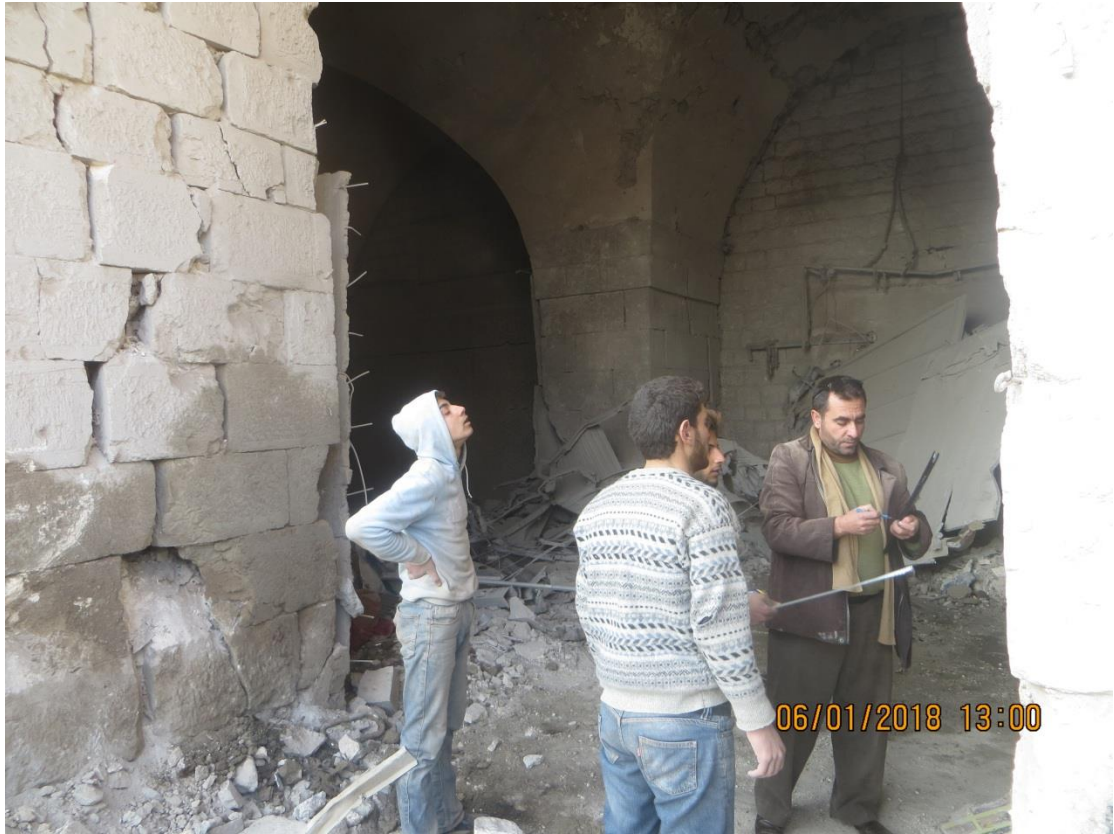
Damage assesment and taking measurements

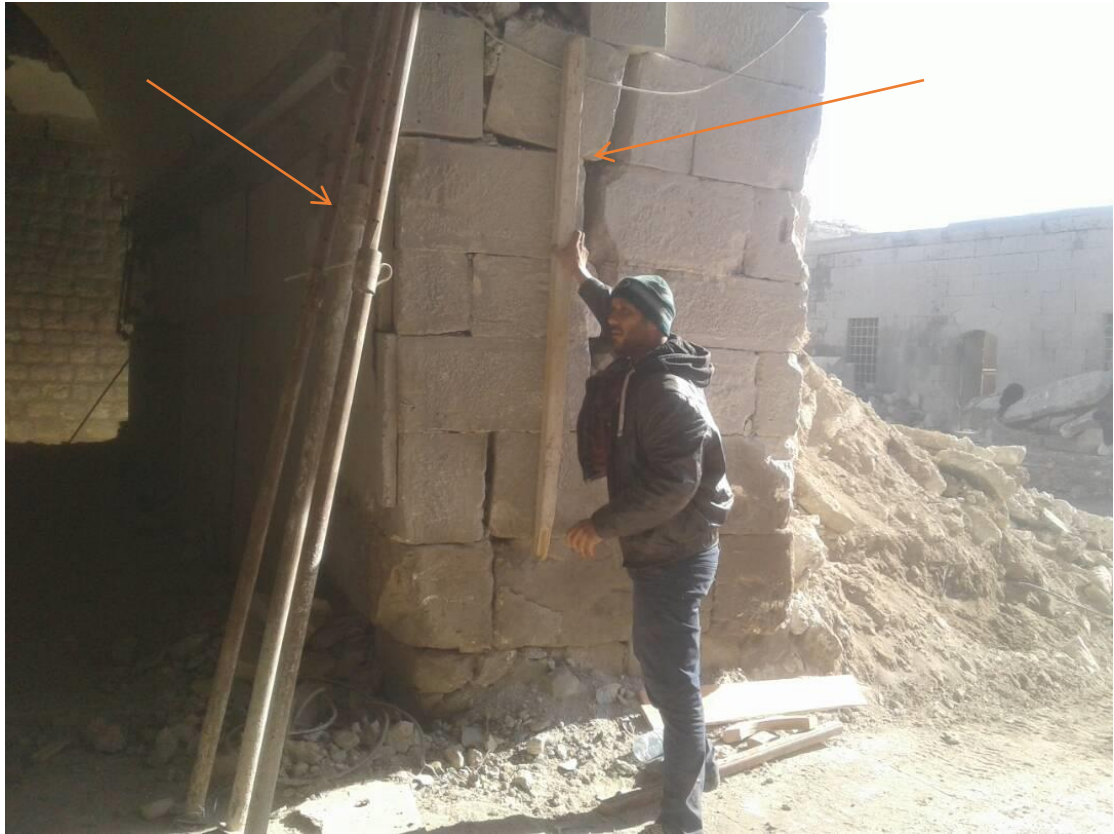
Stabilizing damaged areas using wooden beams and scaffolding

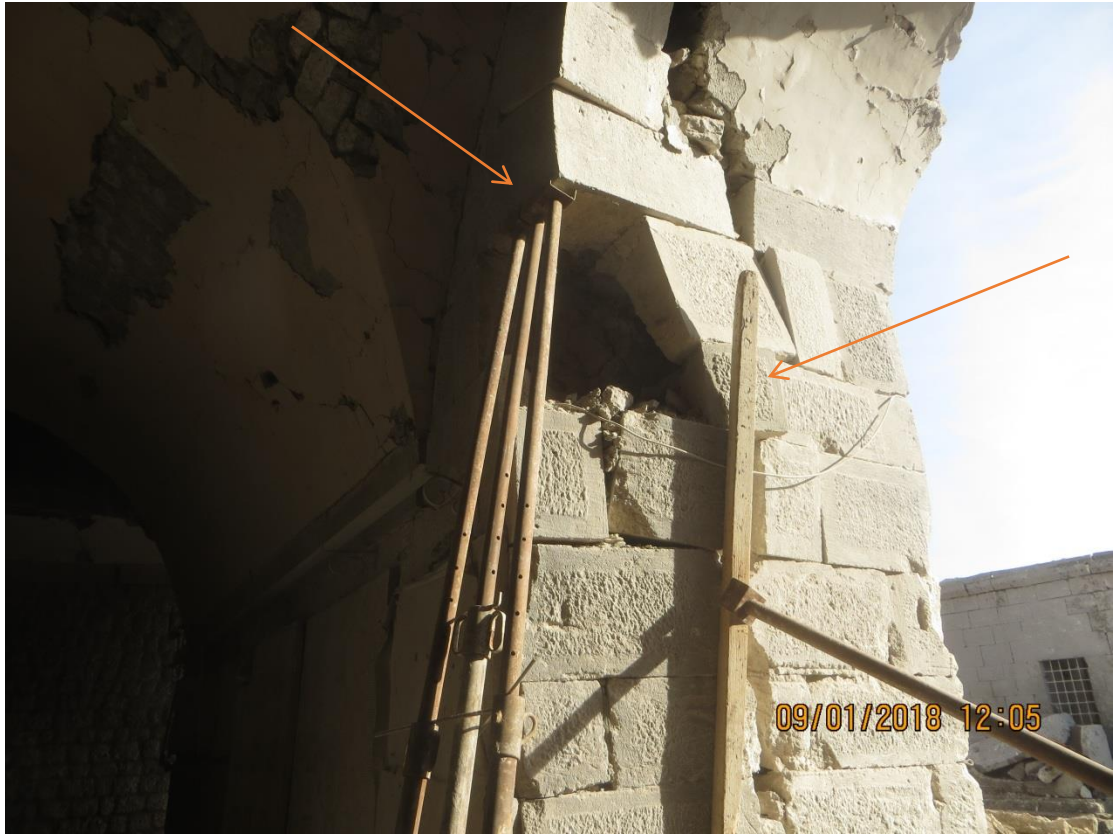
Stabilizing damaged areas using wooden beams and scaffolding

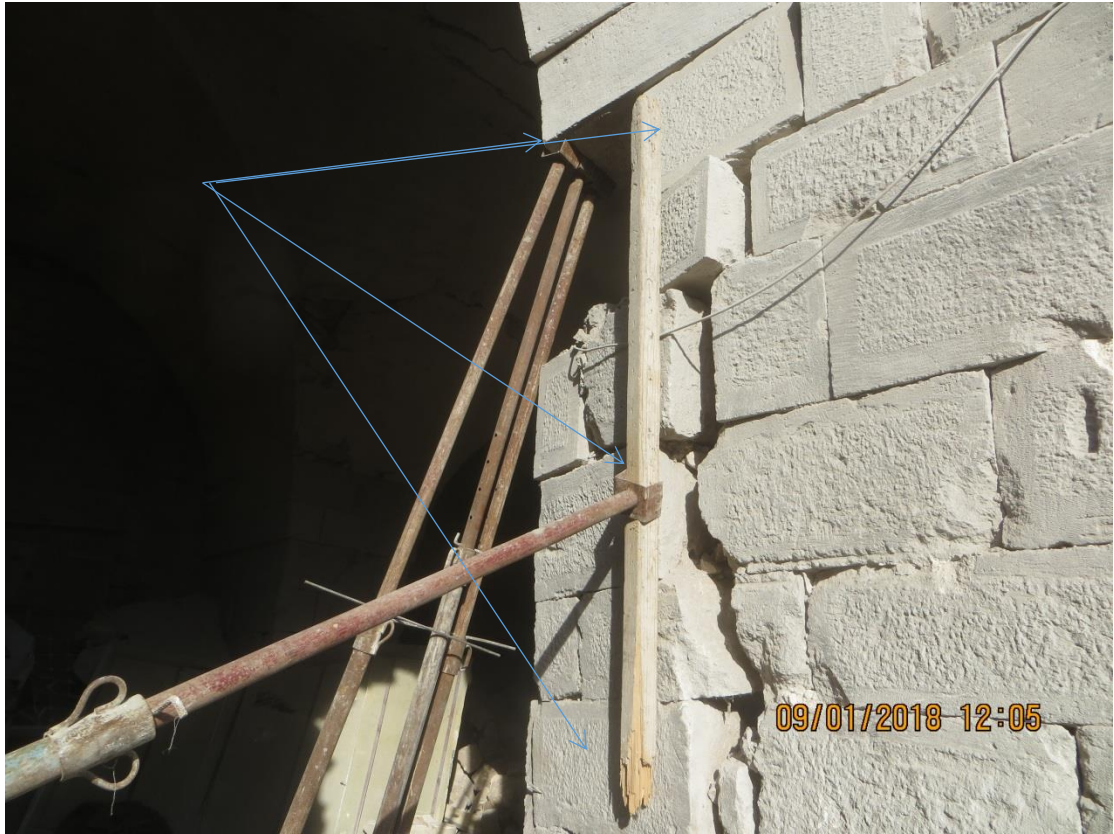
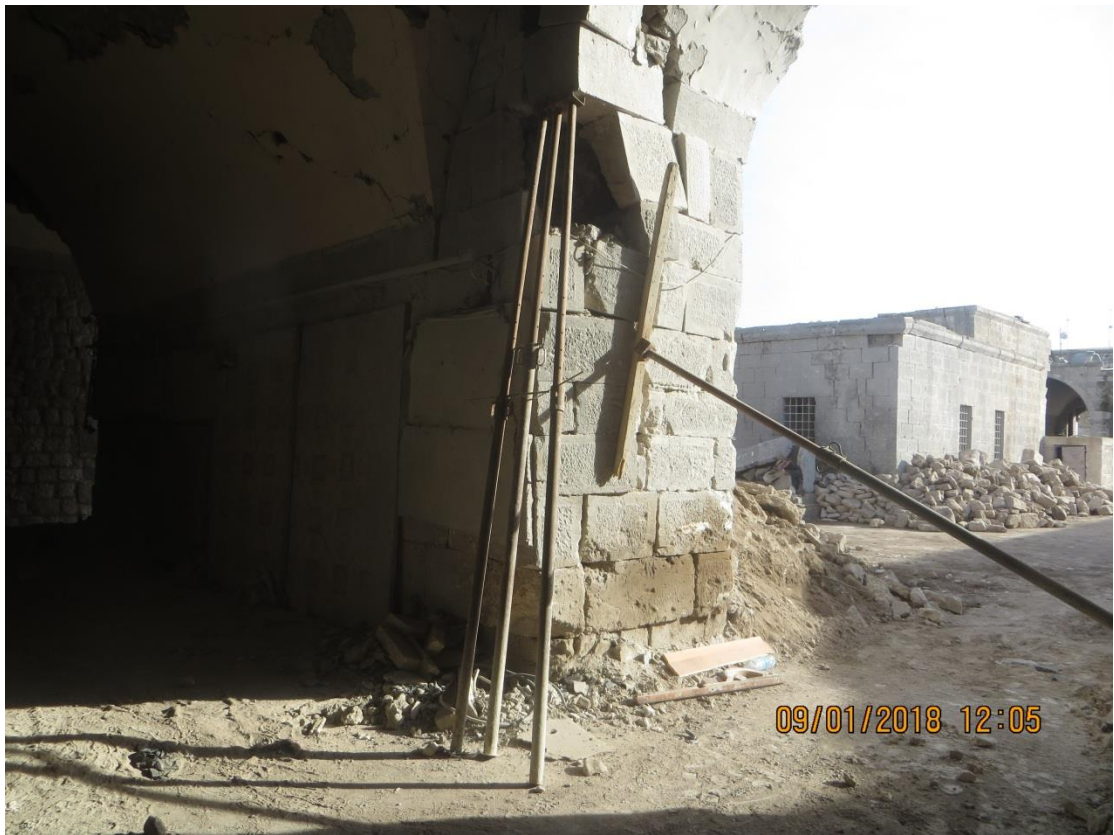
Stabilizing damaged wall area supporting arch

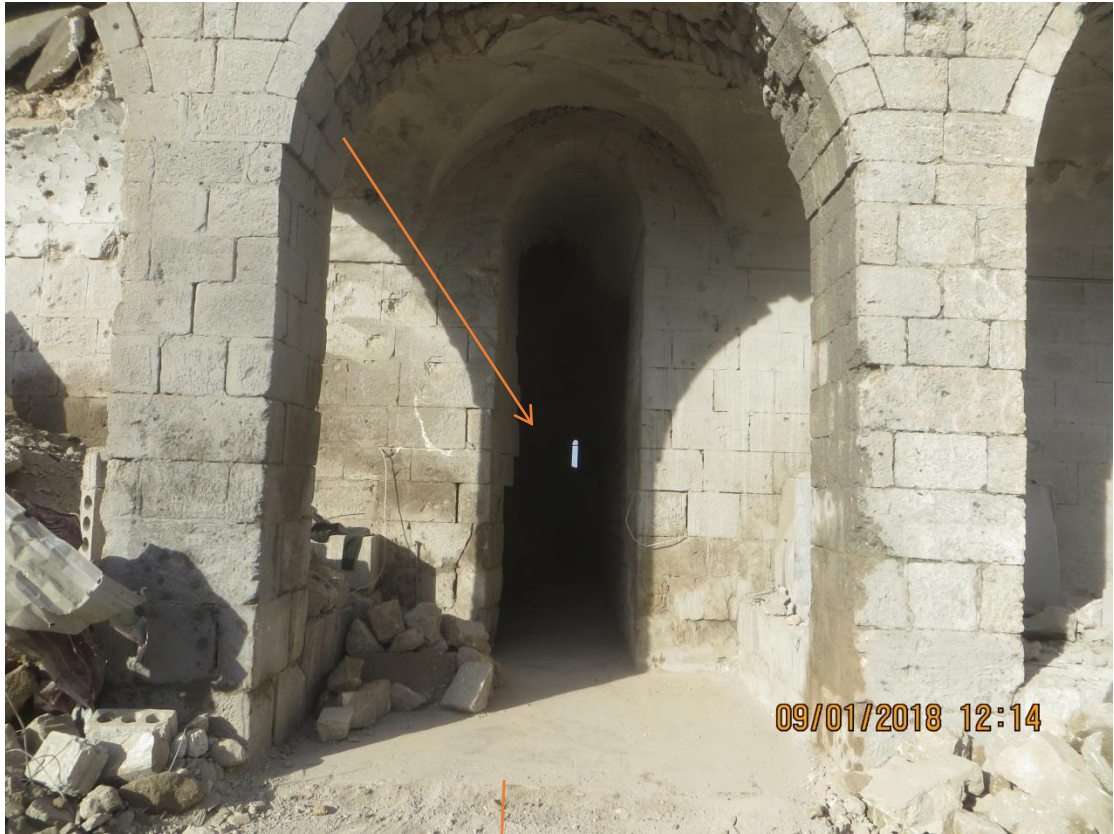
Clearing rubble from gallery entrance

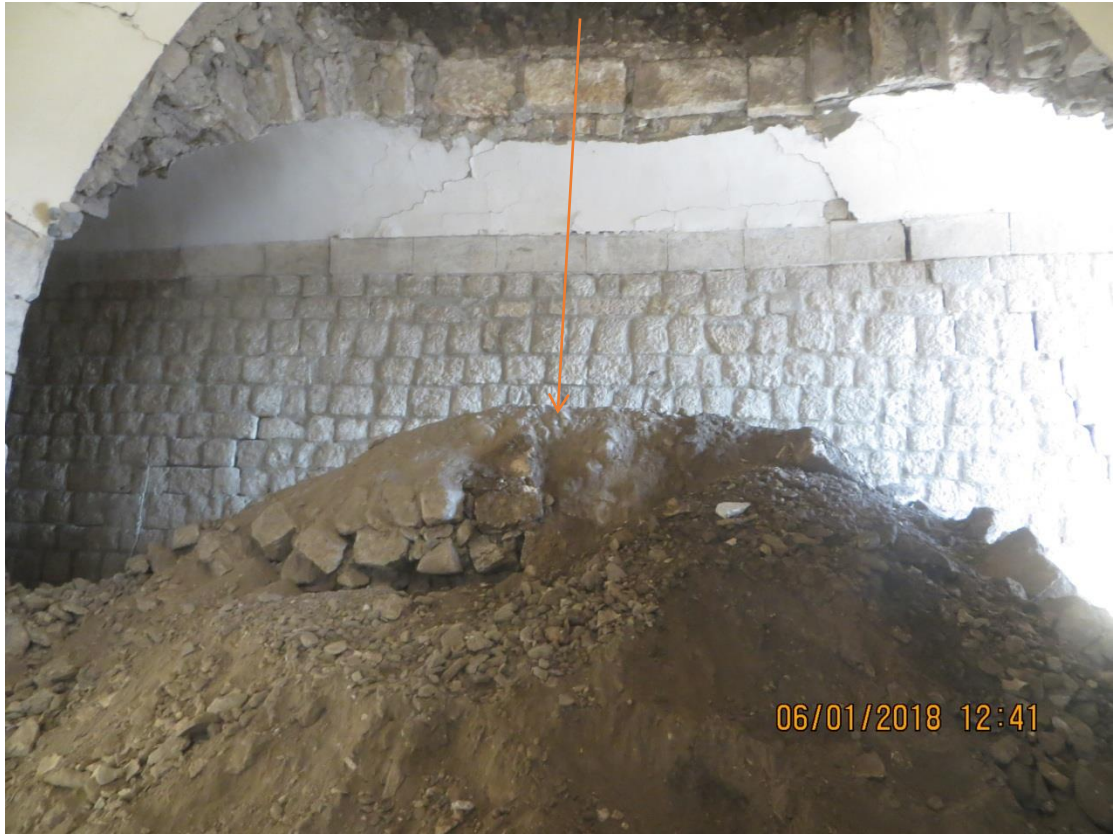
Collapsed roof rubble prior to commencement of work

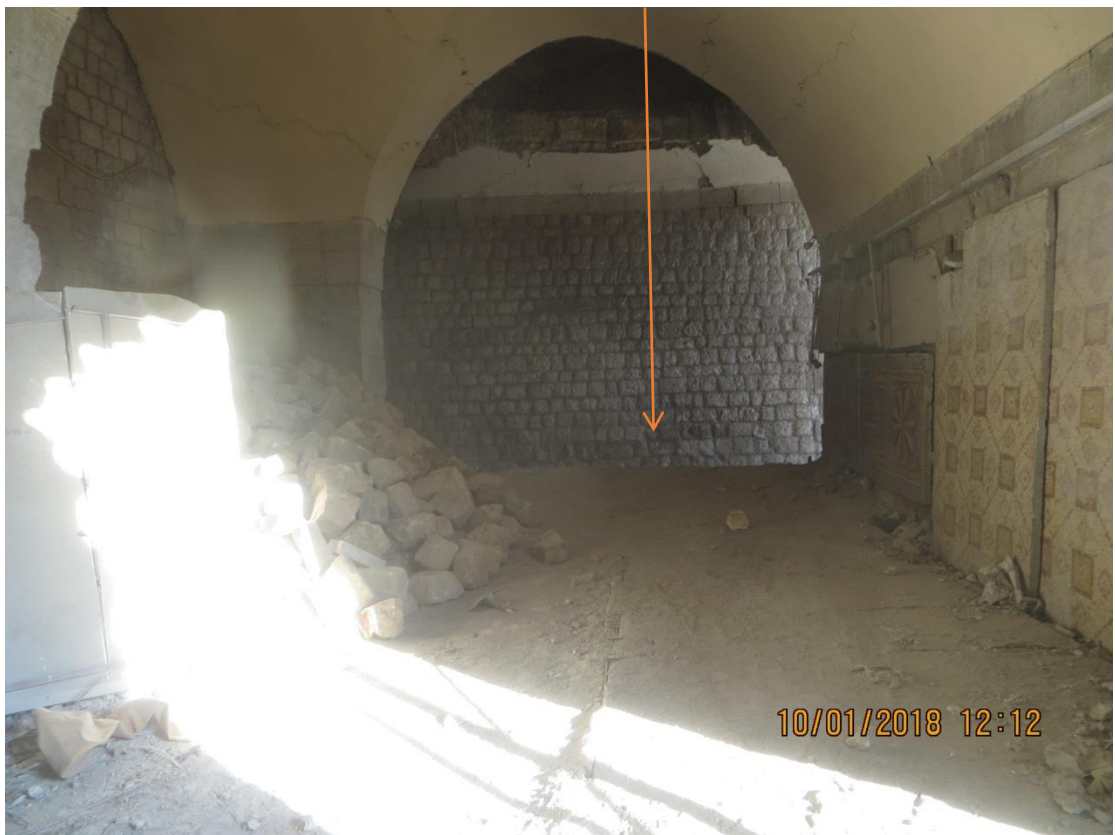
After collapsed rubble removal

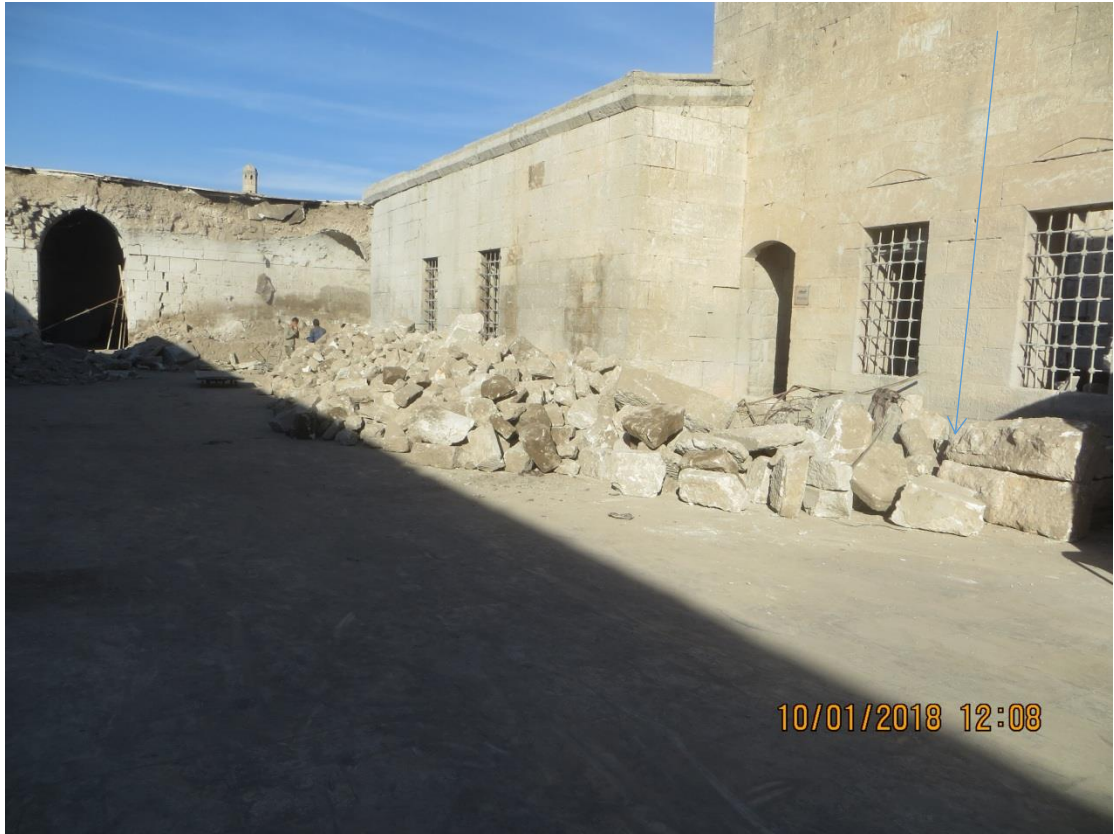
3- Partial destruction of a sarcophagus transported from an area north of Ma'arrat Al-Numan in 1982 and placed on display in the courtyard.

Collecting damaged sarcophagus pieces

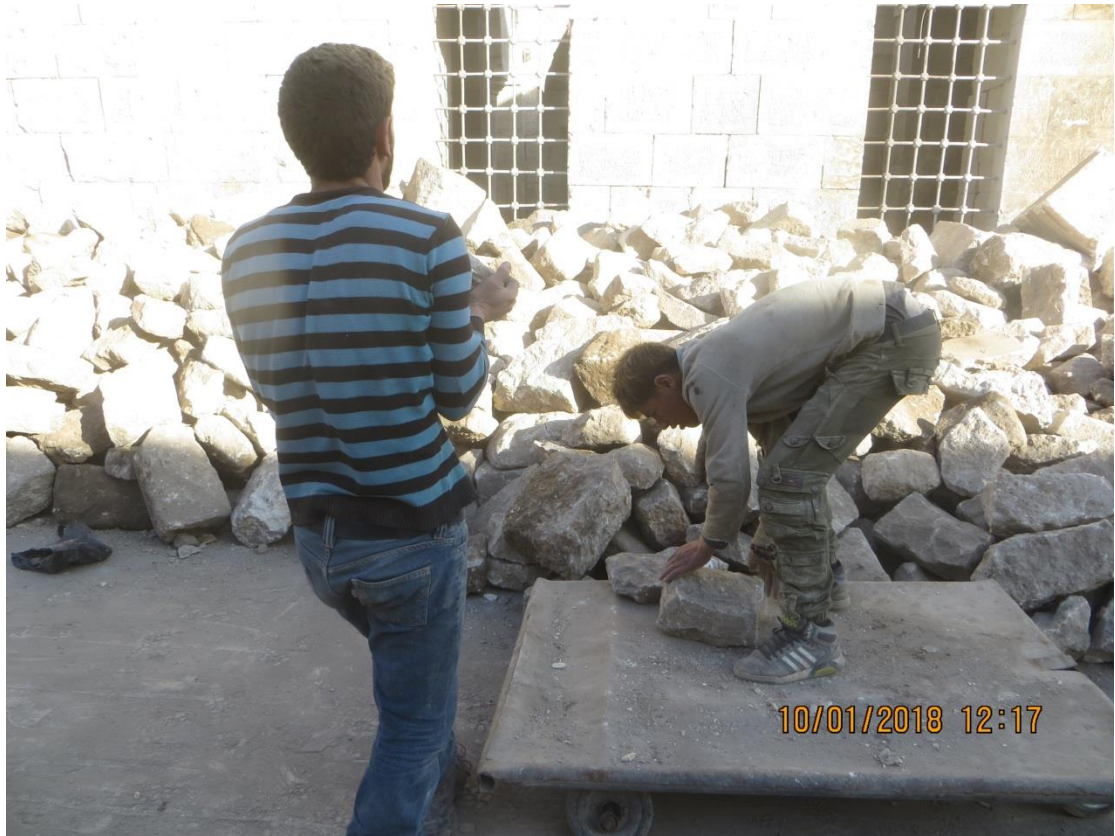
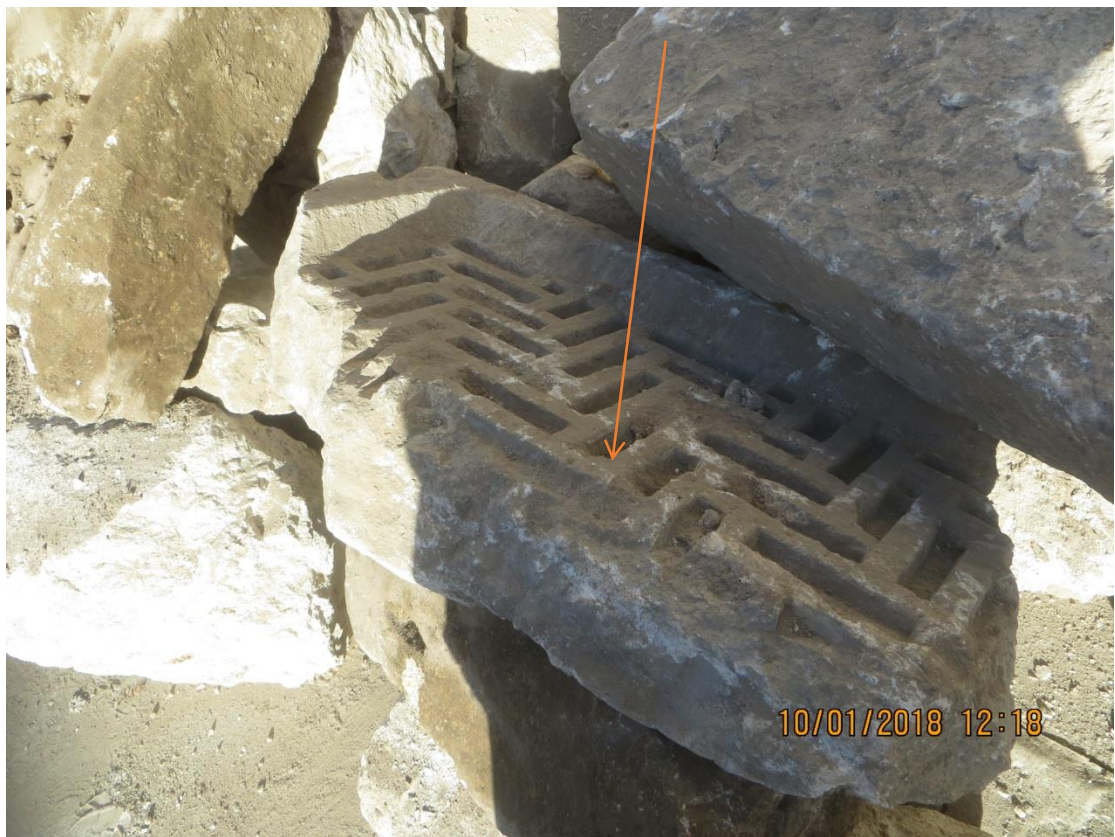
Masonry from the damaged tomb facade

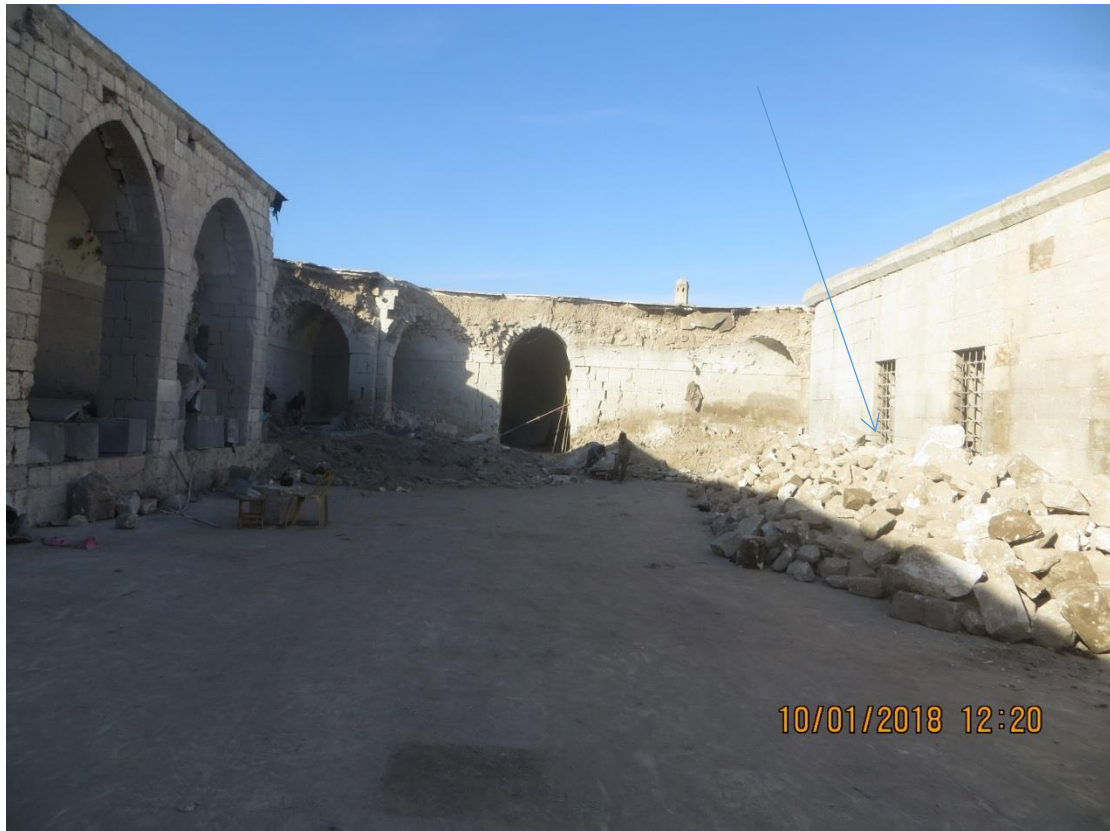
Gathered masonry from the north and west façade

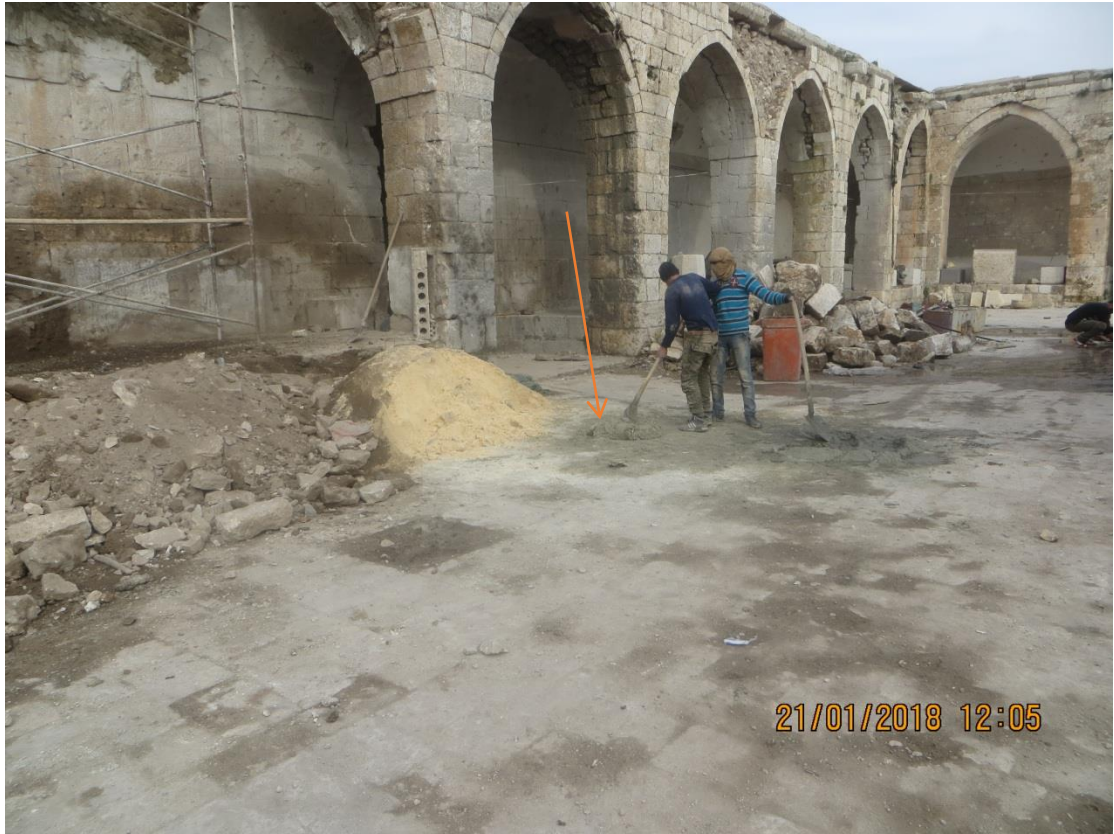
Preparing cement mix and applying it to damaged areas

After the completion of the process of sorting the masonry and rubble removal, the exposed parts of the damaged areas were covered/plastered with 350 kg / m³ grade cement to prevent the penetration of water and protect from further deterioration due to environmental conditions.

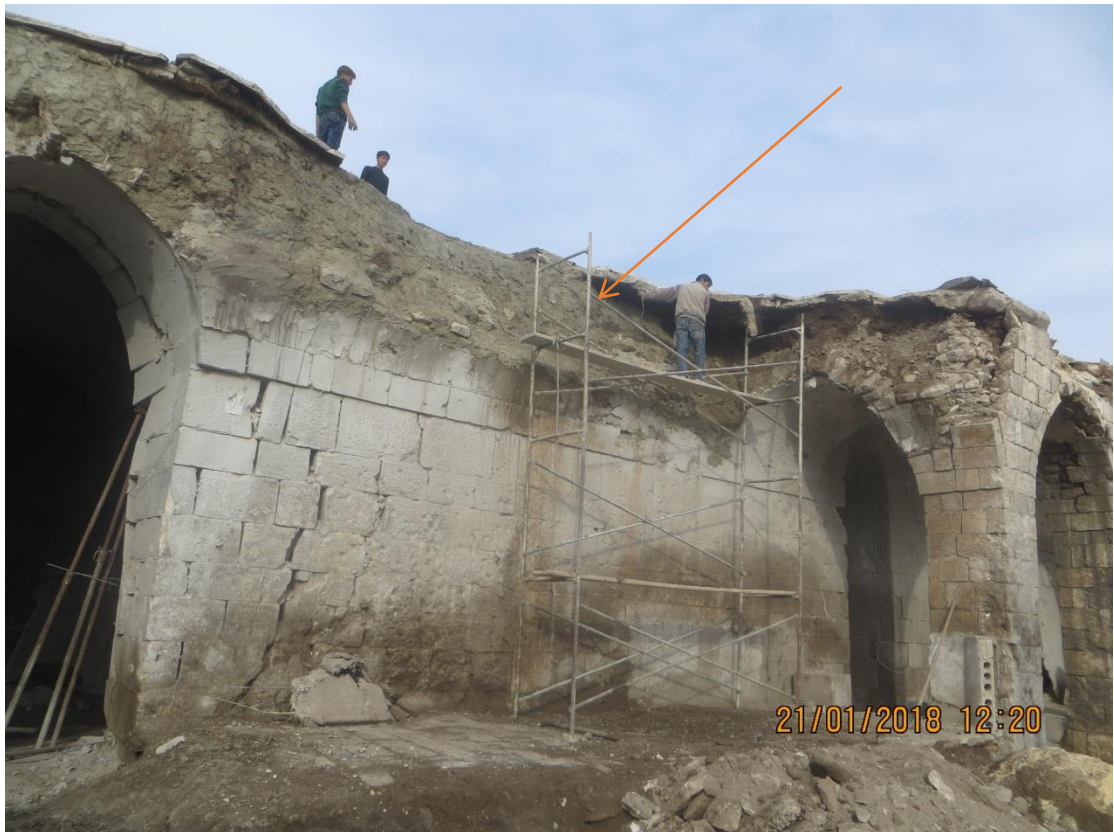
Cracks filled with 400 kg / m³ grade cement. The surface of the cracks was then plastered over and treated with acrylic to prevent water seepage.
