The Day After Heritage Protection Initiative

Site Monitors Project

Progress Report on Damage Assessment, Stabilization and Preservation Work in Ma'arra Museum Following the Third Airstrike January 2018.

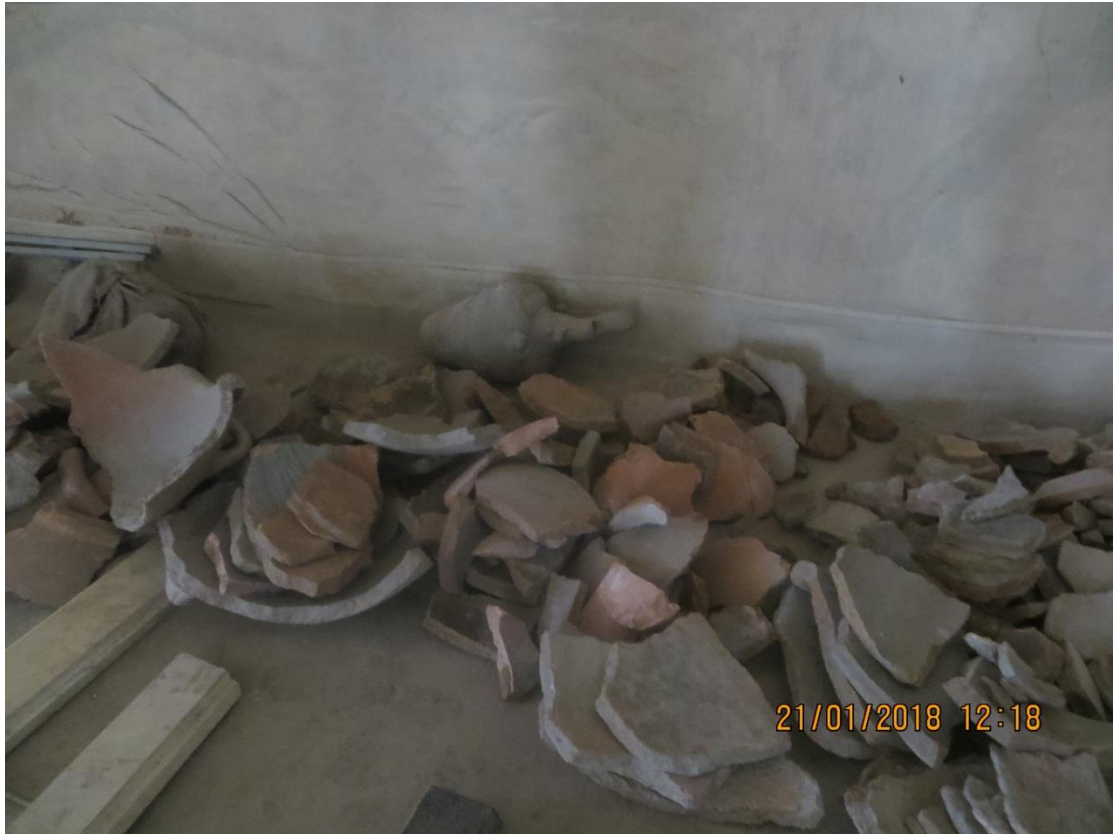
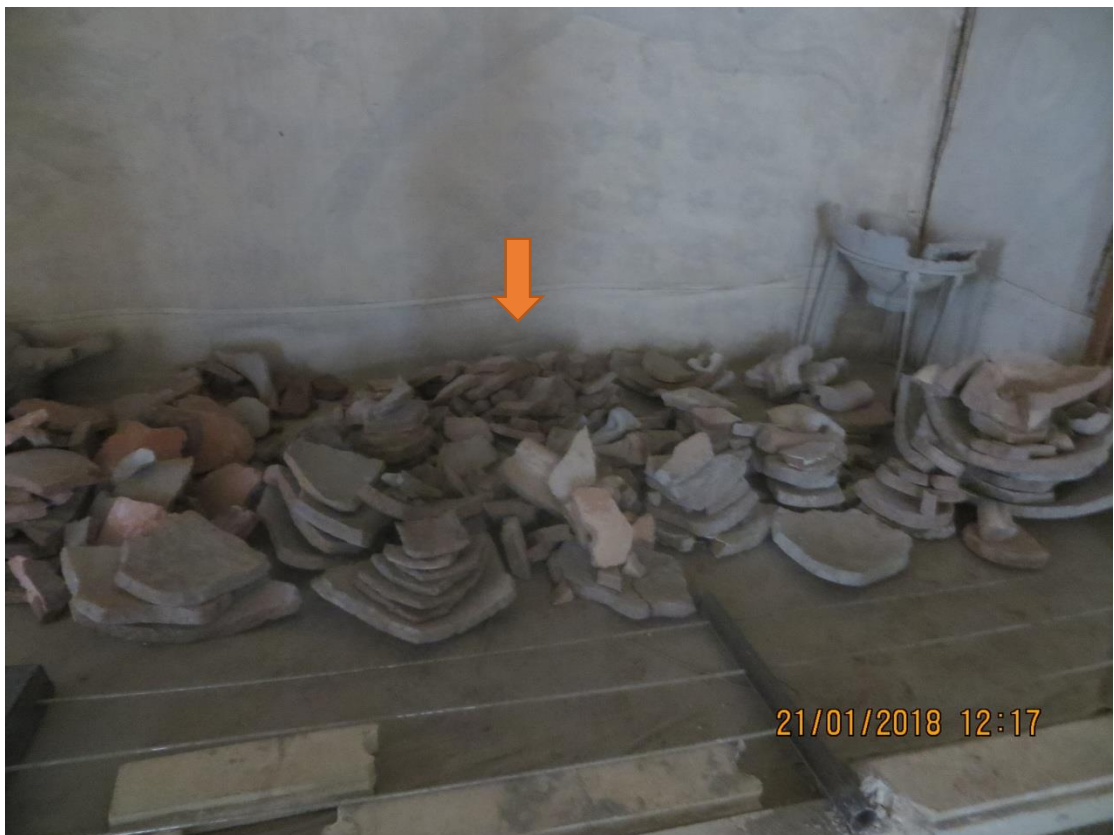
Assembling pottery fragments for later restoration

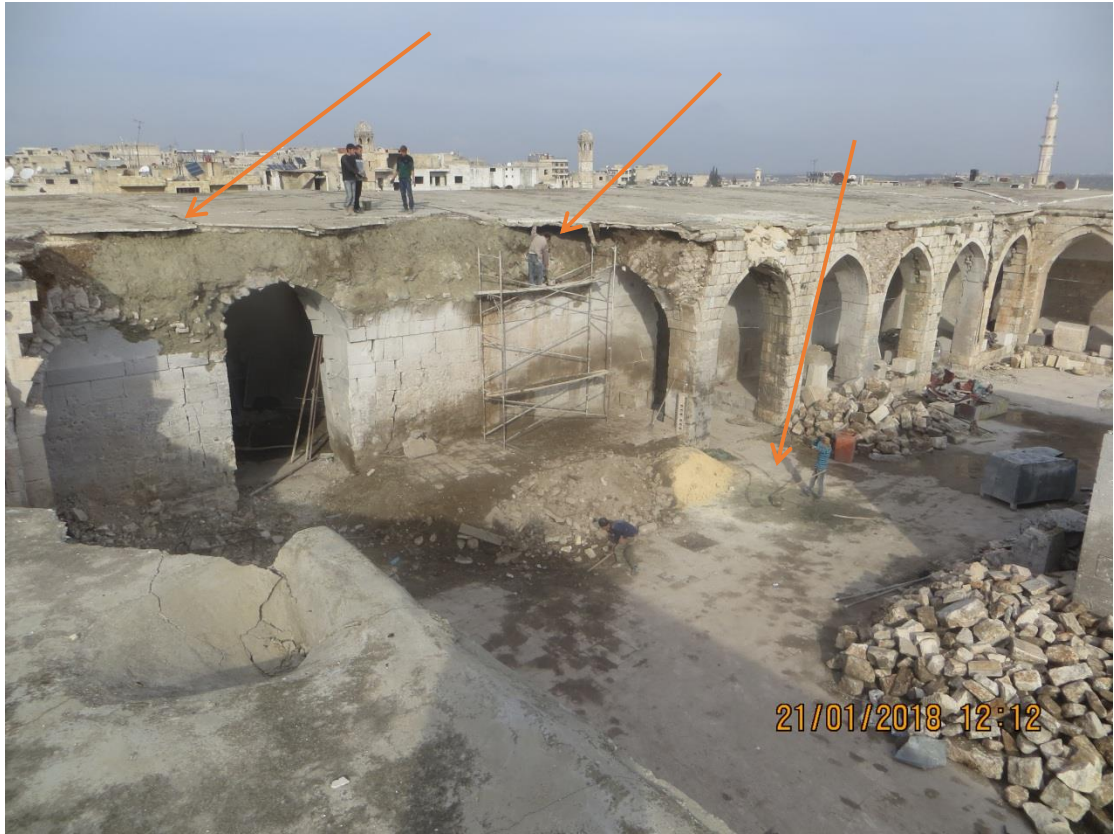
Ongoing repair to prevent deterioration of damaged areas from environmental conditions

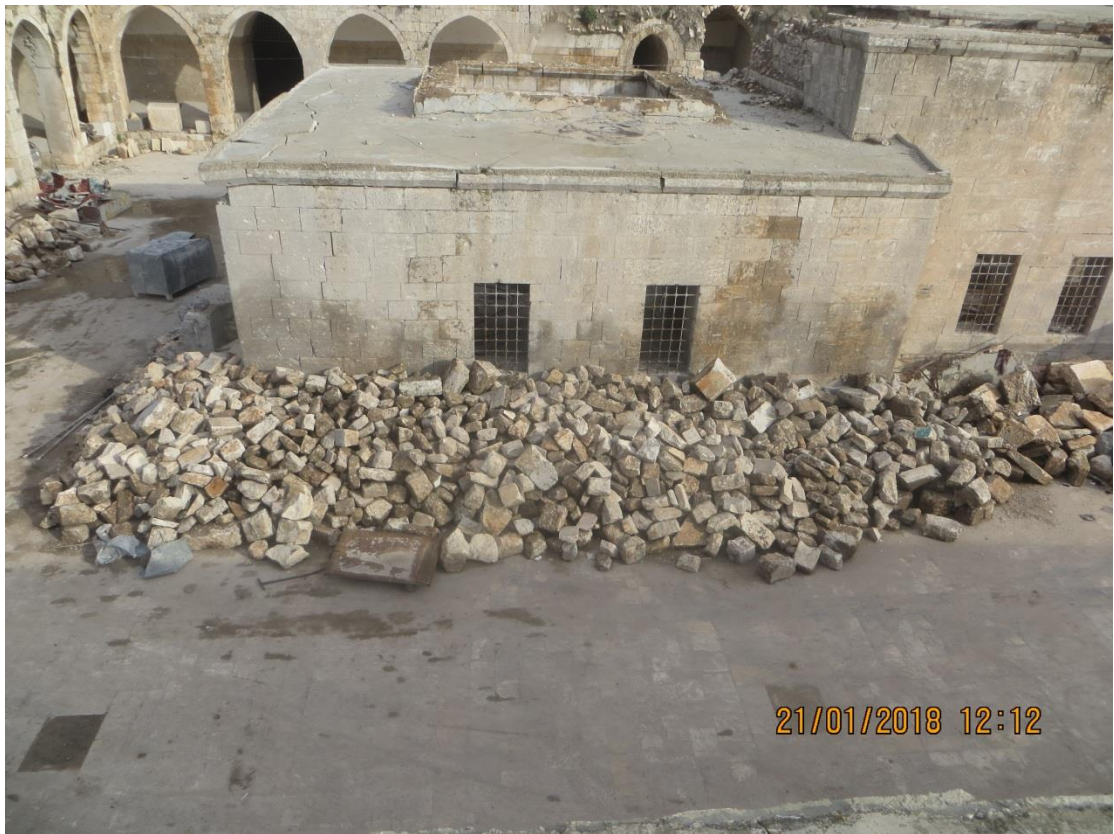
Collection of masonry after completion of sorting
