The Day After Heritage Protection Initiative

Site Monitors Project

Site Monitoring Report on

Ma'arrat Al-Nu'man Castle

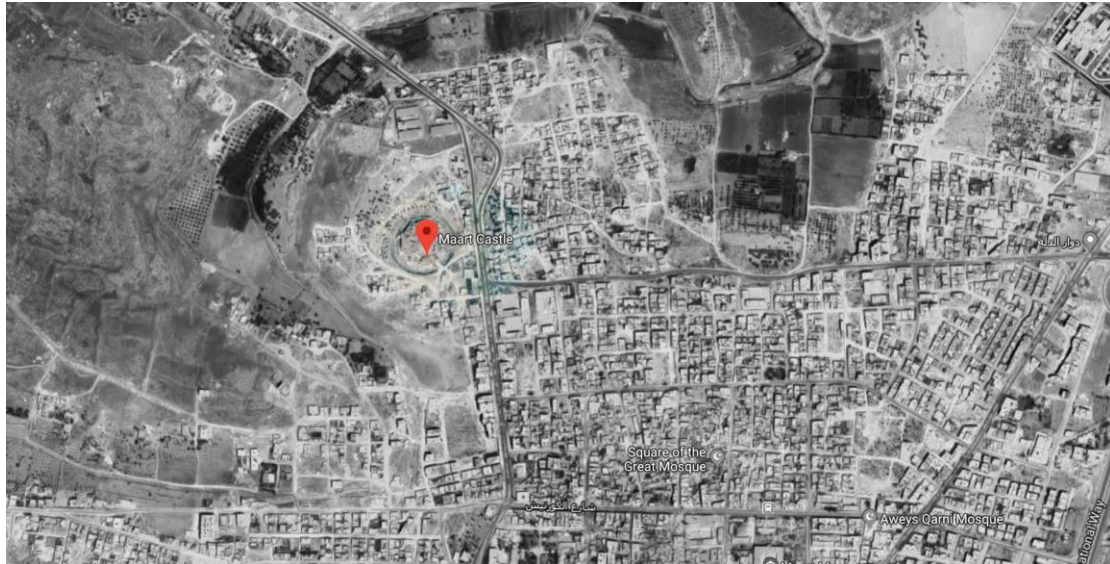
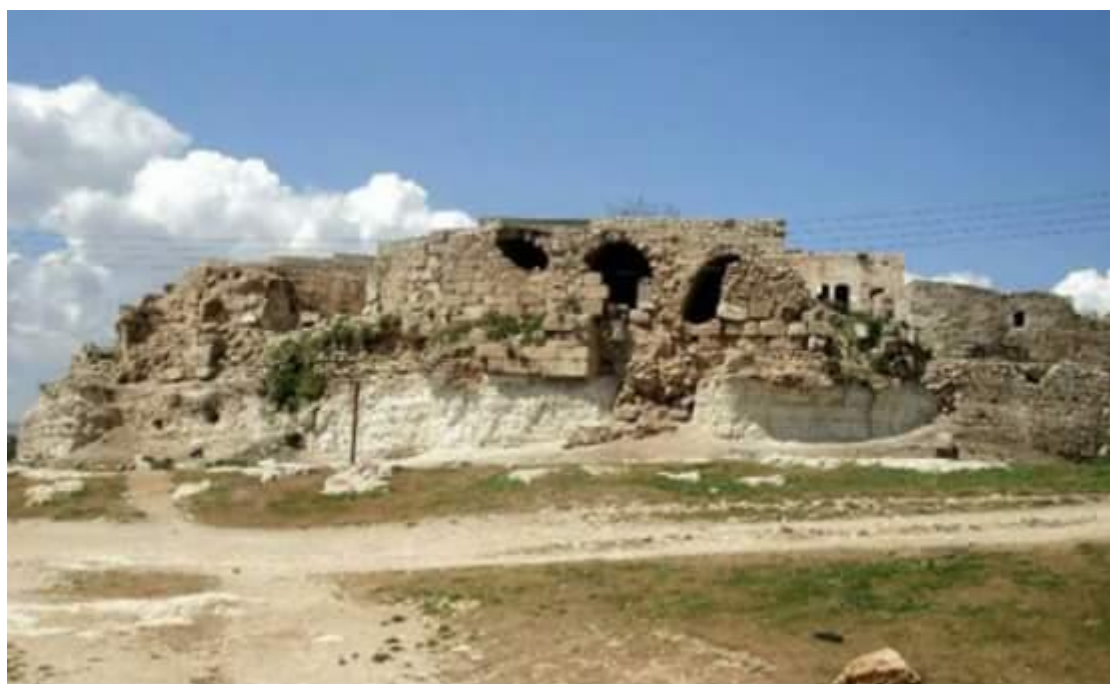
The castle sits on an area of 2500 m² surrounded by the seasonal Hermas river from the north, west, and south. The main entrance to the

castle used to be on the south side through a wooden draw bridge supported by a pillar in the middle of the moat. That part of the moat has since been filled and the southern entrance replaced with a secondary one to the southeast.

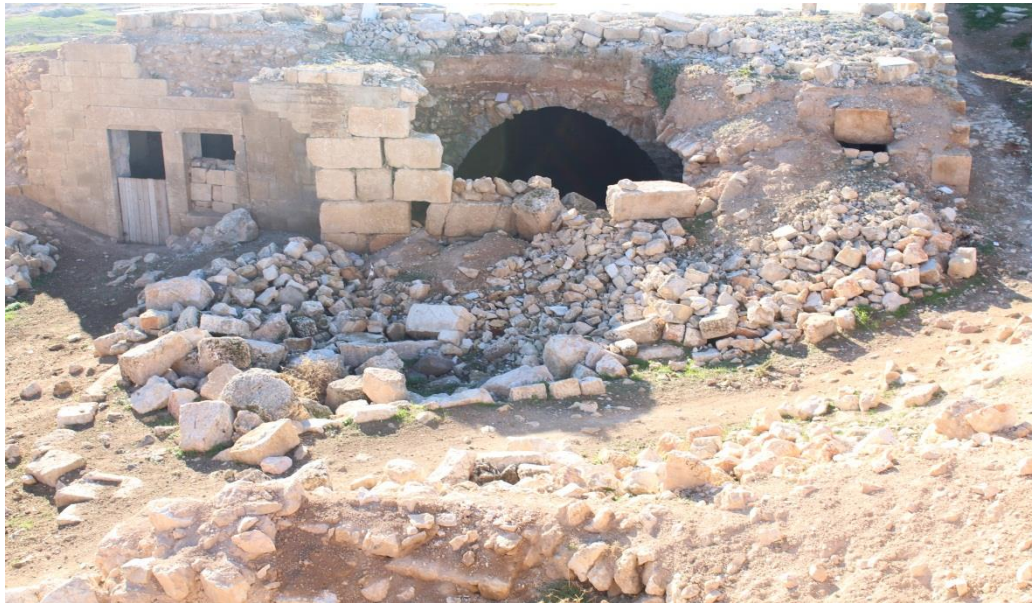
The growth and development of the city of Ma'arra made the castle a part of the town. Locals built their homes on its grounds and took residence in it. Though the eastern section has since been mostly evacuated, a number of families still reside in the castle. Most of the abandoned homes within the perimeter of the castle are currently used as barns for housing animals. This is a cause for concern due to poor sanitation and source for disease.

Additionally, the residents further damaged the castle by removing stones from the moat/trench and building unauthorized sewage lines which caused salt and waste water to seep underneath the castle walls. The castle moat/trench is also used as a dumping site for trash and manure.

The castle has been subject to deliberate and systematic shelling by the Syrian regime through artillery and the airstrikes, compounding the damage already caused by looters and their illicit digging.

The Syrian Heritage Center and TDA-HPI, continue to document damage to this historical structure and attempt to limit vandalism and illicit

digging activity when possible. We also in contact with the local community to raise awareness on the importance of the castle and its significance to the tourism and economic sectors.
