The Day After Heritage Protection Initiative

Site Monitors Project

Damage Report Ma'arra Museum Regime Airstrike May 9, 2016.

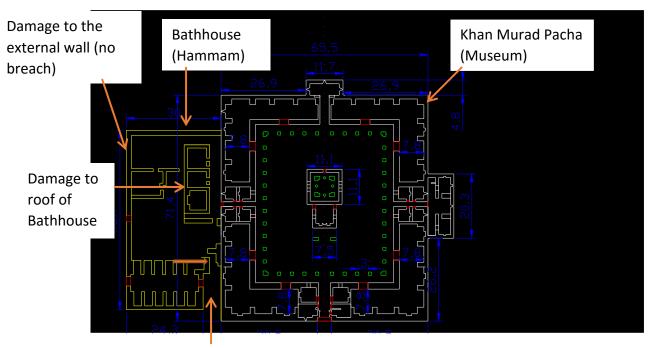
Narrow corridor/between Bathouse and Khan (Museum). Damage cause

a breach/opening in the external wall of the museum.

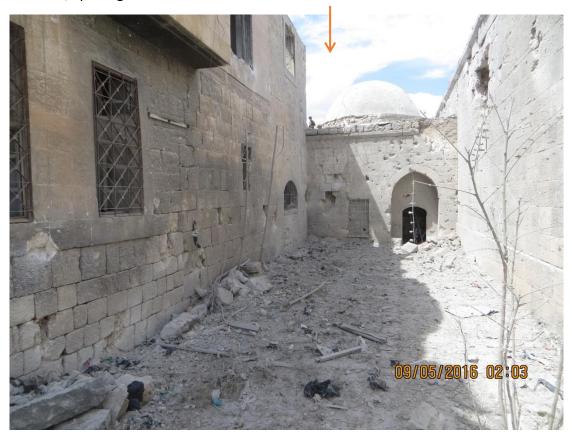
Damage causing a breach in the wall (inside)

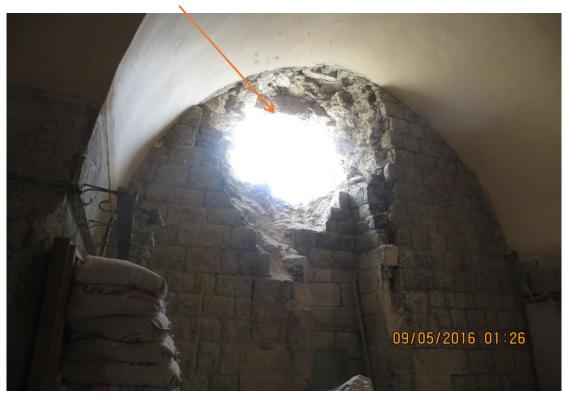
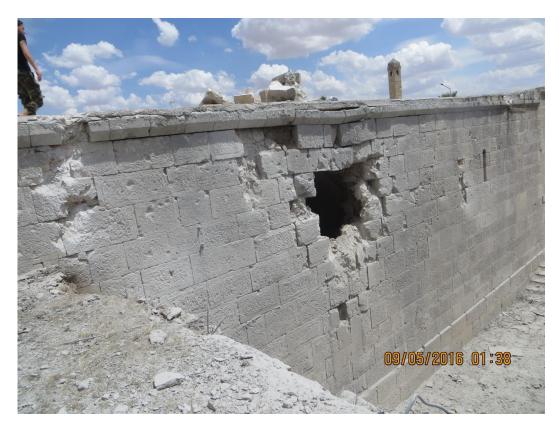
Damage causing a breach in the wall (outside)

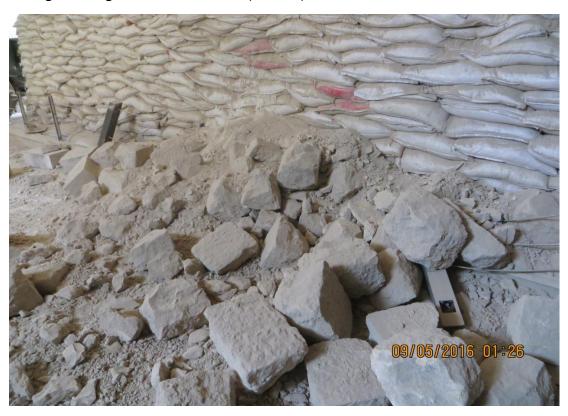
- 1- A breach in the western wall of the building in the fourth wing. The resulting rubble landed inside on the mosaics that the TDA Site Monitors team had previously sandbagged for protection. This measure was effective in preserving the mosaics, the most important of which is that of "Hercules".
- 2- Damage to the northwestern wall separating the Khan/museum from the bathhouse, which caused part of the exterior wall to collapse into the narrow corridor separating the two buildings.
- 3- The bathhouse roof including the dome and cupolas sustained severe damages.

Rubble collapse over the mosaic of Hercules. The mosaic appears to be undamaged due to the protection provided by the sandbags.

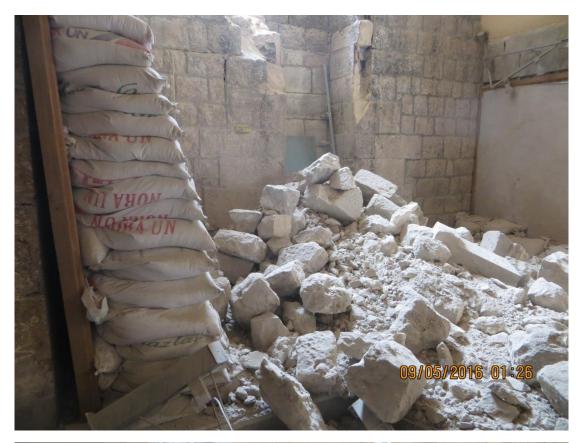
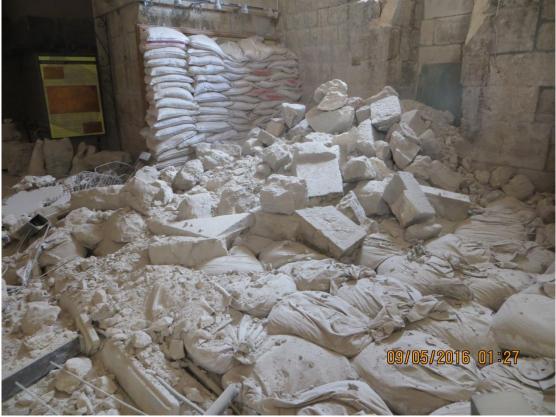
Rubble collapse over mosaic

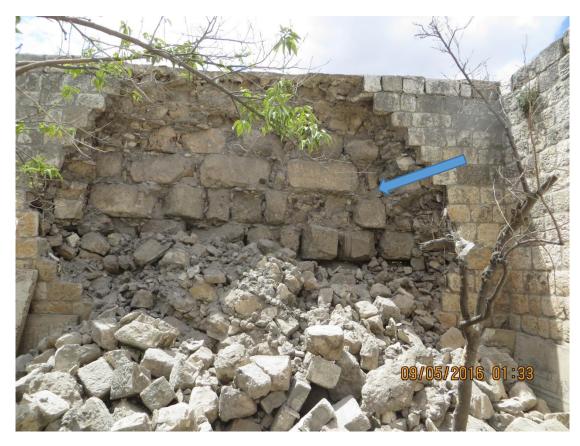
Damage to external wall (see plan above)

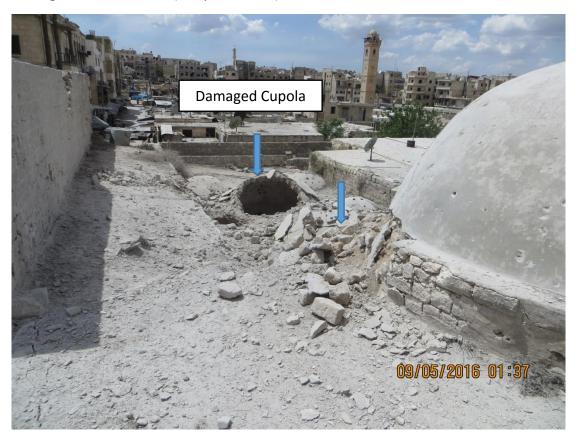
Roof of the Bathhouse (Hammam)

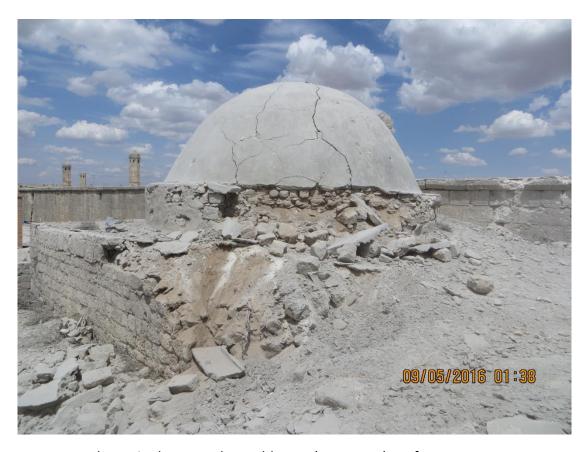
Damage to the main dome on the Bathhouse (Hammam) roof
