## The Day After Heritage Protection Initiative

### Site Monitors Project

#### Damage Report Khan Asa'ad Pasha Regime Airstrike

July 2015

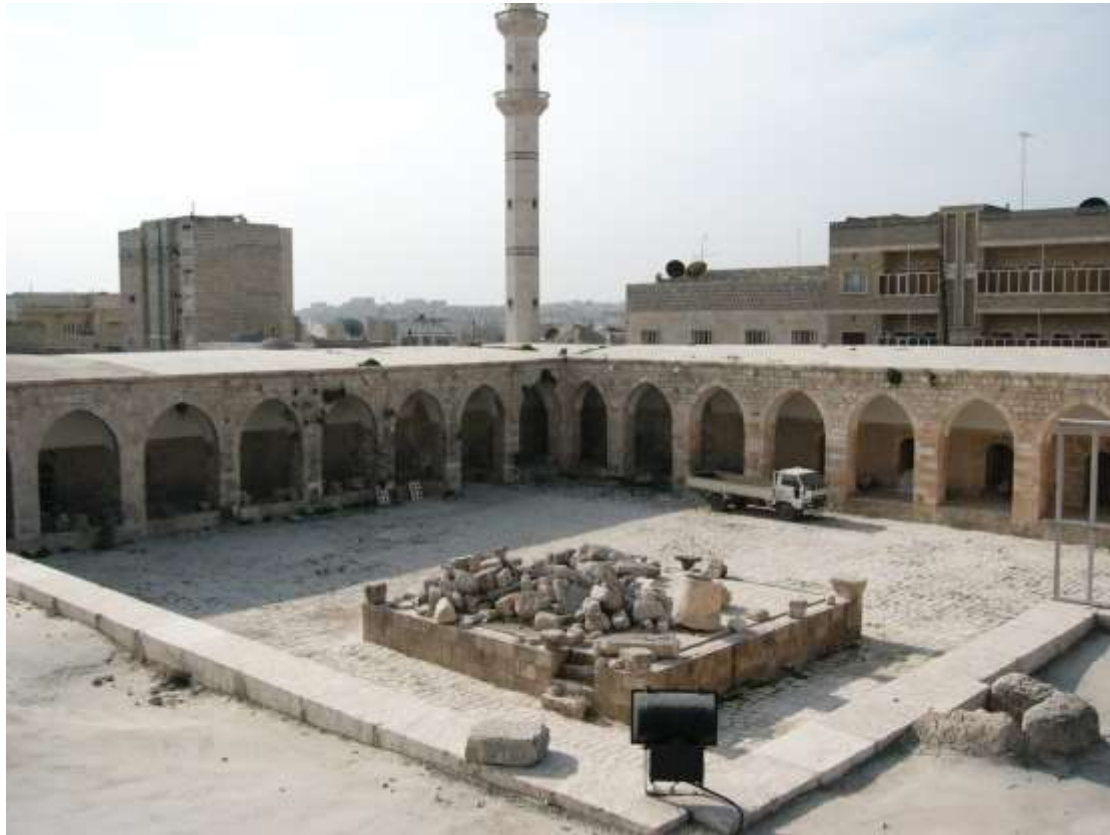
As a result of the military operations by Syrian regime forces in the city of Ma'arra between 12/27/2012 and 6/ 27/2013, Khan Assa'ad Pacha suffered extensive damage. During that time period, an airstrike by the Syrian regime led to the partial destruction of the roof and the arches holding it up as shown in the photos. The room below the damaged roof had been used to house and operate a medical CT scanner.

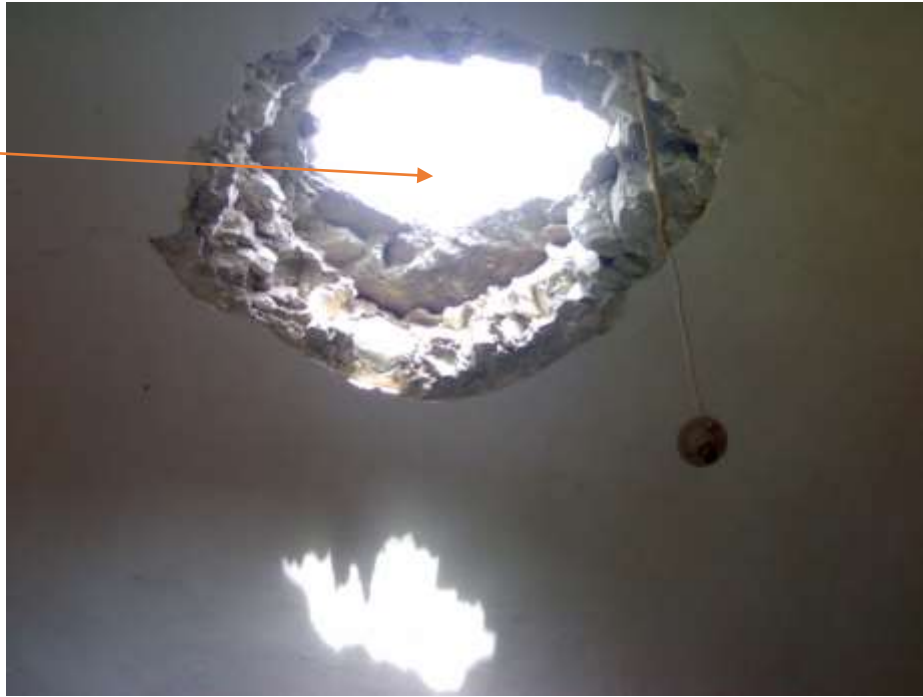
The heaviest and most destructive damage to Khan Asa'ad Pasha was caused by the latest airstrike on 8/7/2015. A large section of the second floor (the lobby) and a portion of the rooms in the western side of the building mostly collapsed as a result of this attack. The lobby on the second floor has two restored mosaics mounted on *Aerolam* boards that are now partially buried in the rubble. Both are in need of emergency extraction from the rubble and stabilization/repair (see images below).
