The Day After Heritage Protection Initiative

Site Monitors Project

Site Monitoring Report: Roman Water Spring

13 March 2018

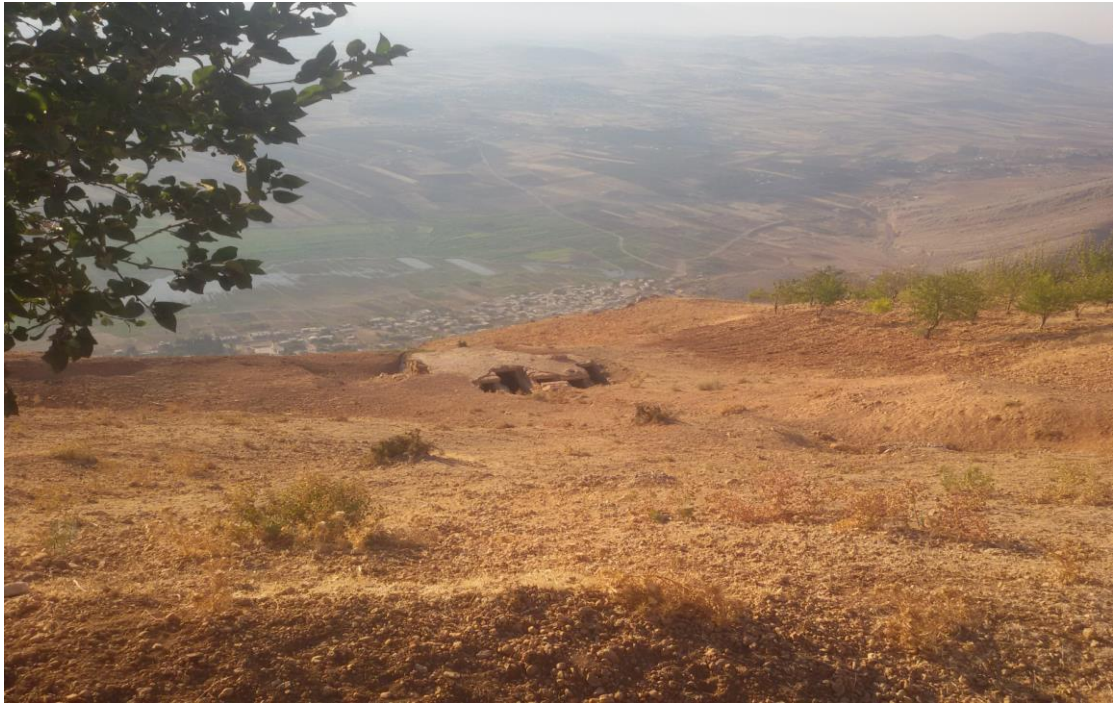
There is illicit digging around the spring and its ruins

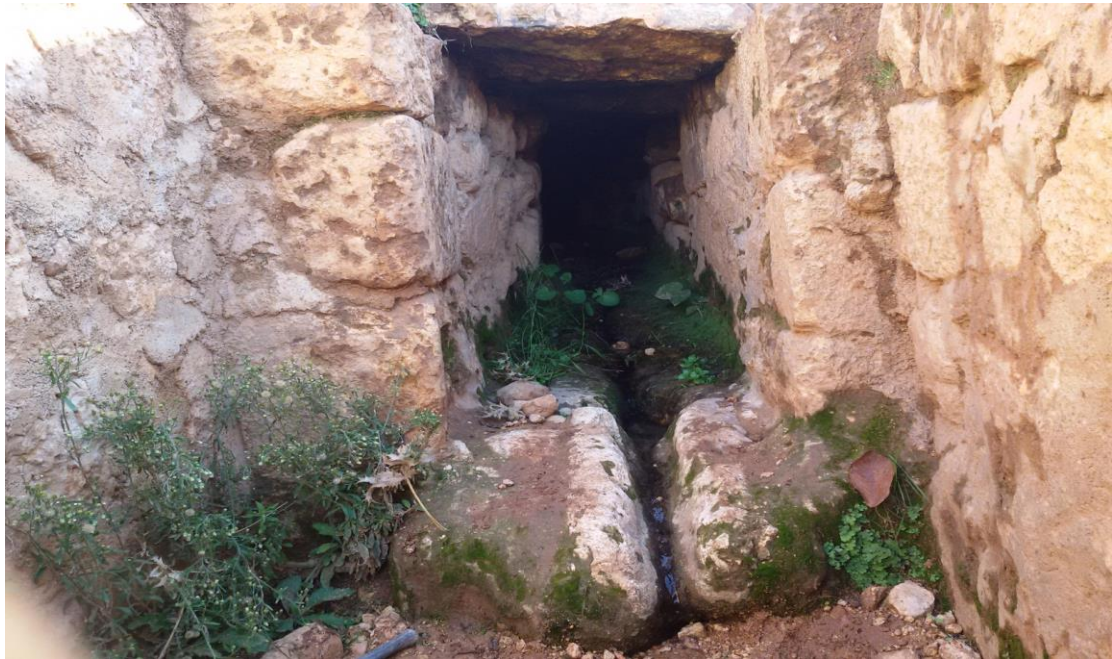
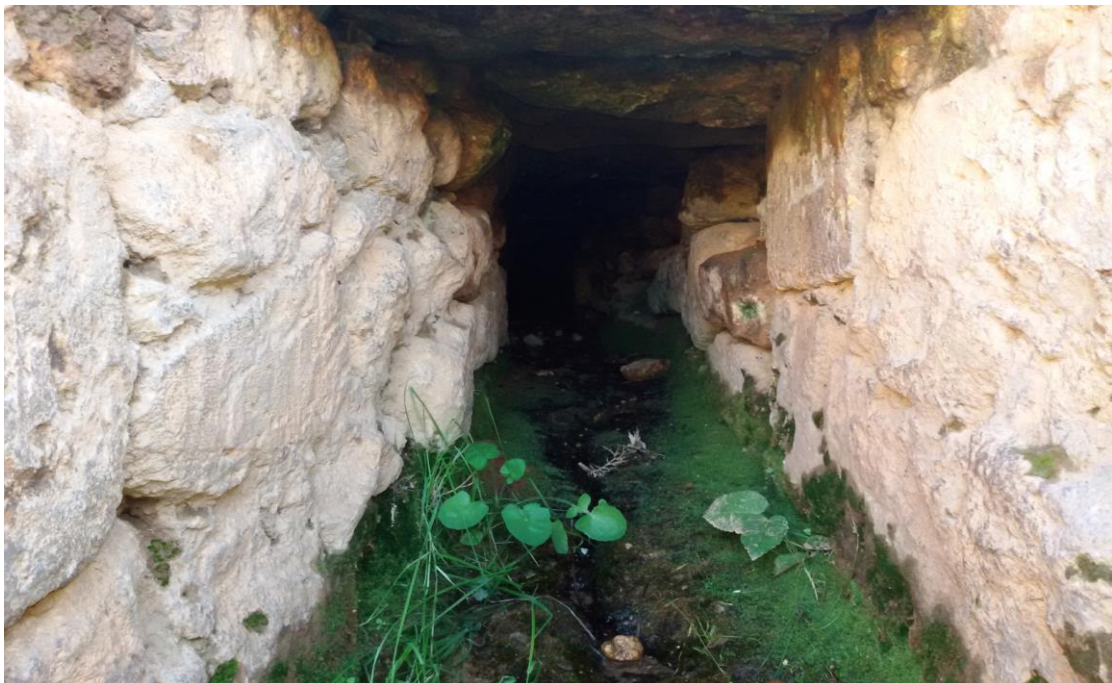
The spring dates back to the Roman period and is comprised of a network of underground channels that all connect/meet into one channel at the point of delivery.

Grass and waste obstructing the main channel

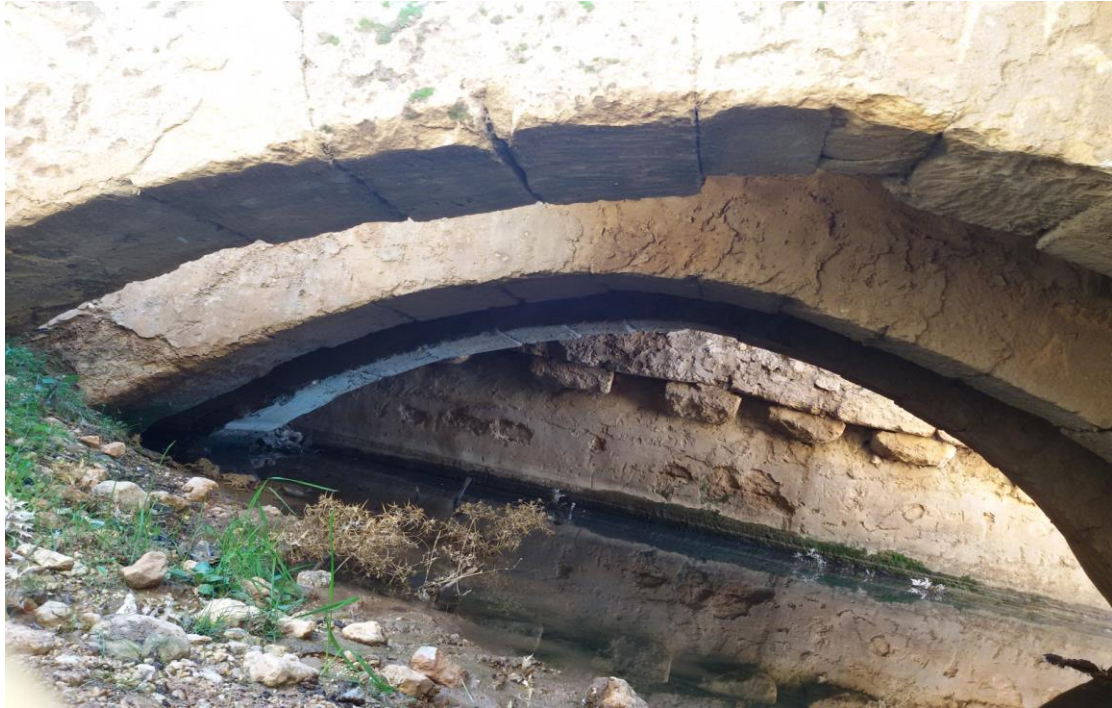
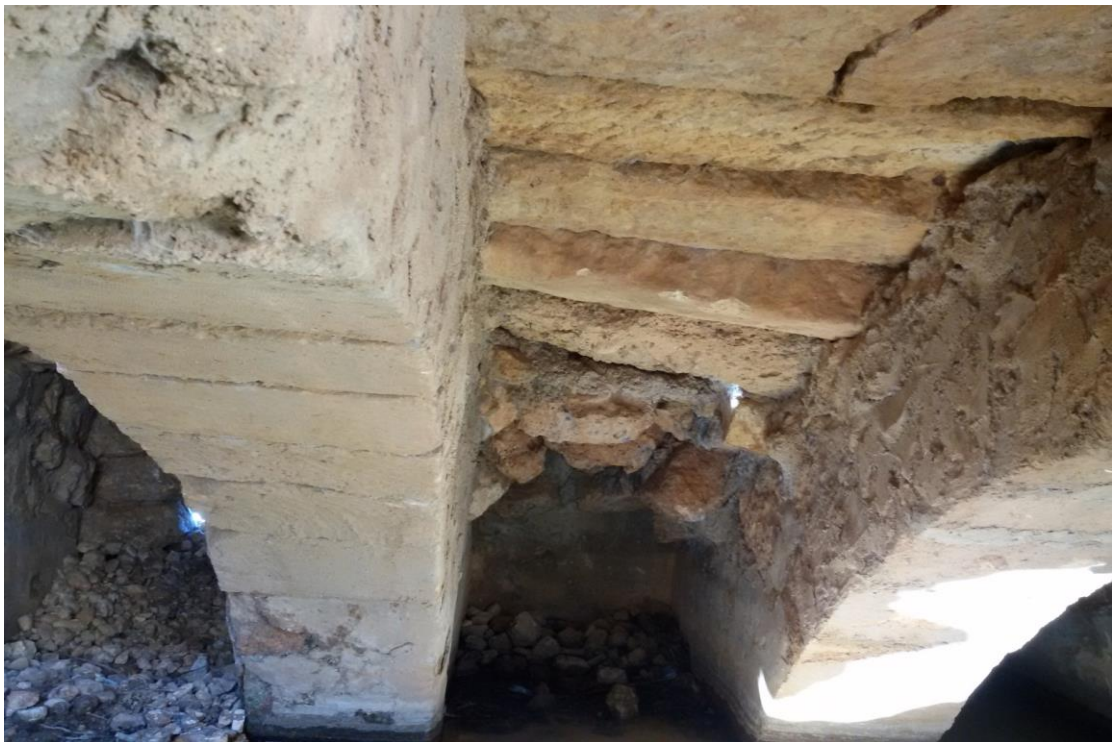
A structure was built over the spring using large stones/masonry supported by arches of medium sized stones

Damage due to weathering and neglect

This vaulted roof was subject to damage and fallen debris, which has collected in large portions of the spring. No restoration work has been done for an extended period of time.

The spring is currently in urgent need of restoration as exposure to the elements threatens to destroy an important historical structure. Additionally, it has long been the only source of water to the village.

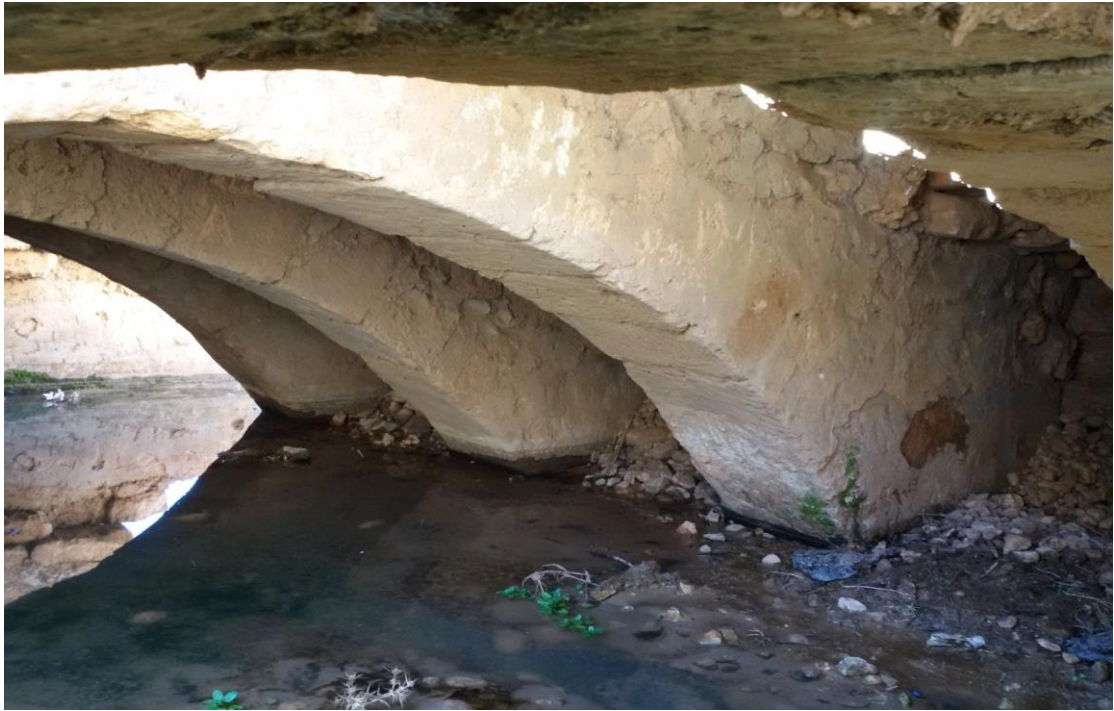
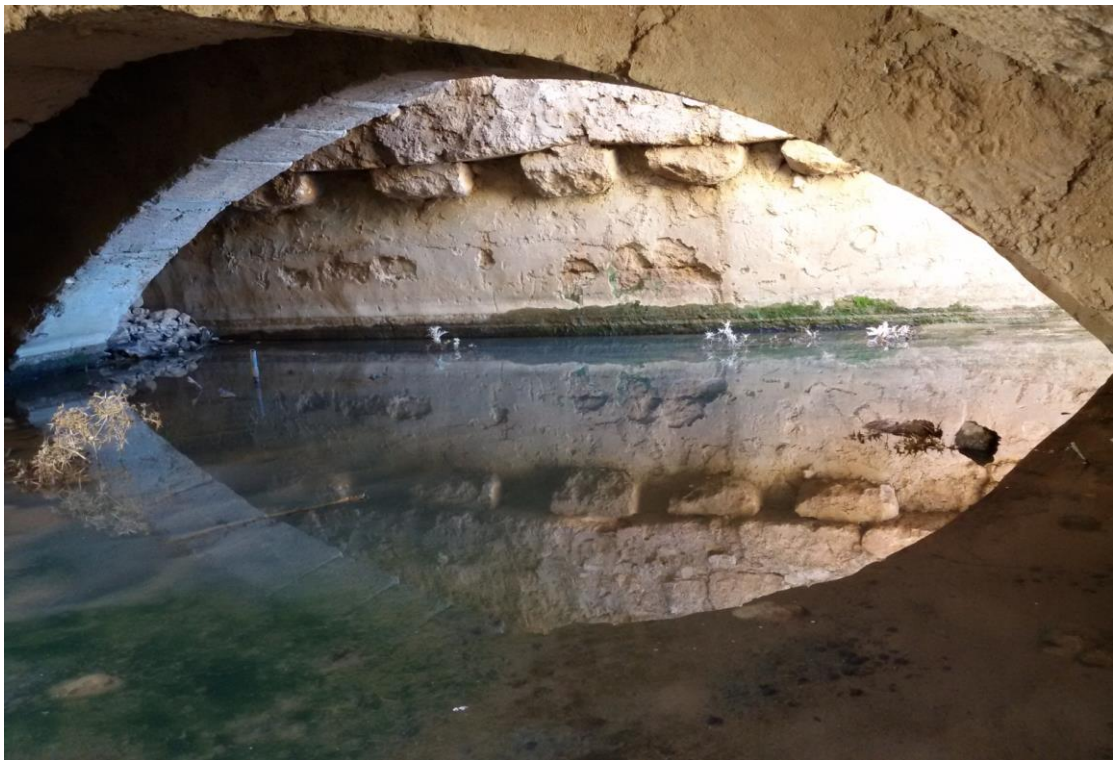
Most of the structure's unique features have been damaged or defaced. A cross that was carved into one of the stones is now buried by fallen rubble. This indicates that restoration or maintenance has not been carried out since the Byzantine era.
